Date of Report: September 29, 2015

BURNED-AREA REPORT

PART II - BURNED-AREA DESCRIPTION**A. Fire Name:** Canyon Creek**B. Fire Number:** OR-MAF-015292**C. State:** Oregon**D. County:** Grant**E. Region:** Pacific Northwest (6)**F. Forest:** Malheur**G. District:** Blue Mountain / Prairie City**H. Fire Incident Job Code:** P6JIK8 (0604)**I. Date Fire Started:** 8/12/2015**J. Date Fire Contained:** 95% contained as of 9/20/2015**K. Suppression Cost:** \$21,133,082 as of 9/14/2015**L. Fire Suppression Damages Repaired with Suppression Funds**

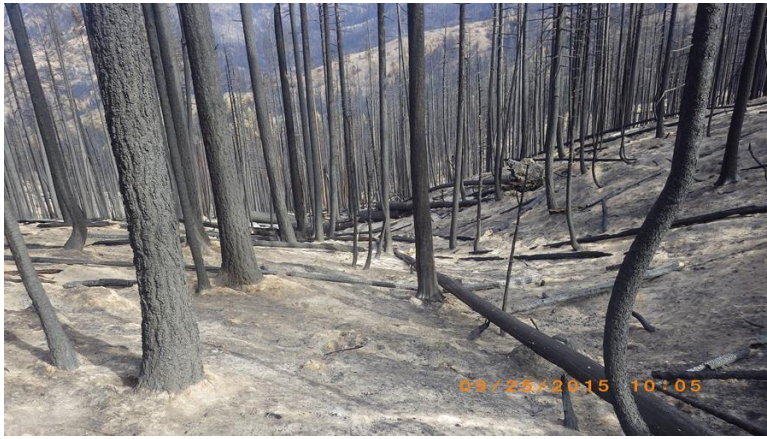
View of Rattlesnake Ridge looking down towards Berry Creek shows high severity burned soil accumulated in draws and prone to erosion.

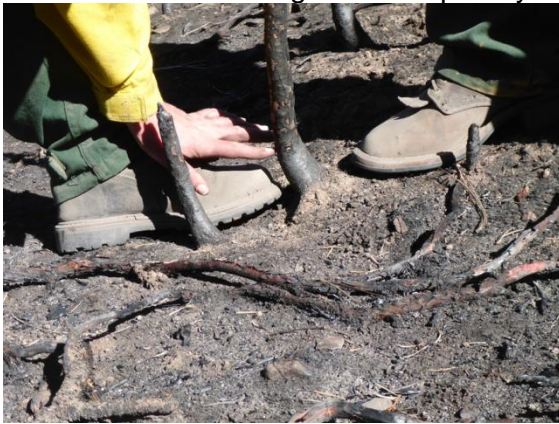
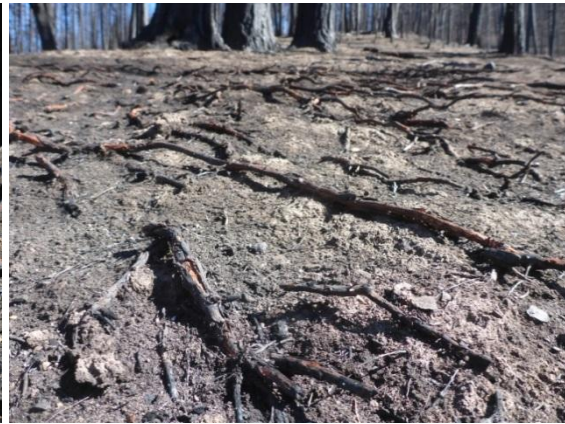
During the fire, one localized area of the Berry Creek drainage experienced winds of 50 mile per hour and greater due to its upwind canyon orientation. This localized area was observed to be primarily comprised of Mazama ash derived soils. Approximately 48% of the fire area is comprised of these types of soils. Portions of this area experienced significant wind erosion, where soil was removed from ridges and deposited in draws. Approximately 500-600 tons/acre was estimated as available for wind transport and erosion. A field check on September 25 indicated that much of the wind driven material remains in the drainage, but concentrated in the draw bottoms and hillside terrace features. It was determined that wood shred produced on-site would be the most effective treatment. Mulching will be most effective before another wind event, as the fine ash is very vulnerable to wind erosion.

Post-Fire wind erosion showing the susceptibility of A-Horizon Mazama derived soils in an area of the fire.

L3- Mulching – 2,449 acres (1,149 acres of non-wilderness and 1,300 acres of wilderness) of mostly high soil burn severity are proposed to be treated this fall within Berry Cr, Vance Cr, Pine Cr and Indian Cr. There is an additional spring mulch treatment proposed for 961 acres if monitoring shows the need.

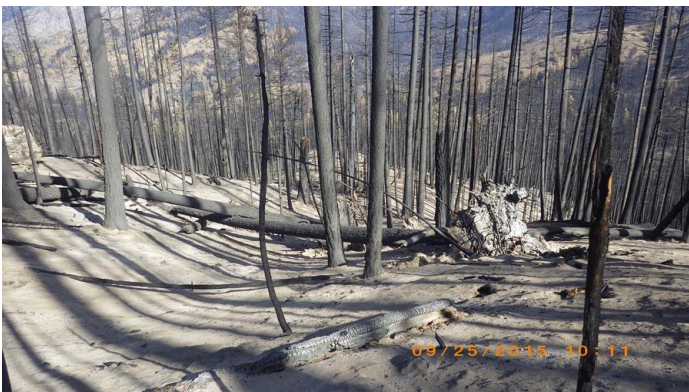
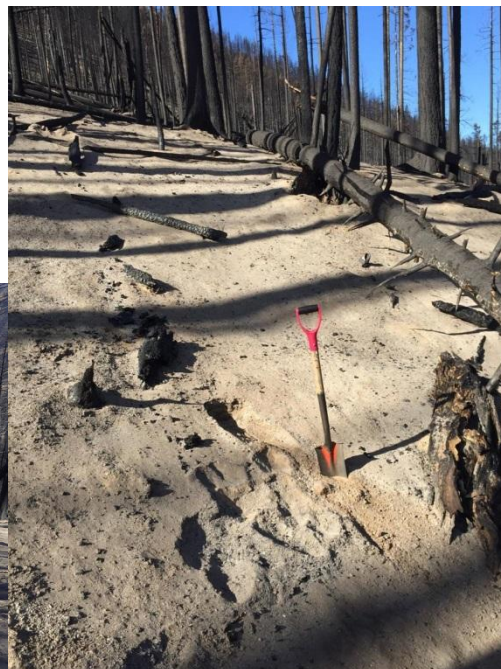
Photos below and to the right illustrate wind-blown burnt soil accumulations on the hillslopes and in the draws in the Mazama ash derived soils on Rattlesnake Ridge on 9/25/2015.

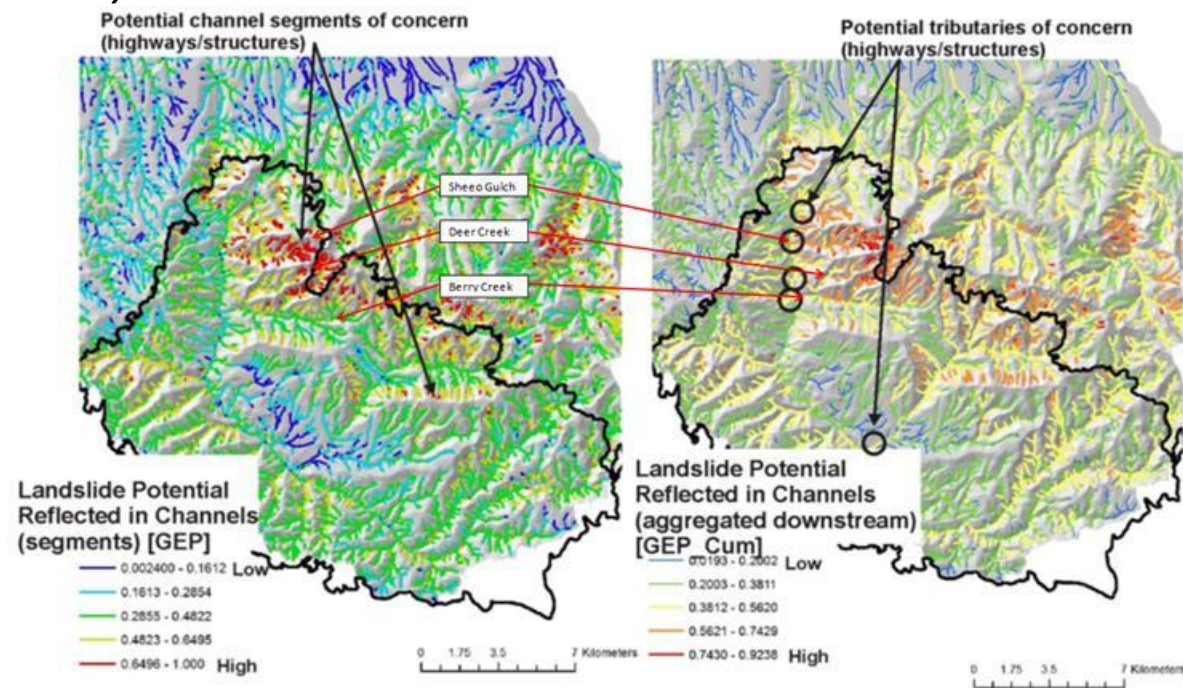
Field observations indicate Berry Creek and Deer Creek debris flow modeling were underestimated with the USGS model. This suggests most of the hazard in the Canyon Creek drainages are underestimated. With a NetMap modeling (www.terrainworks.com) analysis based on GEP (Generic Erosion Potential), which is considered the universal driver of shallow failure, regardless of geology or climate, and used in this assessment as a predictor for shallow failure that drives debris flows, the NetMap tool predicts high risk of shallow failure in Sheep Gulch and Deer Creek, and lower risk in Berry Creek. The geologic characteristics, and observed debris flow deposits in the Berry Creek channel indicate the creek and its tributary channels are also at high risk for debris flow. The underlying geology in Berry Creek is the Clarno Formation, a lahar and debris flow lithology prone to landslides. The high potential for debris flows in Sheep Gulch, Deer Creek, and Berry Creek may contribute considerably to the sediment potential in the event of shallow failure and debris flow. Observations of a debris flow initiated from a small fire (approx 6400 acres) in 2011 within the Berry Creek drainage included loss of bridges, deposits of bedload on alluvial fans, and indicates similar behavior will likely occur at a larger scale with any significant precipitation event.

Figure 1. NetMap shallow failure landslide potential with red arrows pointing at Sheep Gulch, Deer and Berry Creeks.

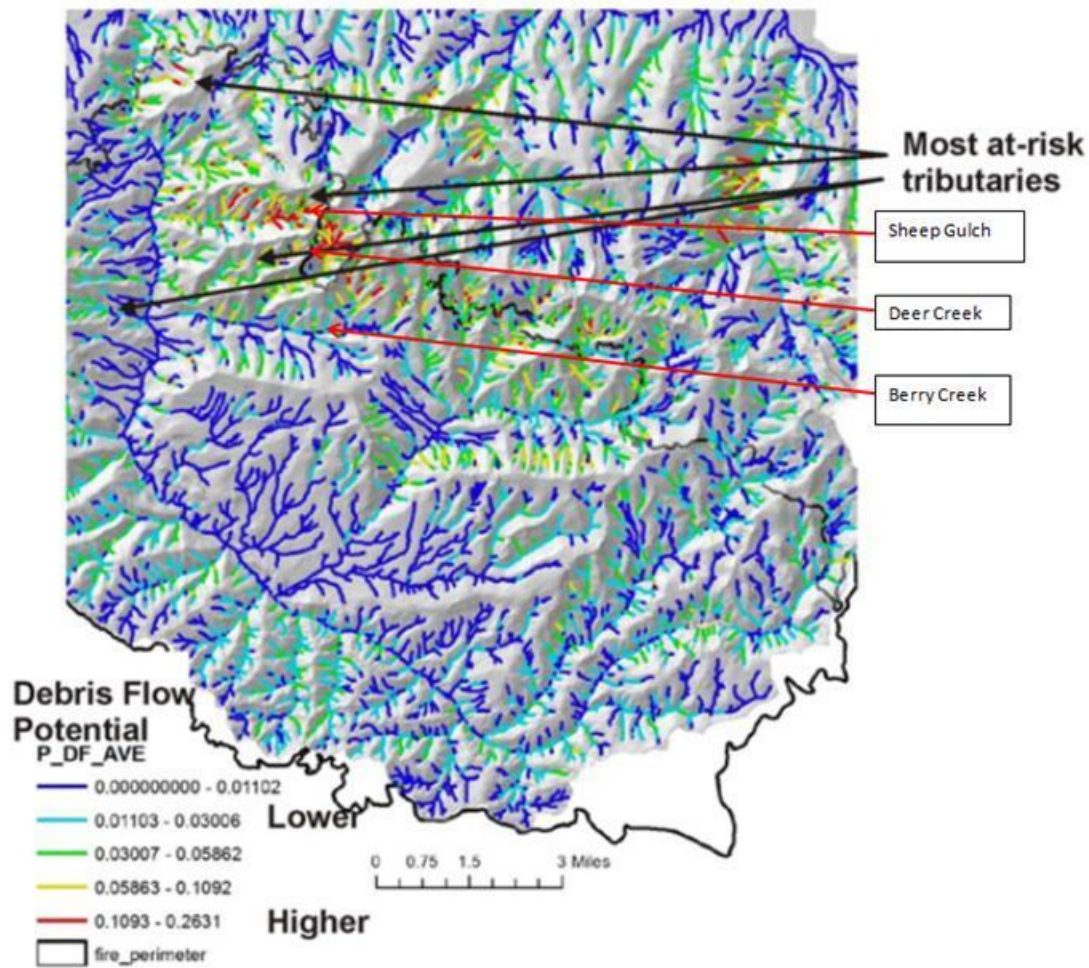
Figure 2. NetMap susceptibility of tributary debris flow with red arrows pointing at Sheep, Deer and Berry Creeks.

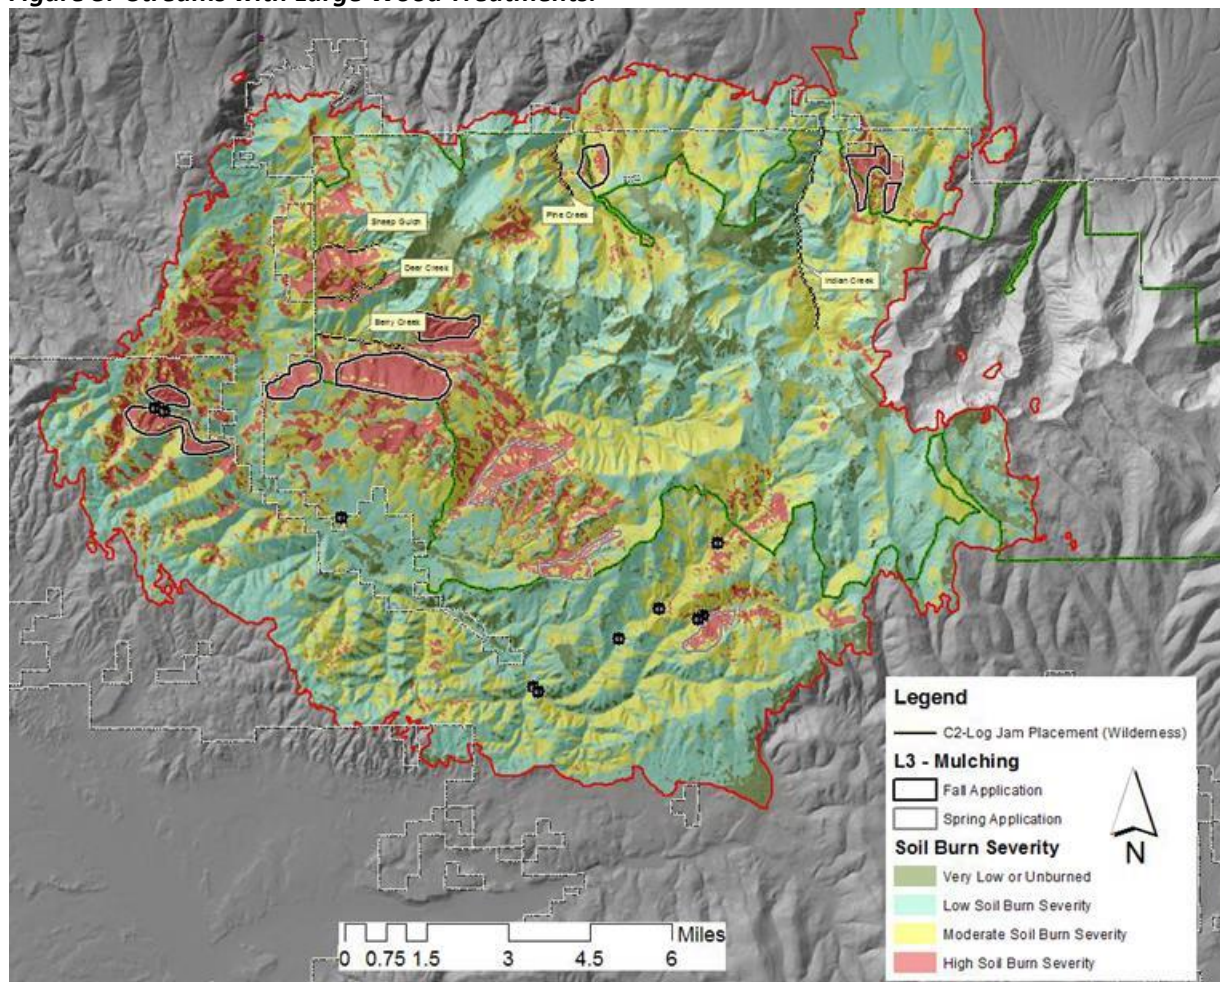
Figure 3. Streams with Large Wood Treatments.

Tributaries of Canyon Creek that drain Canyon Mountain. Elevation changes from 8,000 to 4,000 feet within 2-3 miles.

Five streams proposed for Log Jam Placement in Wilderness, mulching and other wood placement
