**BURNED-AREA REPORT**

**PART II - BURNED-AREA DESCRIPTION****A. Fire Name:** Damnation**C. State:** Montana**D. County:** Flathead**E. Region:** Northern (1)**F. Forest:** Flathead**G. District:** Spotted Bear      **H. Fire Incident Job Code:** P1HVV8**I. Date Fire Started:** August 11, 2013      **J. Date Fire Contained:** No active suppression**K. Suppression Cost:** <\$200,000**L. Fire Suppression Damages Repaired with Suppression Funds**

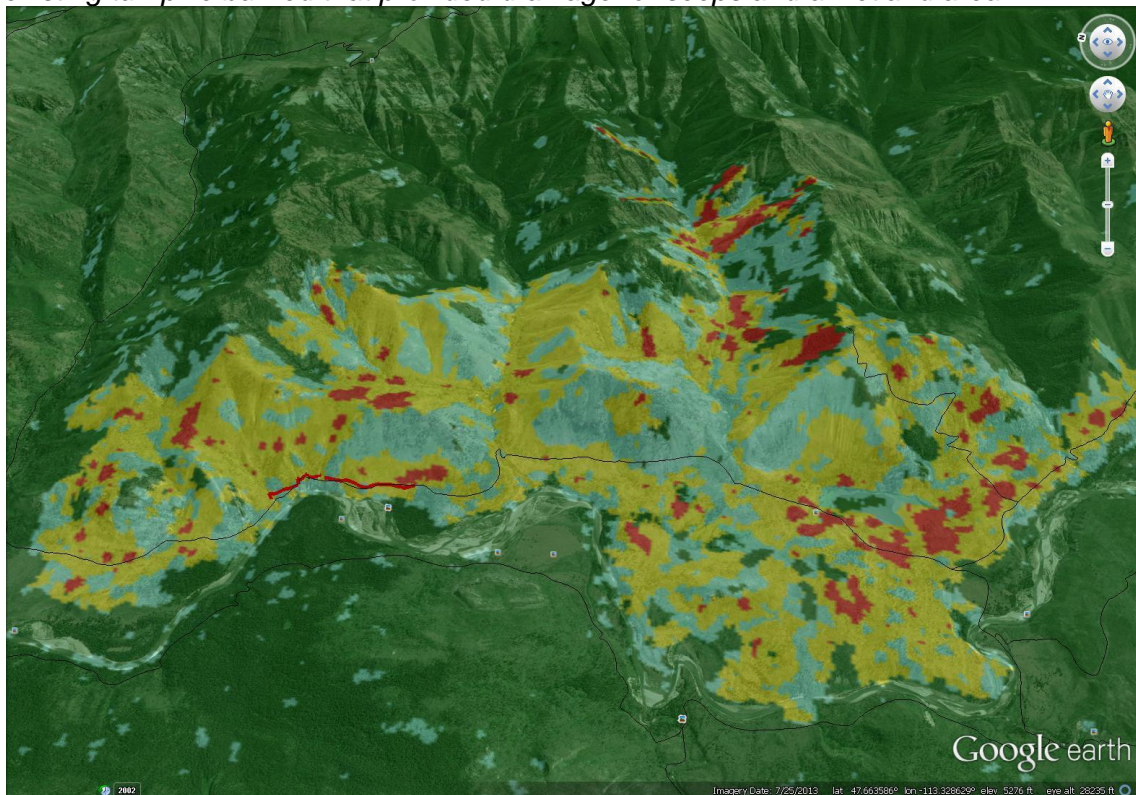
Figure 1. BARC imagery of Damnation Fire looking east. The South Fork Flathead River from the western boundary of the burned area. Trails are shown in black. High risk trail sections are shown in bold black and red.

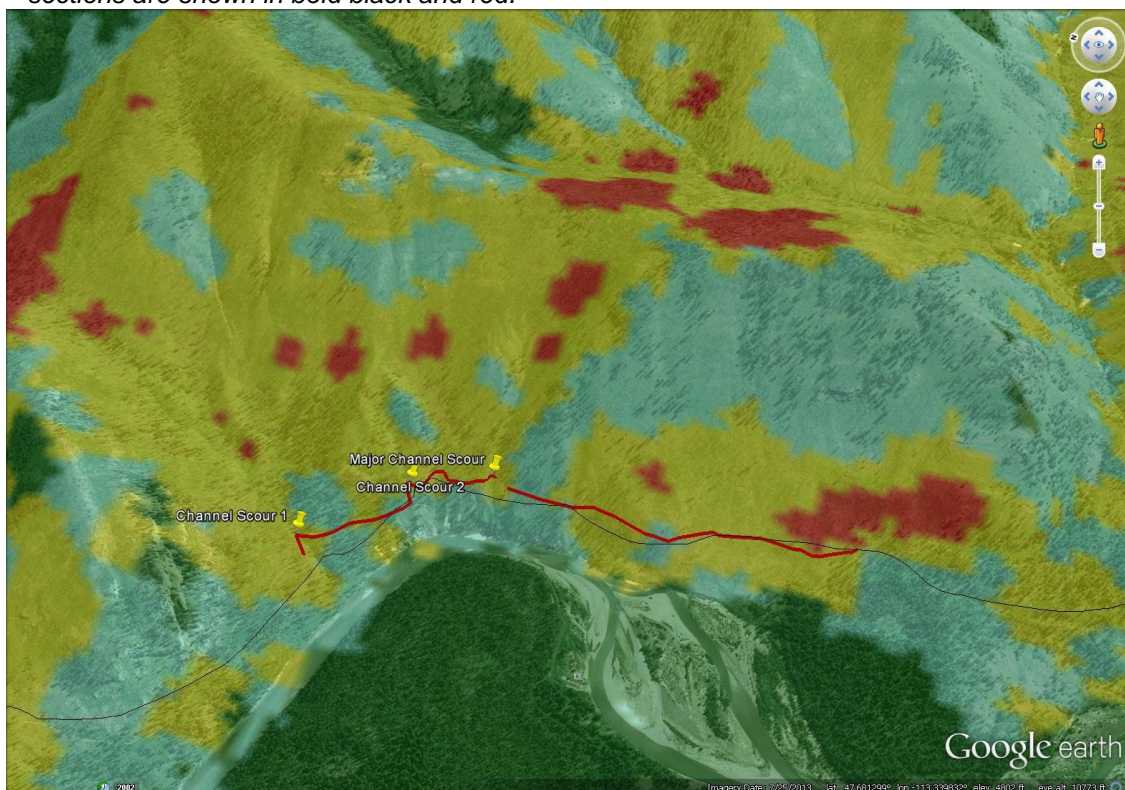
*Magnitude of Consequence: Major – Portions of Trail 80 are located on a very steep hillslope that has burned. It has been heavily damaged by recent flooding and more damage is very likely. Further damage will continue to impact the integrity of this trail. Additionally portions of Trail 470 is also on a very steep hillslope and has a high likely hood of trail tread damage accruing with future erosion and sedimentation. The consequence of further damage would be increased cost of repair.*

Figure 2. High risk sections of the main-line trail looking south. This section is located on a steep, linear hillslope above the SF Flathead River. Recent channel scour locations are highlighted.

*Risk Level: Very High – Complete trail inspection in all burned areas to ensure proper drainage structures are in place. Where needed, install water bars and other drainage structures to minimize the potential for surface erosion and sediment delivery. Considering the existing conditions found on the trails surveyed, trail damage and some off-trail erosion/sediment delivery to channels is likely to occur along identified sections of the trails with vulnerable conditions. Trail incision and complete loss of trail tread could occur, therefore resulting in loss of infrastructure possibly leading to significant repairs and costs to restore sections of trail. Loss of water control may lead to off-trail slope erosion and gully formation. Once active gullies develop, they can continue to erode during each storm event and contribute to downstream sedimentation and trail instability. Approximately 8 miles of Trail 80 runs along the valley bottom on the east side of the South Fork Flathead. This is the “main-line” trail that provides the primary access into the Bob Marshall Wilderness. Much of the trail has high future risk of direct sedimentation in the South Fork of the Flathead River. Trail 470 is 3 miles in length accessing the historic Mud Lake Look Out. There are*

- Install and/or maintain existing drainage control structures on 11 miles of trail that will reduce potential for further trail impacts and provide for safety along the trail.
- Remove hazard trees as necessary to provide safe environment for FS employees and trail users.
- Install signs to warn trail users of post-fire hazards.
