**BURNED-AREA REPORT**  
(Reference FSH 2509.13)**PART I - TYPE OF REQUEST**

**PART II - BURNED-AREA DESCRIPTION**A. Fire Name: GaviotaB. Fire Number: CASBC 004032C. State: CAD. County: Santa BarbaraE. Region: 5F. Forest: Los PadresG. District: Santa BarbaraH. Date Fire Started: 06-05-2004 I. Date Fire Controlled: Contained on 6/10, control expected 6/14J. Suppression Cost: approximately 5 million dollars

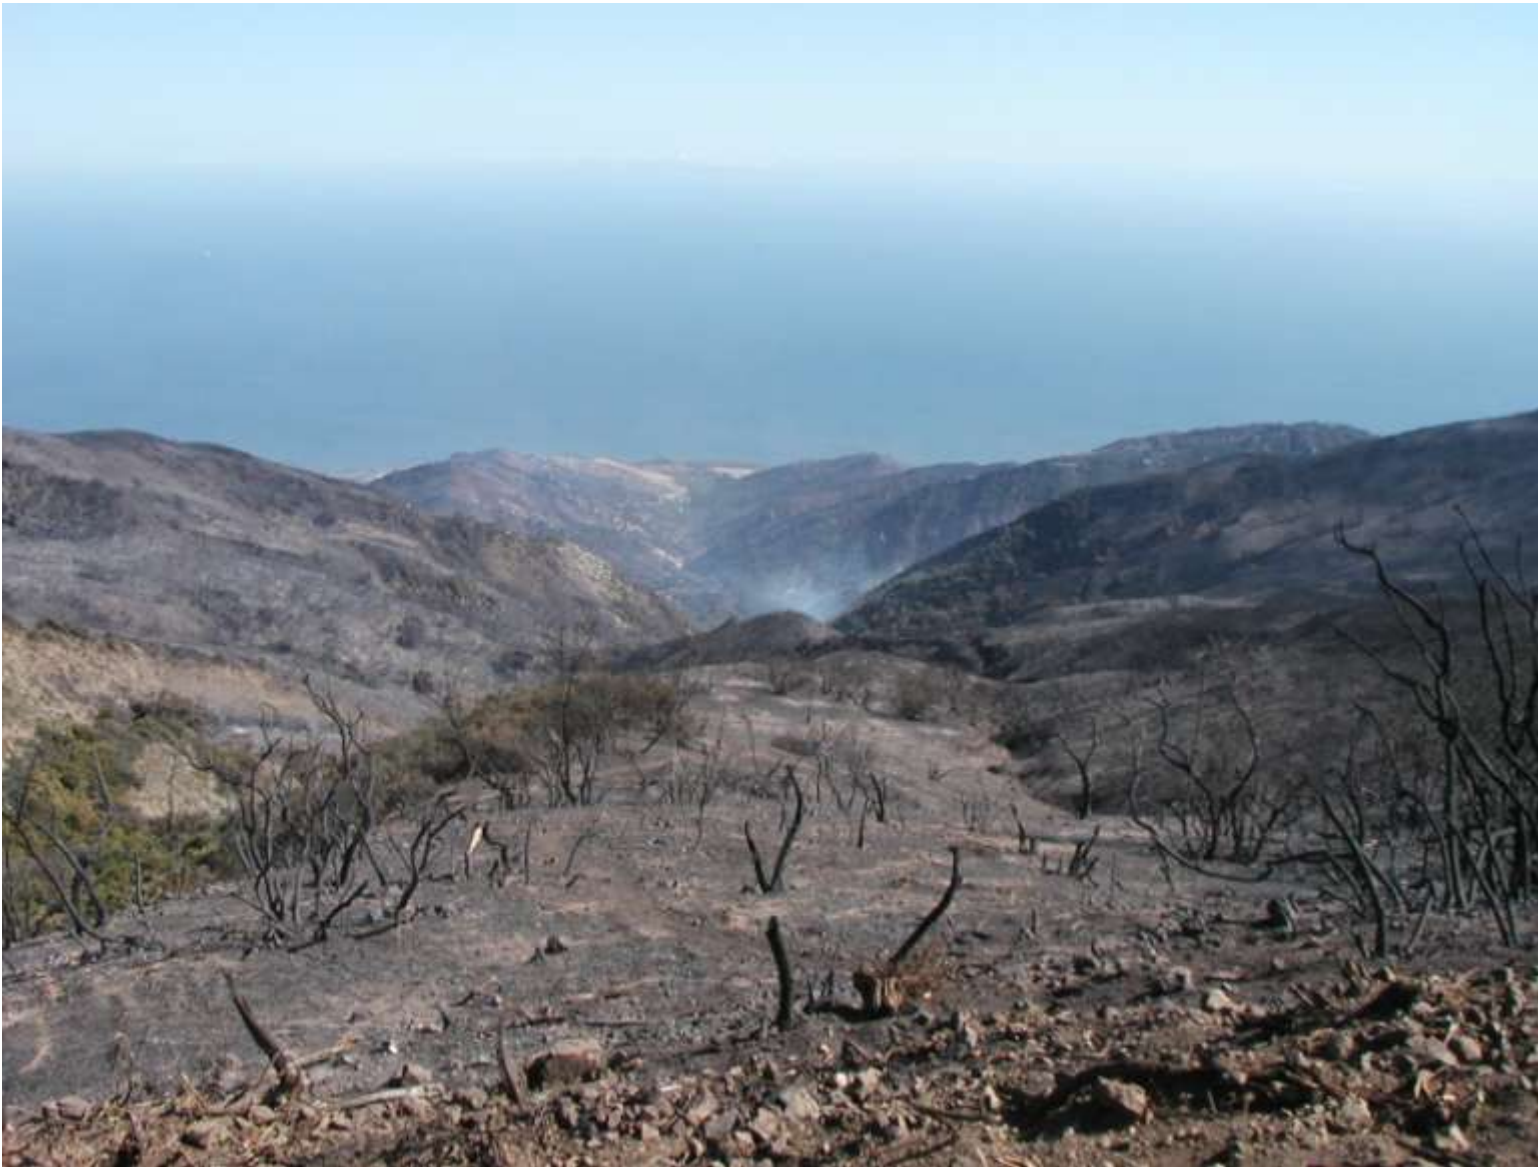
Photo #1. Looking down San Onofre Creek from USFS land on top of Gaviota Ridge. Hwy101 is at the terminal end of the drainage, against the coast.

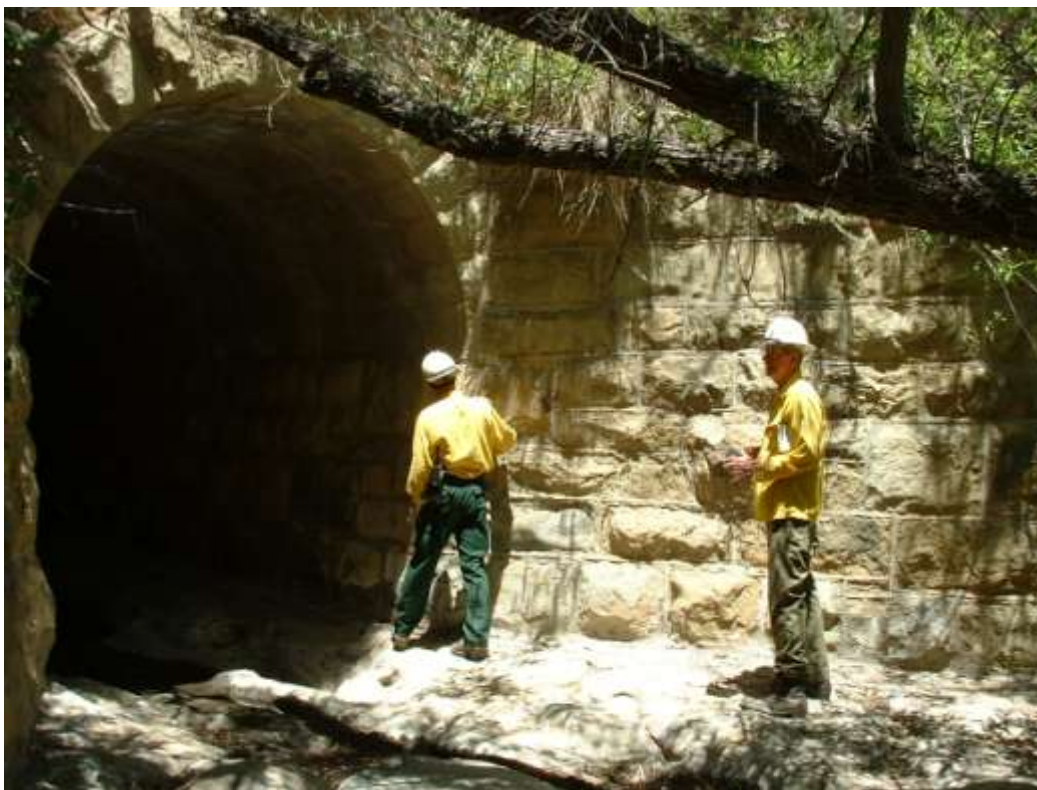
Photo #2. Exit of San Onofre culvert which runs under Hwy101 and Union Pacific Railway for 345 feet.

Possibly enlarge culverts, install risers at the catchment basins to settle out sediment, then clean these basins after storms, and install trash racks, or sediment basins. All of this work will be determined by and accomplished Caltrans or Union Pacific. There are no feasible treatments on USFS lands because of the steepness, and because USFS lands are at the very top of the drainage, whereas the risks are at the very bottom; any treatment done on FS lands would not protect structures below since there is too much burned area between the forest boundary and the areas at risk. The burned area of mid and lower slopes that would produce large amounts of runoff and debris due to its large area, are privately owned. Seeding is not recommended for any of the burned areas because research regarding seeding has shown that it is not effective in retarding soil movement in the Central Coast ecosystem (Robichaud, et.al. 2000). See the seeding criteria for the Los Padres National Forest (attached). Structural treatments on FS lands would be ineffective because most slopes are 60% or greater, making the probability of success in holding soil and water back very unlikely.

**Accomplishments:** No work was done on FS land for this treatment, and no BAER funding was used; all of this work was accomplished by Caltrans by improving Highway 101 culverts. Some of the culvert work was not completed before the heavy rains, and flooding of the highway resulted in several closures near Gaviota Tunnel, and the Gaviota rest area was closed due to mud and debris. All of the culvert upgrading for the burn area has been completed and the vegetation has re-grown to about 70% cover on average, so the likelihood of future flooding due to this burn has been greatly reduced.

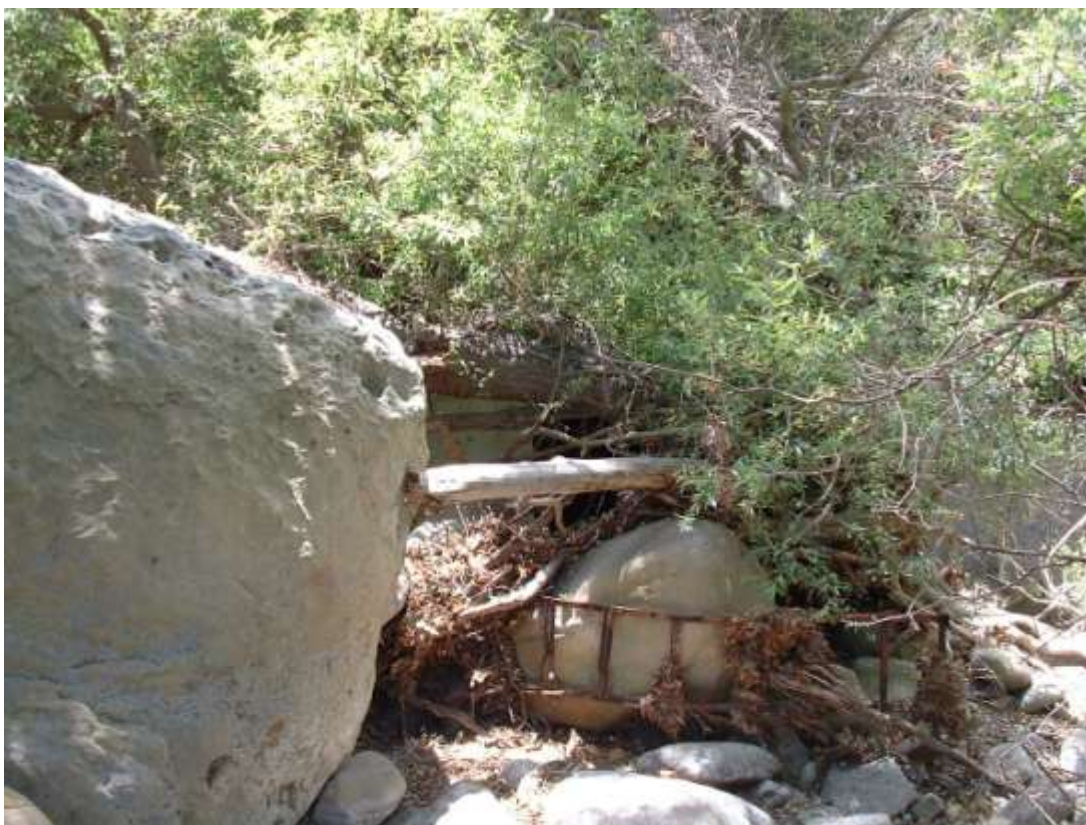
Photo #3. Debris blocking entrance to Posta Creek culvert.

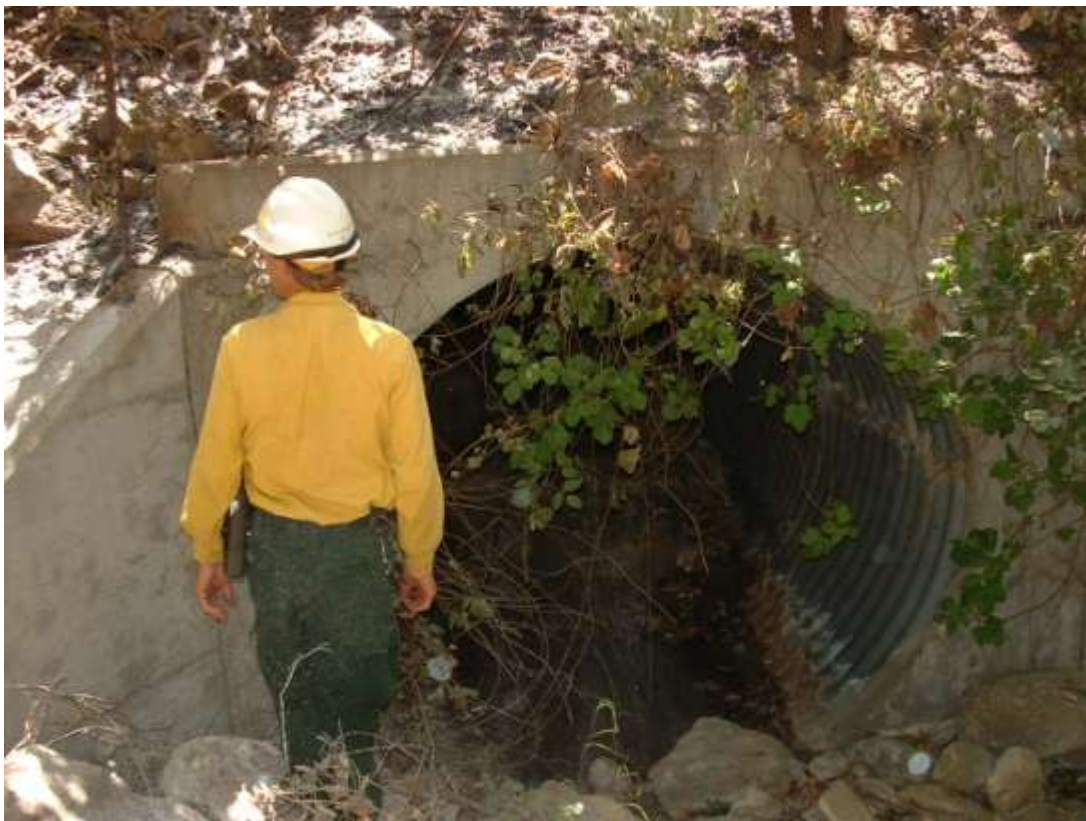
Photo #4. Tunnel Creek culvert.

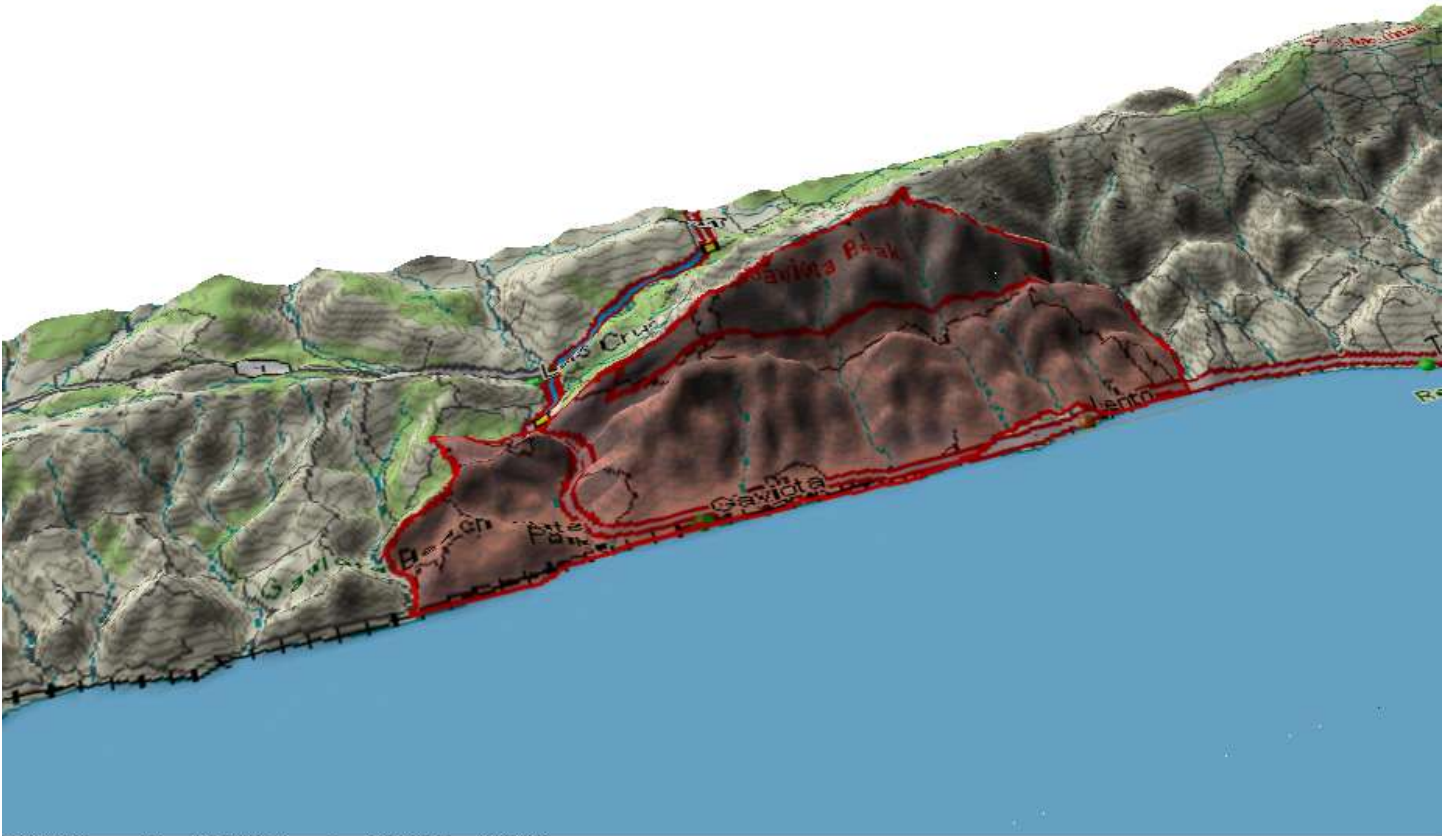
Map #2. 3d view of fire. USFS land is delineated with a dark red polygon at the top of the ridge. Culverts of concern are located at the highway (double dark red line) along the immediate coast.
