### **PART III - WATERSHED CONDITION**

### **PART V - SUMMARY OF ANALYSIS**

#### Introduction

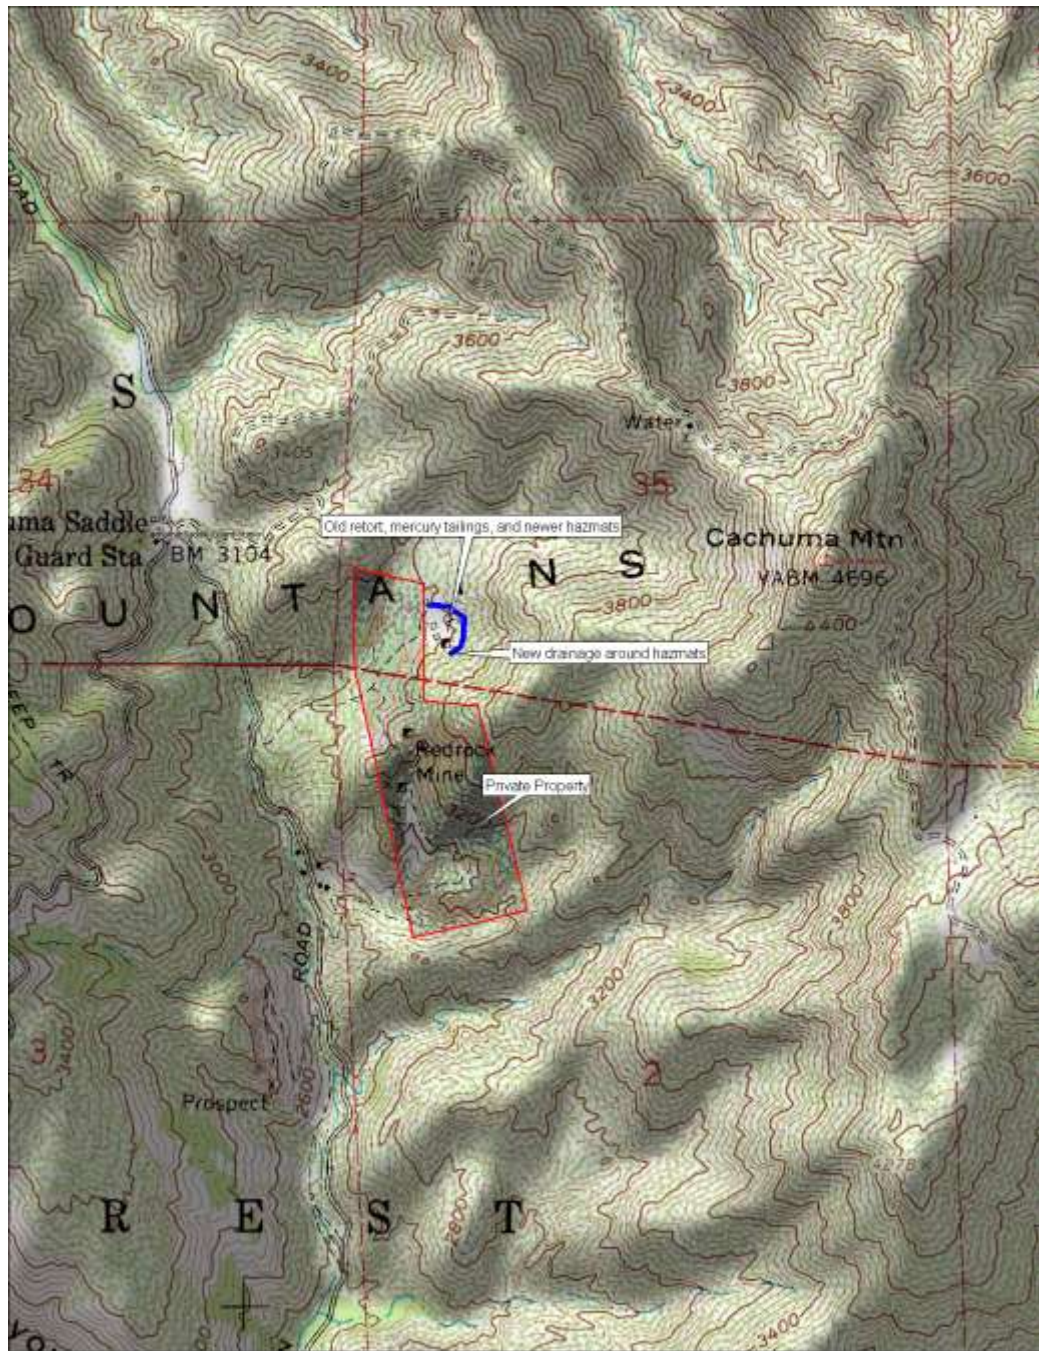
Map showing the Redrock Mine private land (red line) and the diversion around the hazmat area on NFS land (blue line).

Structures: In order to prevent water from the three drainages above the mine site from transporting hazardous materials into Cachuma Creek, the three small drainages (3.1 acres, 7 acres, and 3.6 acres) will be diverted onto the road above the mine and above any hazmats. This water will run down the road and enter a small drainage at the top of the mine site then flow through the mine area without affecting any hazardous materials. Santa Barbara County hazmat specialists and USFS hazmat specialists examined the site and determined this diversion would circumvent the probability that excess runoff generated by the burned watershed would rapidly deliver hazardous soil and hazardous wastes into Cachuma Creek. A small bulldozer and backhoe will be used to in-slope the road to an appropriate depth and to berm the areas where the drainages hit the road in order to capture sediment and prevent the water from flowing down into the mine area. The diversion will be re-visited up to three more times during the first winter to remove excess sediment, re-build berms, and clear the channel. Most of the sediment loaded in these channels through dry ravel will unload during the first storms. Once the bulk of this sediment is removed, the total volume of water coming off of these drainages will easily be held by this channel system. The road was impassable and unused before the fire, but was re-established as an attempted fire line during initial attack. This road is on USFS land, and there is no need or use for this road other than the intended water diversion at this time. This road will experience some erosion from water flow, but the base material that it will flow over is fairly solid rock, and unlikely to fail completely as a watercourse. After 5 to 7 years, when the vegetation has completely stabilized the site, and the threat of transporting hazardous materials is reduced, this diversion will be rehabilitated with other funds as available.

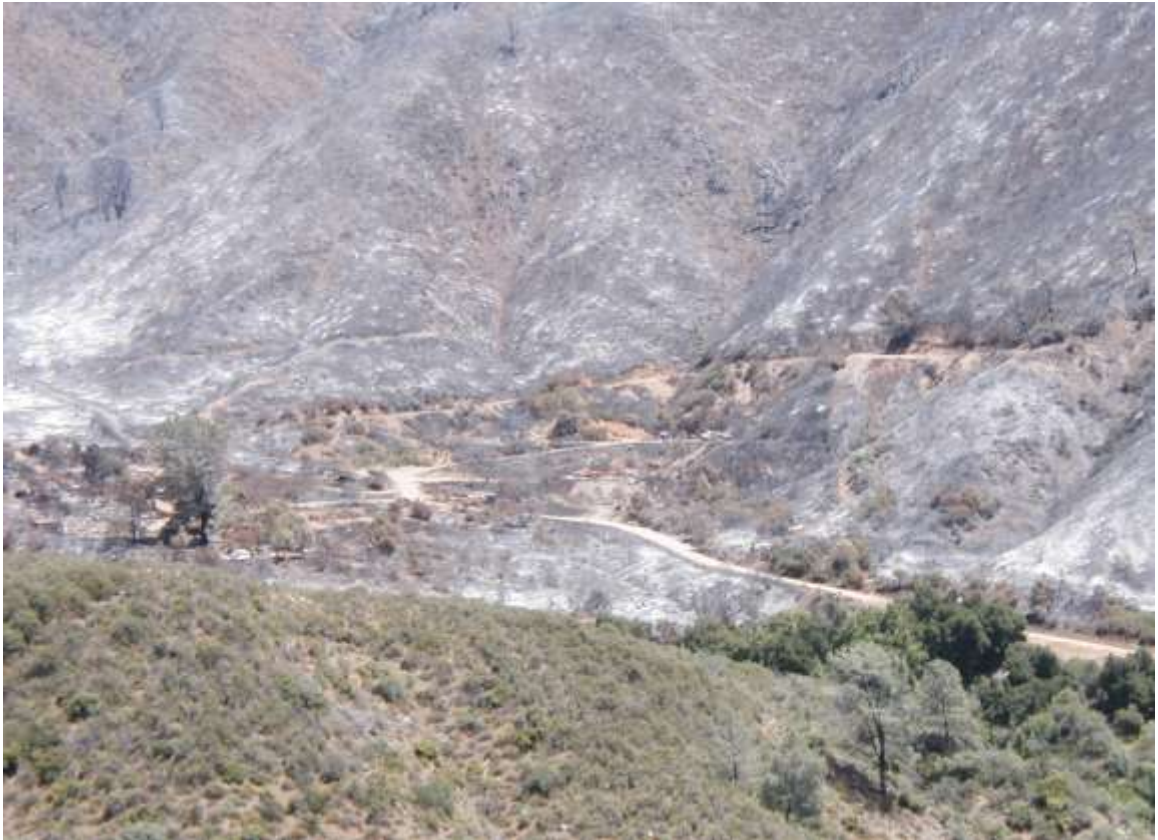
Photo 1. Looking into the mine area. Note the upper road where water from the drainages will be diverted to the left and into a natural drainage clear of hazmats.

**Results: The diversion was created as planned along the abandoned road during the fall of 2004, and withstood the heavy rains (over 70 inches) of winter. All three drainages eroded heavily above the road diversion, indicating high energy flows occurred there, but these drainages remained stable with very little sign of water flow below the road diversion, thus preventing mobilization of mine wastes and other hazmats. This diversion was maintained once during the winter. After one year, the vegetation coverage is approximately 60 percent, greatly reducing the potential for hazmat mobilization during subsequent years.**

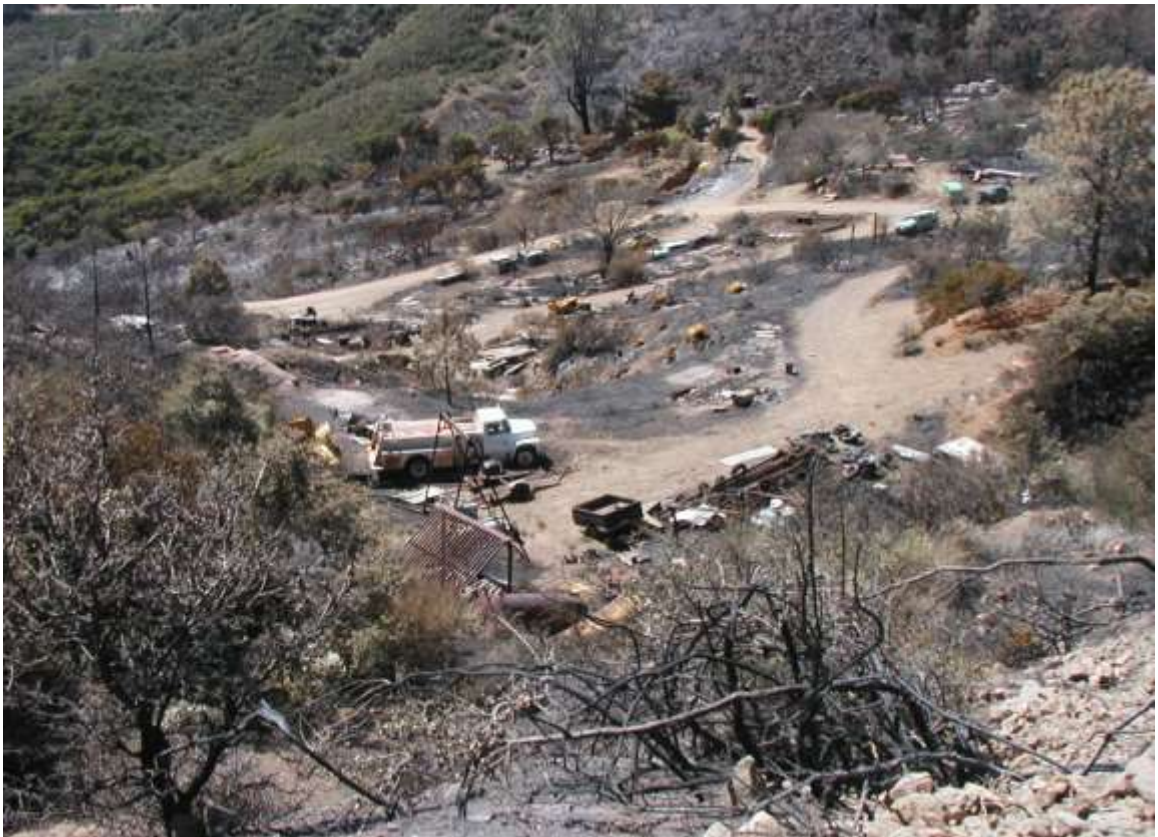
Because the fire will increase runoff and erosion into the mine site (on National Forest System land), there is an increased risk of contaminated soil from the mercury processing site being washed into Cachuma Creek. Mercury compounds from the condensing operations often accumulate in the soil around the retort from fumes, from old condenser equipment, and from tailings left from cleaning the retort. Above normal mercury levels in the air were detected by Santa Barbara hazmat investigators at this site in confined areas. Soil testing is presently under way. Another indication that soil at this site may have elevated mercury is that two firefighters on initial attack experienced a type of dermatitis consistent with mercuric sulfite exposure, which may be released from the soil with heat from the fire. Other similar mines in this area (Rinconada and Deer Trail Mine in San Luis Obispo County on Los Padres NF) have elevated soil mercury at the retort site, and are presently under CERCLA cleanup. The values at risk downstream of the Redrock Mine from mercury and other hazardous materials are the following: Cachuma Creek supports a recreational trout fishery that is stocked every spring; there is

Photo 2. Looking down onto the mercury processing site and adit. The bottom  $\frac{3}{4}$  of this photo is NFS land. There are many hazmats scattered throughout this area, as well as elevated mercury levels in the soil.

Objective: The objective is to divert the excess water and sediment resulting from the fire that will enter the hazmat site into a safe passage around the site and that will not move hazardous materials from either Forest or private land into Cachuma Creek. Water from the slopes above the site will be diverted completely around areas that have been identified as hazardous by the Santa Barbara County and by USFS hazmat specialists.
