BURNED-AREA REPORT
(Reference FSH 2509.13, Report FS-2500-8)

A. Fire Name: **TatooshCedarVan** B. Fire Number: **WA-OWF-550; WA-OWF-553; WA-OWF-638**

NOTE: This 2500-8 includes 3 fires from the same area: Tatoosh Complex, Van Peak and Cedar Creek.

G. District: **Methow Valley Ranger District** H. Fire Incident Job codes: Tatoosh Buttes: P6C4WZ; Cedar Cr.: P6C4U1; Van Peak: PNC6LK

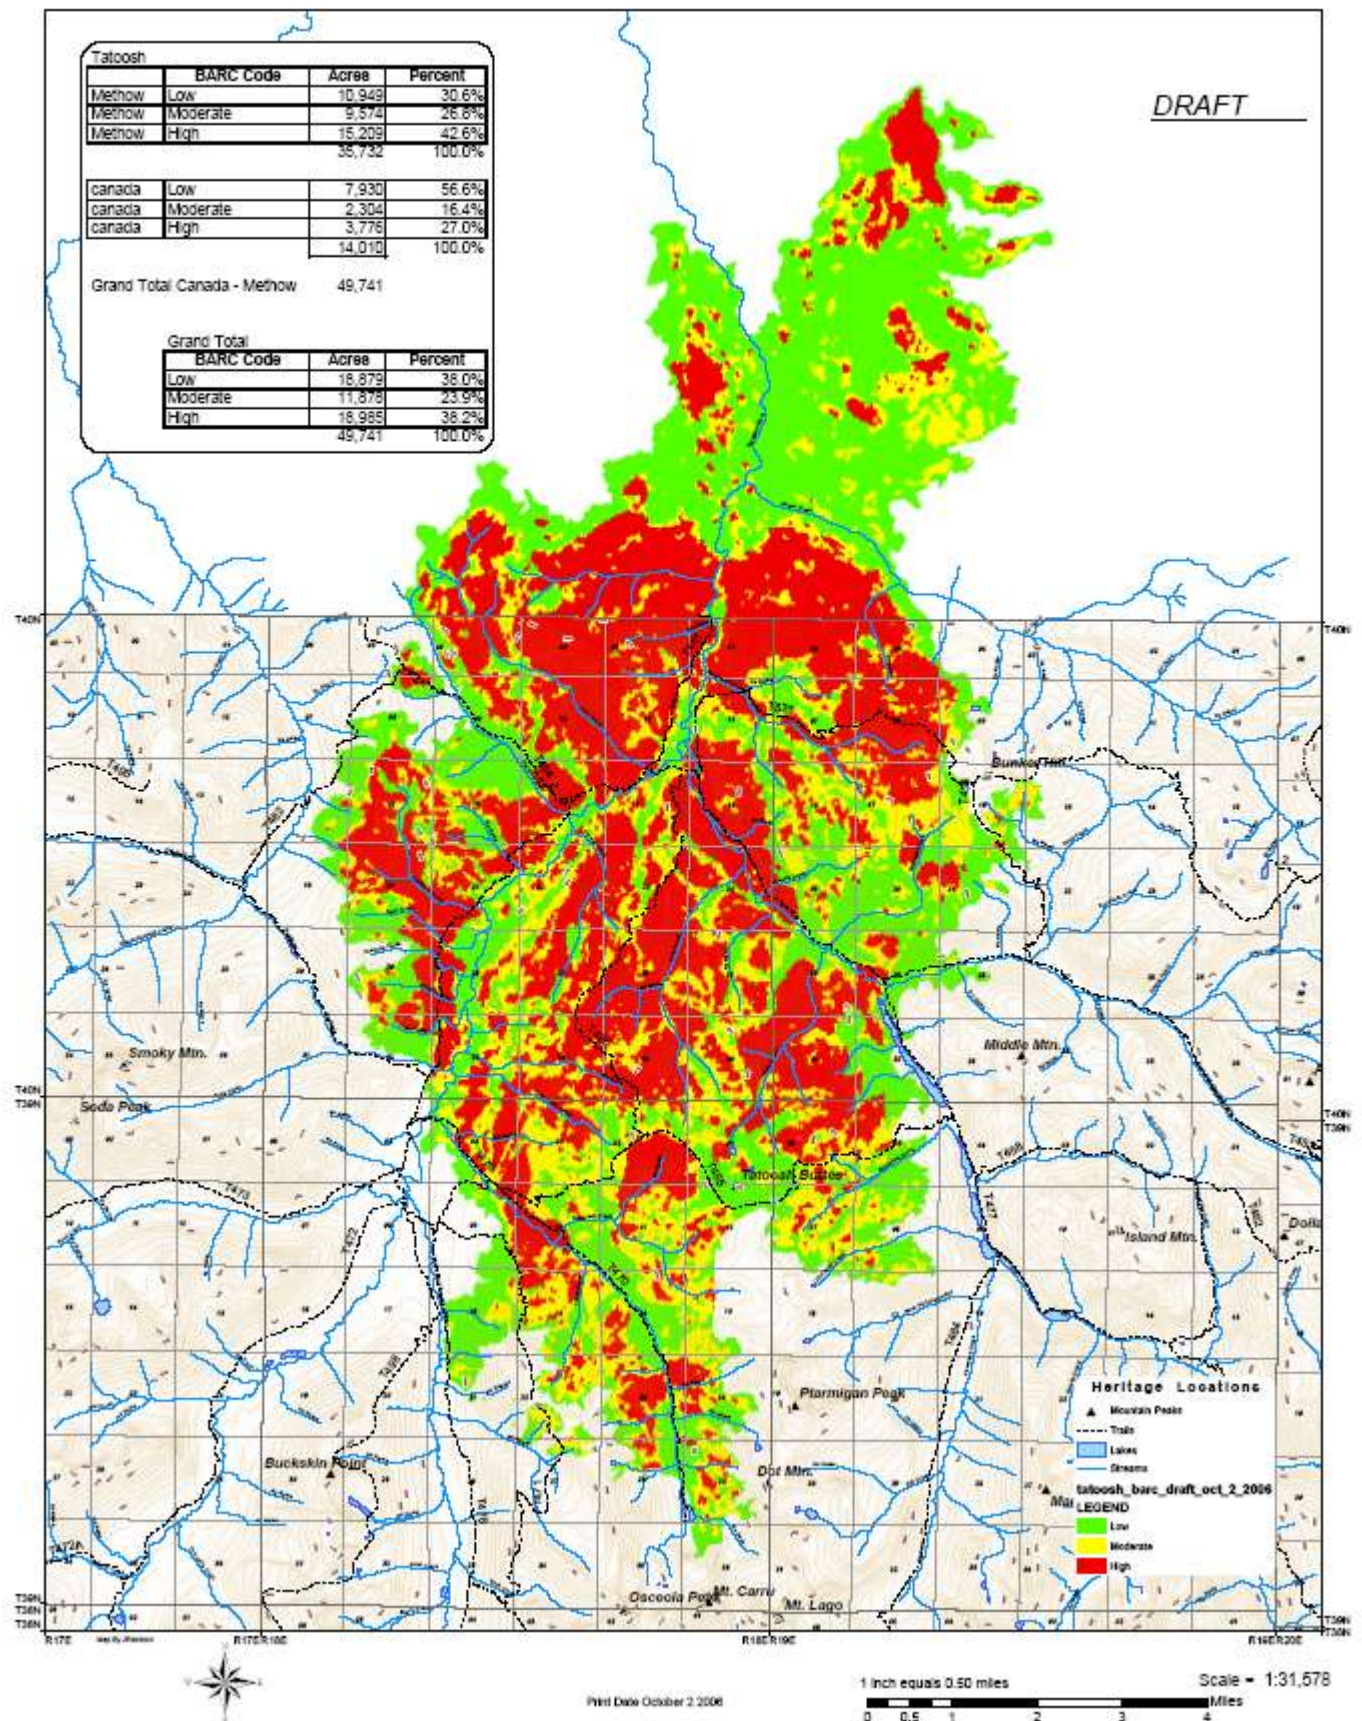
Tatoosh Incident Severity(BARC Codes) Map

Tatoosh	18879 low	11878 moderate	18985 high	1930 unburned
Cedar	841	722	99	
Van Peak	775	906	131
