**KERLIN FIRE BURNED-AREA REPORT**  
(Reference FSH 2509.13)

Subject: Kerlin Fire Burned Area Report

A. Fire Name: Kerlin Fire B. Fire Number: CA-SHF-001438  
C. State: CA D. County: Trinity  
E. Region: 5 F. Forest: Shasta-Trinity  
G. District: SFMU H. Fire Incident Job Code: P5L4KN18  
I. Date Fire Started: 9/12/2017 J. Date Fire Contained: 9/20/2018  
K. Suppression Cost: \$7.6 million

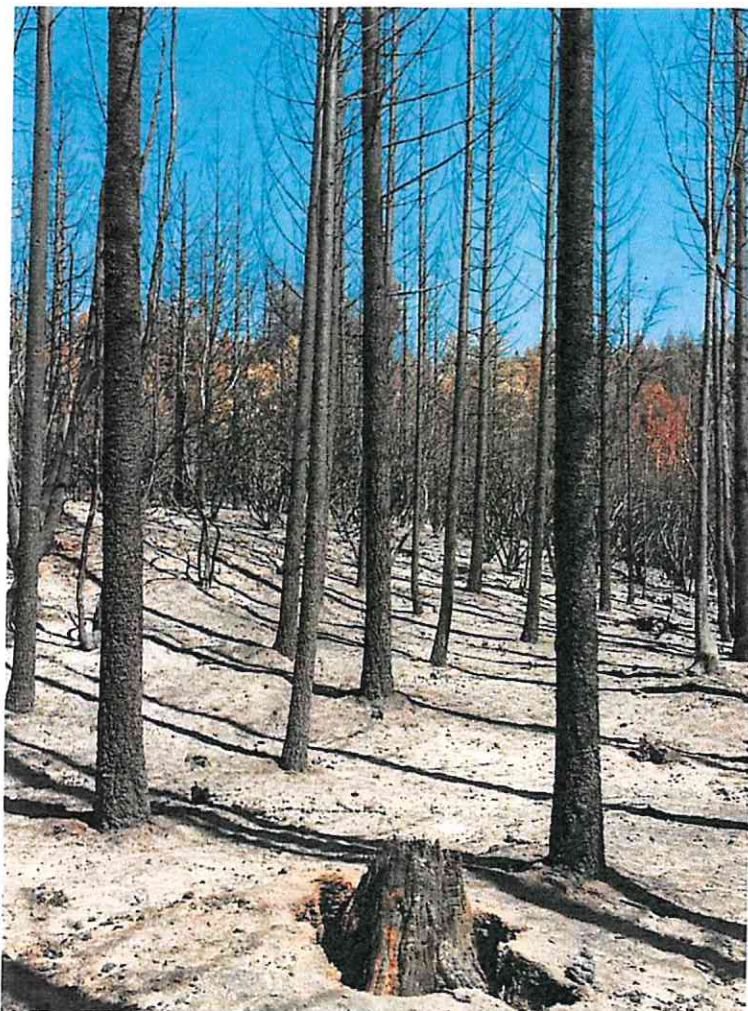
Kerlin Fire in a burned plantation above Hyampom, CA

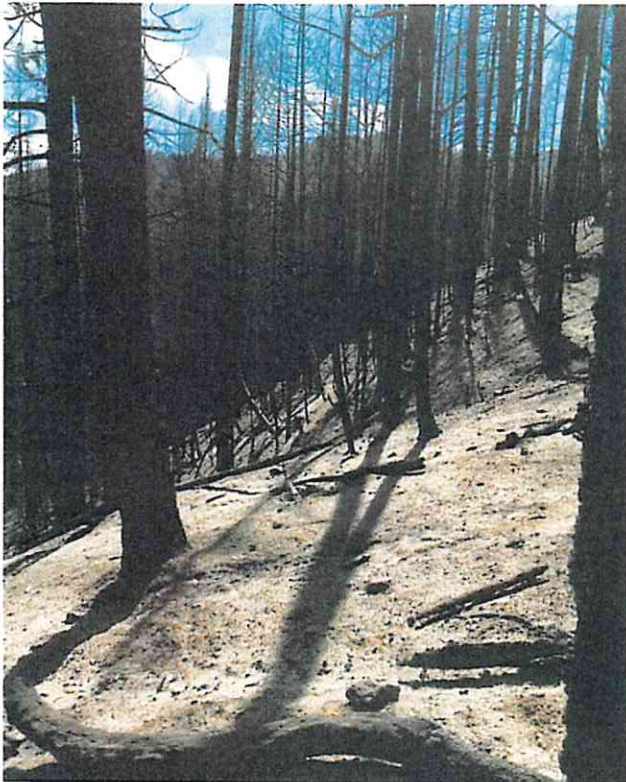
General trends ridges burned moderate to high severity fed by aligned up-canyon South Fork River winds. Midslope areas burned moderate and lower areas along creeks and the Trinity River had low burn severity. In high soil burn severity areas on mixed brush/Douglas Fir/tanoak in Kerlin Creek had deep water repellency, deep, soil char, and repellency to 2 inches.

Kerlin fire high soil burn severity in gravelly loams

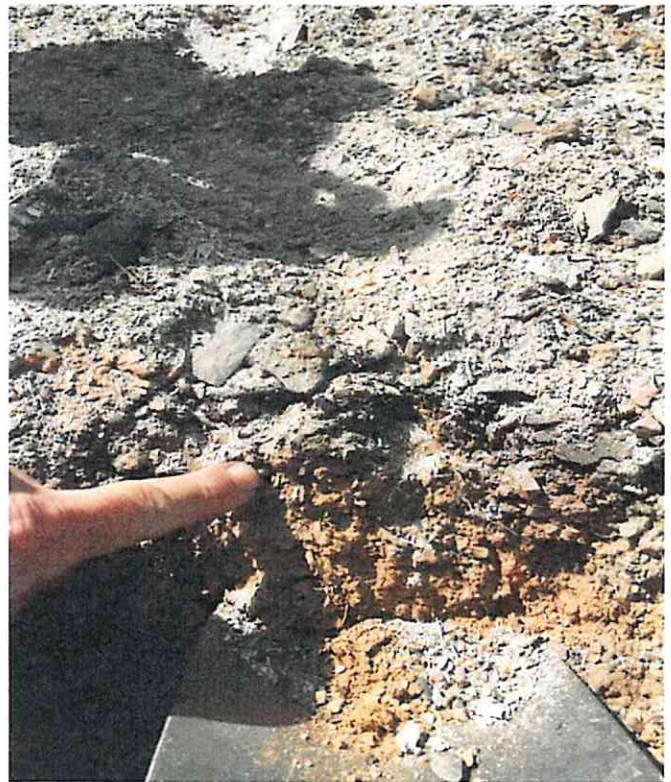
High soil burn severity topsoil destruction
