BURNED-AREA REPORT
(Reference FSH 2509.13)

A. Fire Name: Murphy Complex

Accomplishments for the Murphy Complex BAER
(As Of July 21, 2011)
Nogales Ranger District
Coronado National Forest

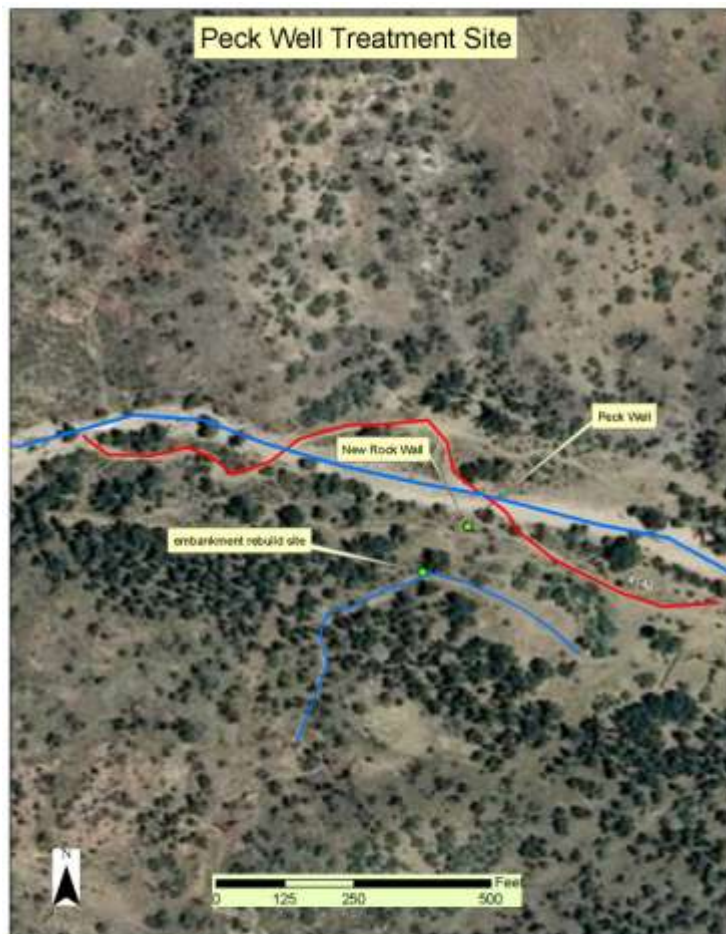
At Peck well, an embankment that was created long ago to protect the well on a secondary channel was failing at a critical point. It was determined that any increase water flow would further degrade this critical point, and eventually allow water and sediment to impact the well. A treatment of rebuilding the embankment at this point to match the rest of the embankment wall was implemented. Class III and larger riprap was installed on this rebuilt area to further strengthen it. The channel was out sloped away as best as possible from this rebuild section, as well as widened by 4 feet to reduce any velocity that could occur from increased water flow. In the main Peck Canyon channel adjacent to the well, a class III and larger riprap wall was created to add shielding to the structure of the actual well. All materials for both treatments were collected from on site.

Both treatments were carried out under the Coronado Roads Maintenance IDIQ contract, with Trinity Southwest Contractors as the chosen contractor to do the work. A front end loader and backhoe were utilized in this treatment. Both pieces of equipment were chosen due to their mobility in accessing the well site, and ability to handle the road into the area. The work was completed in one day.

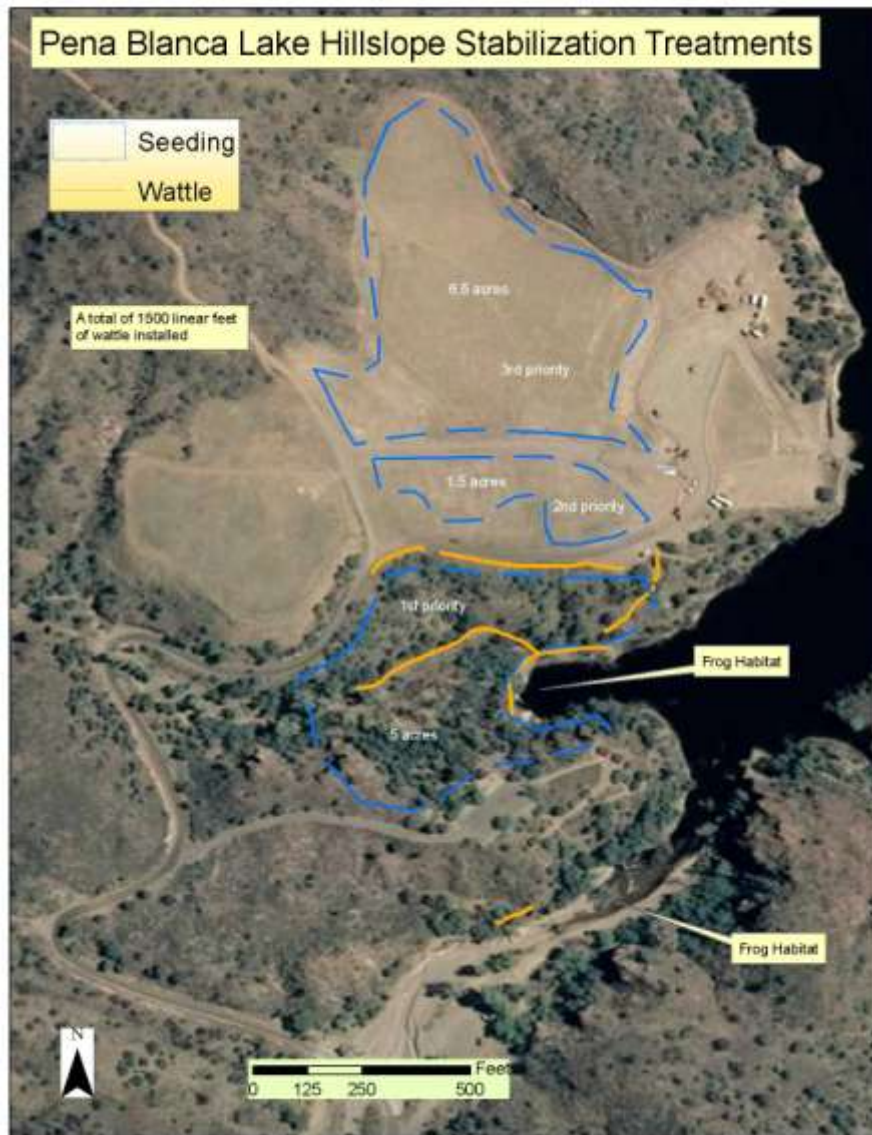
Straw Wattles

It was identified in the assessment that the hill slope area around the recreation areas of Pena Blanca Lake were at risk due to the burning off of the existing vegetation during the fire. The two inlets on the south end of the lake (Lower Thumb and old boat ramp areas) were identified specifically for Chiricahua leopard frog habitat. The 1st treatment installed in these areas was a watering system, with the intent to provide early and available water for vegetation to resprout. One watering system was at the lower boat ramp area, and one was at the upper cap area just above the new boat ramp and the Lower Thumb area. Both watering systems operated for 3 days prior to watering being ordered suspended.

Straw wattles were purchased for various treatment sites. A total of 2000 linear feet of wattle was ordered, along with 873 wooden stakes. Due to the rocky ground around Ronquillo Pond, and in places where wattle was installed at Pena Blanca Lake, rebar was used to stake the wattle in place. Rebar caps are being used as a safety measure to mitigate any issues with the general public that uses these areas.

The third treatment installed was a light reseeding with a native grass mix. This grass mix was acquired from a local source used by the Forest, and currently being used on other BAER projects with reseeding as a treatment. It is a species mix, the basis of which was formulated during last major fire restoration efforts on the Nogales District. Species include: *Aristida purpurea* / Purple Three, *Bouteloua curtipendula* / Sideoats Grama, *Bouteloua gradilis* / Blue Grama, *Bouteloua rothrockii* / Rothrock Grama, *Leptochloa dubia* / Green Sprangletop, *Plantago insularis* / Indian Wheat, *Schizyachrium scoparium* / Little Bluestem, *Setaria macrostachys* / Plains Bristlegrass, and *Sporobolus cryptandrus* / Sand Dropseed. This native grass mix is weed free, and applied at a rate of about 40% to 50% coverage. Straw mulch was intended to be installed on top of the seed, mainly on the upper cap area above the lake. But due to exposed nature of the area (wind conditions and flat terrain), it was deemed that this would be an unsuccessful treatment, and it was not installed.

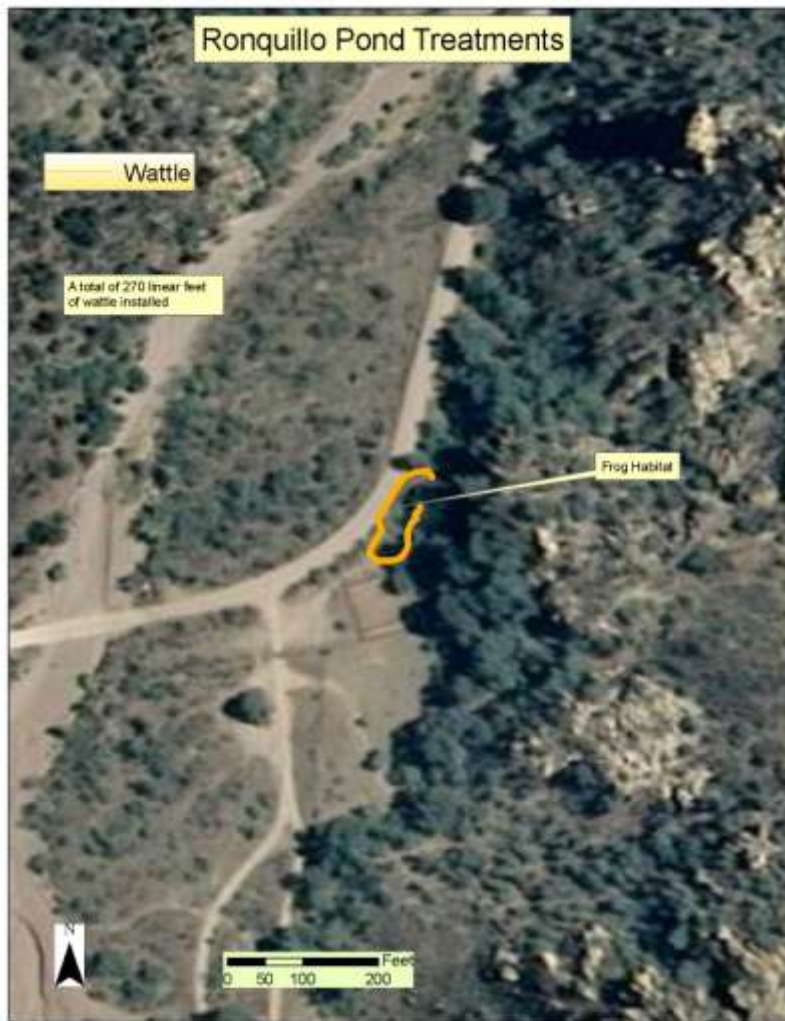
Cleaning Ronquillo Pond Sediment Traps

It was identified in the assessment report that the Ronquillo Pond and sediment trap was in need of treatment. Please refer to the documentation above concerning the Alamo Canyon Sediment trap and the decision for no treatment. Also as part of this overall treatment, the Ronquillo pond area was identified as needing protection from surface water flow. The idea is to keep sediment from infiltrating into the Chiricahua Leopard frog habitat of the pond itself thru the monsoon rain season. Upon evaluation of the site, it was determined that wattle installation would be the appropriate treatment to protect the pond. A total of 275 feet of 12" wattle was installed around the pond using local Nogales Ranger District staff (Engine 522, and Recreation Staff) in one day. This was not a complete circling of the pond, but installation of wattle so that the most likely source of any overland flow would be intercepted by the installed wattle. This was also the day that the media was covering the Murphy Complex BAER treatments.

Out of the total of \$6137 allowed for this treatment, \$1486 dollars have been spent in the planning, evaluation, materials, and treatment installation around the pond. No funds have been spent cleaning out the identified sediment traps.

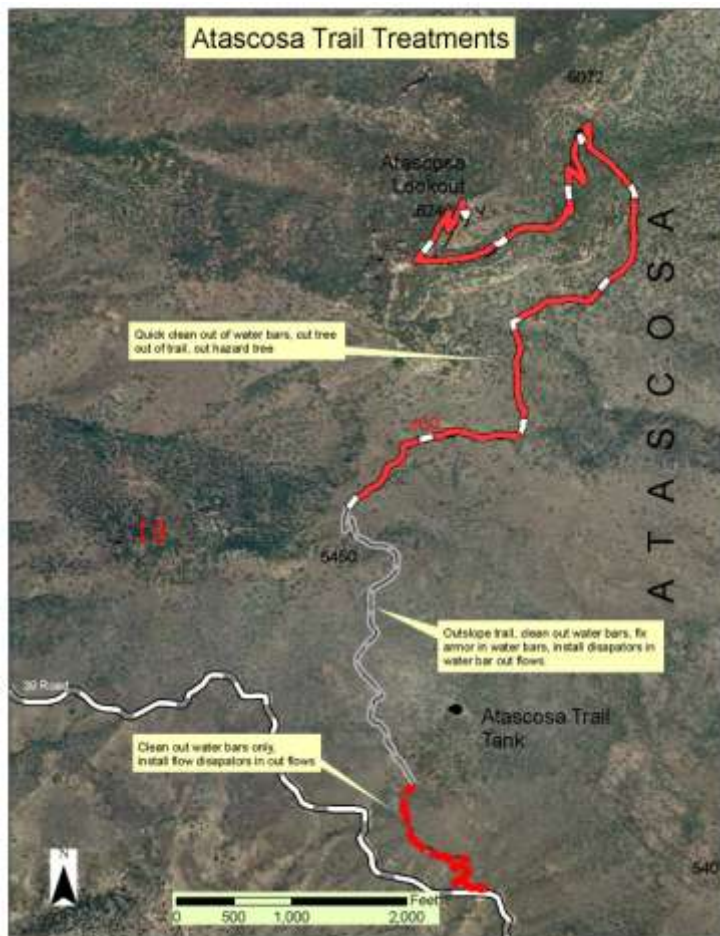
Trail Treatment (Stabilization)

The Atascosa trail was broken into three parts based upon the conditions of the trail, and the feasibility of applying treatment to the trail. From the trail head to the gate, or the bottom part of the trail, treatment consisted of cleaning out the existing water bars, and armoring or maintaining the armor that is present in each water bar. Also, dissipaters were installed or reinstalled in the out flow of each water bar to break any velocity of water coming off the trail. Due to the rockiness of the trail and other past improvement made to this part of the trail using concrete, out sloping of the trail was not feasible. The amount of work required to reconfigure the trail is beyond the scope of BAER treatments to fix these problems. But due diligence was given to the current features in place.

The entire trail was assessed for any tree that could pose a hazard by falling on the trail, and all of these hazards were mitigated by cutting and scattering the tree remains as best as possible. Bigger pieces of tree material were left where they fell so as to not cause any damage to the trail in their removal.

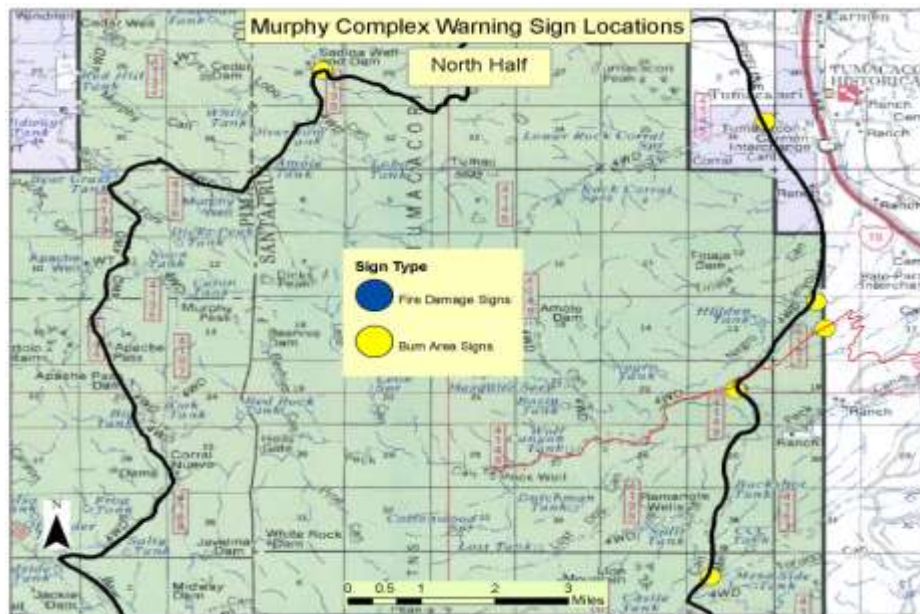
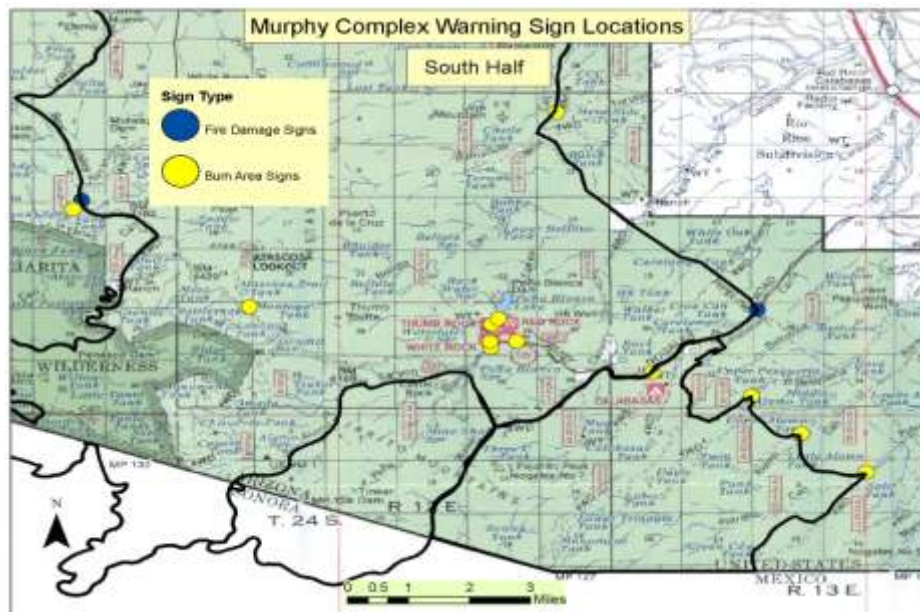
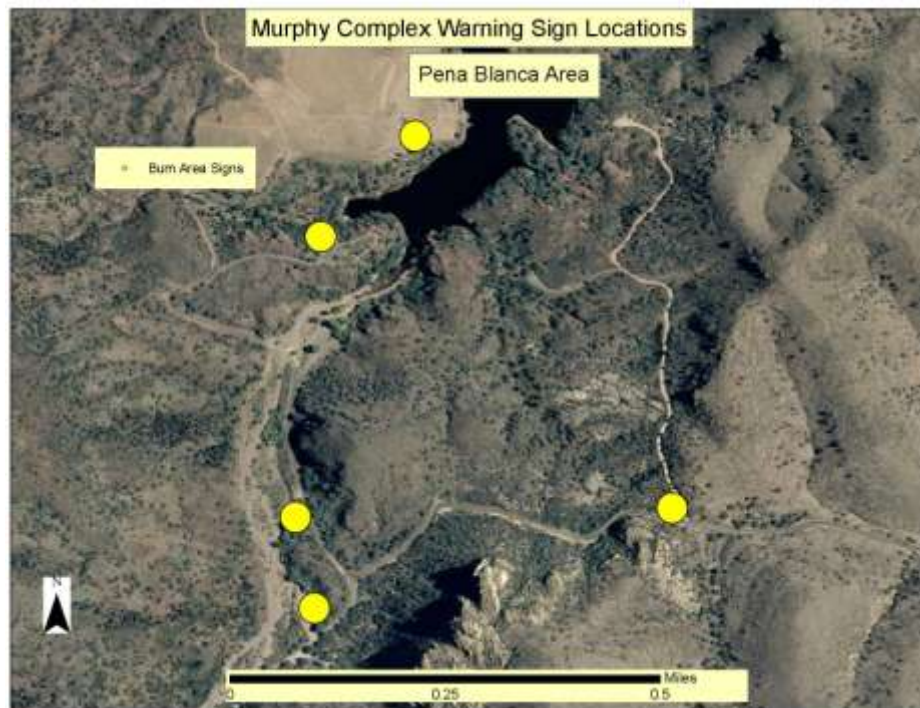
Protection / Safety (Signs)

The assessment for the Murphy Complex identified the need to install warning signs in strategic locations around the burn area. The goal is to warn the recreating public about the dangers that exist post fire. There will be two types of signs installed: a few large diamond signs warning of floods and debris flows along Hwy 289 (staying off the State Hwy right of way) coming west into the fire area, and on the 39 Road coming east into the fire area from Arivaca; multiple medium rectangle signs in specific locations leading into burn areas on all major identified road accesses, and on the sign boards for all campground, picnic, and other recreation areas.

There will be two types of installation of these signs. For the recreation areas in the burn, the local Recreation staff will install signs that were in storage (basically the same sign that is being ordered) on the information sign boards for each recreation area. The other installation will be completed thru a purchase of services. Recently, three quote requests have been received and the sign order and installation will be purchased. Local Nogales staff will check on the final installation of the signs once the chosen vendor indicates all work thru installation has been completed.

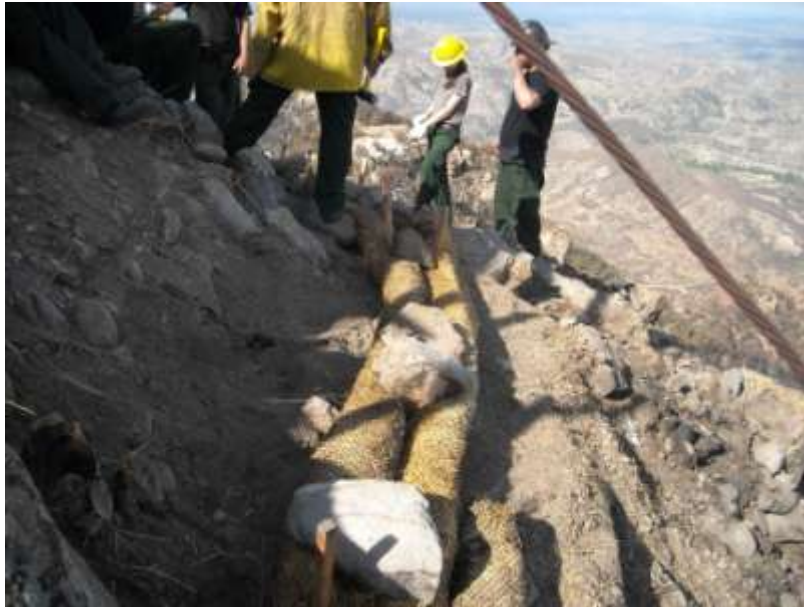
Atascosa Lookout Treatment

The assessment report for the fire identified the Atascosa Lookout and the hazards the burnt residual material from the Lookout as needing treatment. The goal is to prevent any hazardous materials from leaching into the watershed below the lookout site.

The installation of straw wattle was placed around the western slope just below the foundation of the lookout. The wattle was installed by the Nogales Crew 5-2. 75 feet of wattle (doubled up) was installed, with all work completed in 6 hours from start to finish.
