USDA-FOREST SERVICE

BUCK FIRE BURNED-AREA REPORT
(Reference FSH 2509.13)

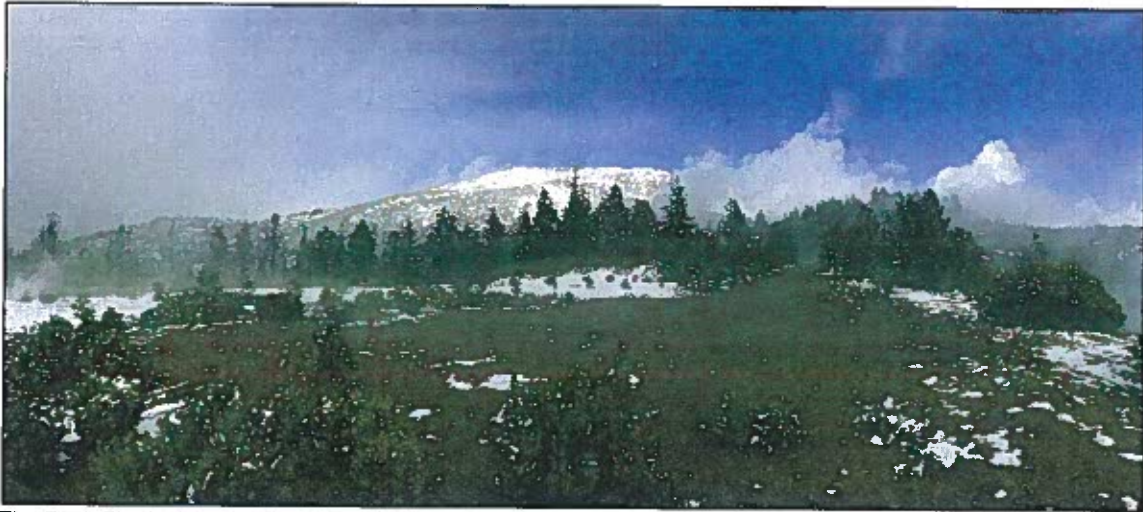
The Buck Fire looking at Black Rock in the Yolla Bolly Wilderness after early season snow on October 20th 2017.

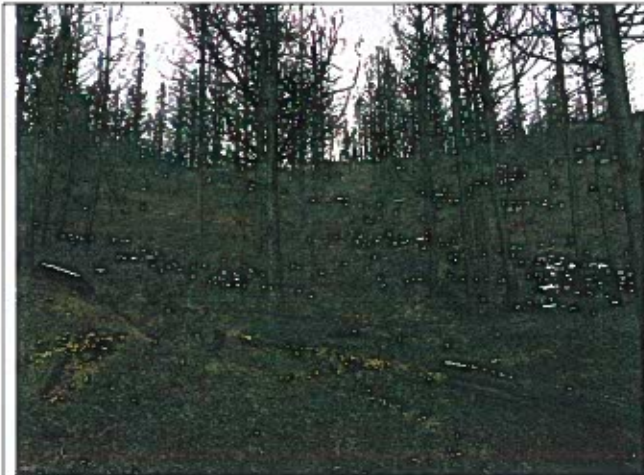
South-facing plantations high soil burn severity in Blossum

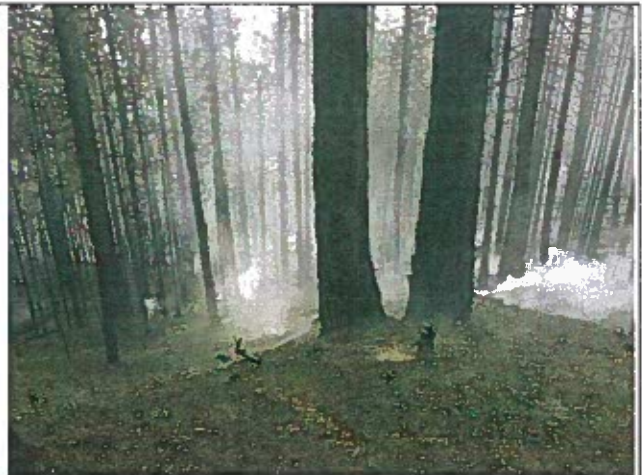
West-facing moderate soil burn severity above South Fork

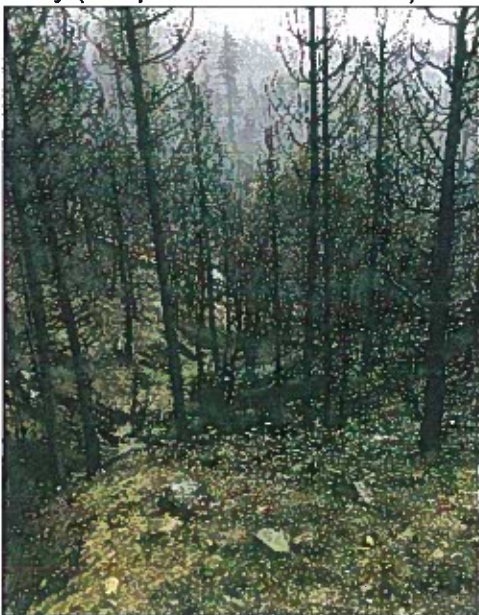
High soil burn severity with 1 in char in vgr loam soil.

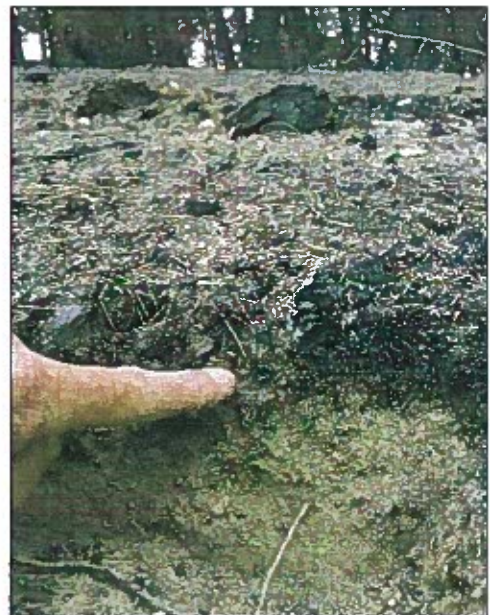
Moderate soil burn severity with repellency in gr loam.
