Date of Report: September 23, 2013

BURNED-AREA REPORT
(Reference FSH 2509.13)**PART I - TYPE OF REQUEST**

A. Fire Name: Hardluck

B. Fire Number: WY-SNF- 251C. State: WyomingD. County: ParkE. Region: 2F. Forest: ShoshoneG. District: WapitiH. Fire Incident Job Code: P2HR4QI. Date Fire Started: 07/17/2013J. Date Fire Contained: 09/16/2013K. Suppression Cost ~ \$723,981 on 9/12/2013

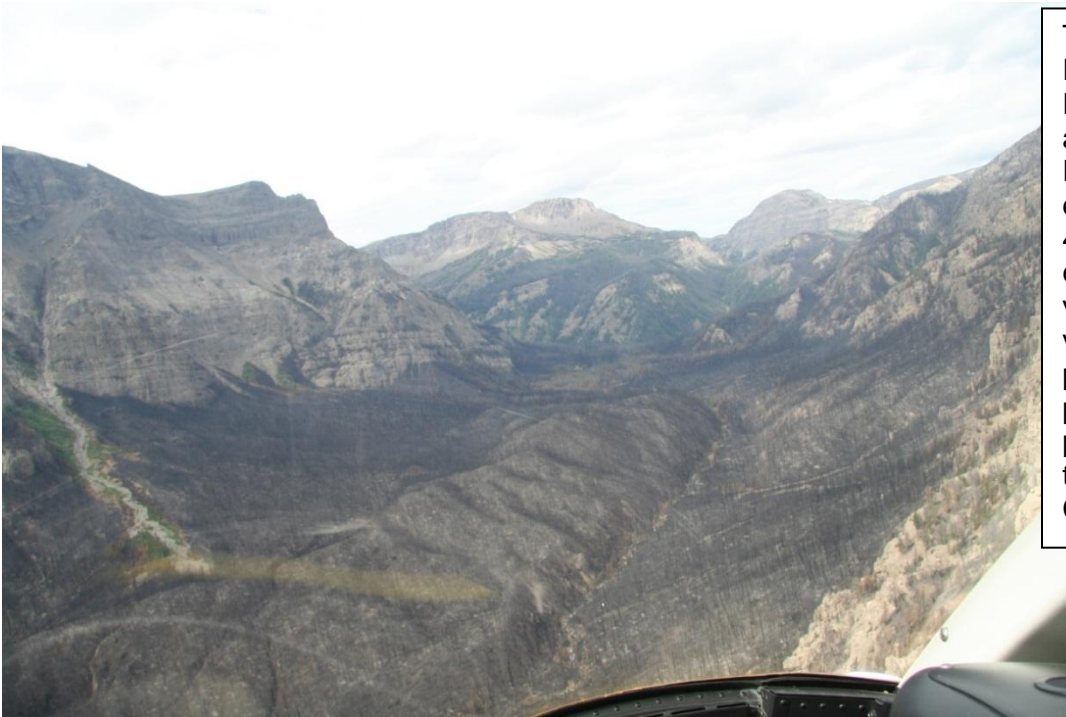
The East Fork Shoshone River, Saddle, and South Fork Shoshone Watersheds are affected by the Hardluck Fire. The fire is in highly dissected terrain which has 4000 feet of relief. The coarse textured Absaroka volcanic soils are quite vulnerable to debris flow processes. Post fire erosion processes pose extensive potential to damage Forest trails. This is the Marston Creek drainage.

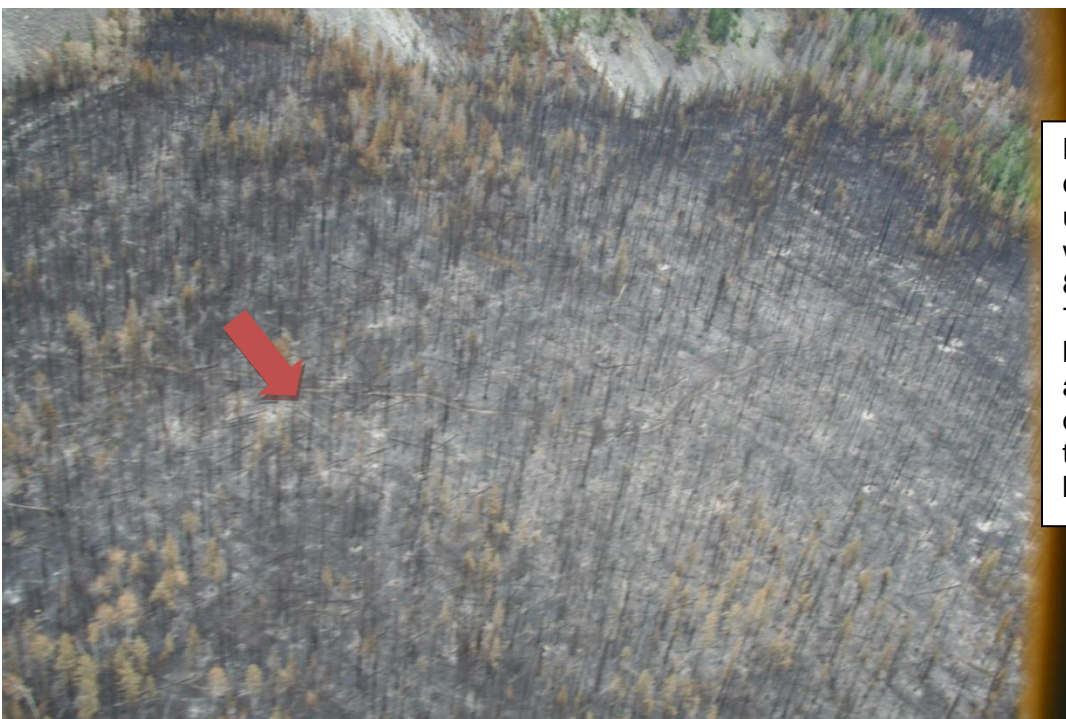
High severity burn area is common in the in the upper Shoshone River watersheds. Forest trails 809.2, 772.5, 812.3, and 772 traverse much of this heavily burned area. They are subject to erosion damage. The arrow shows the trail crossing a high burn severity area.

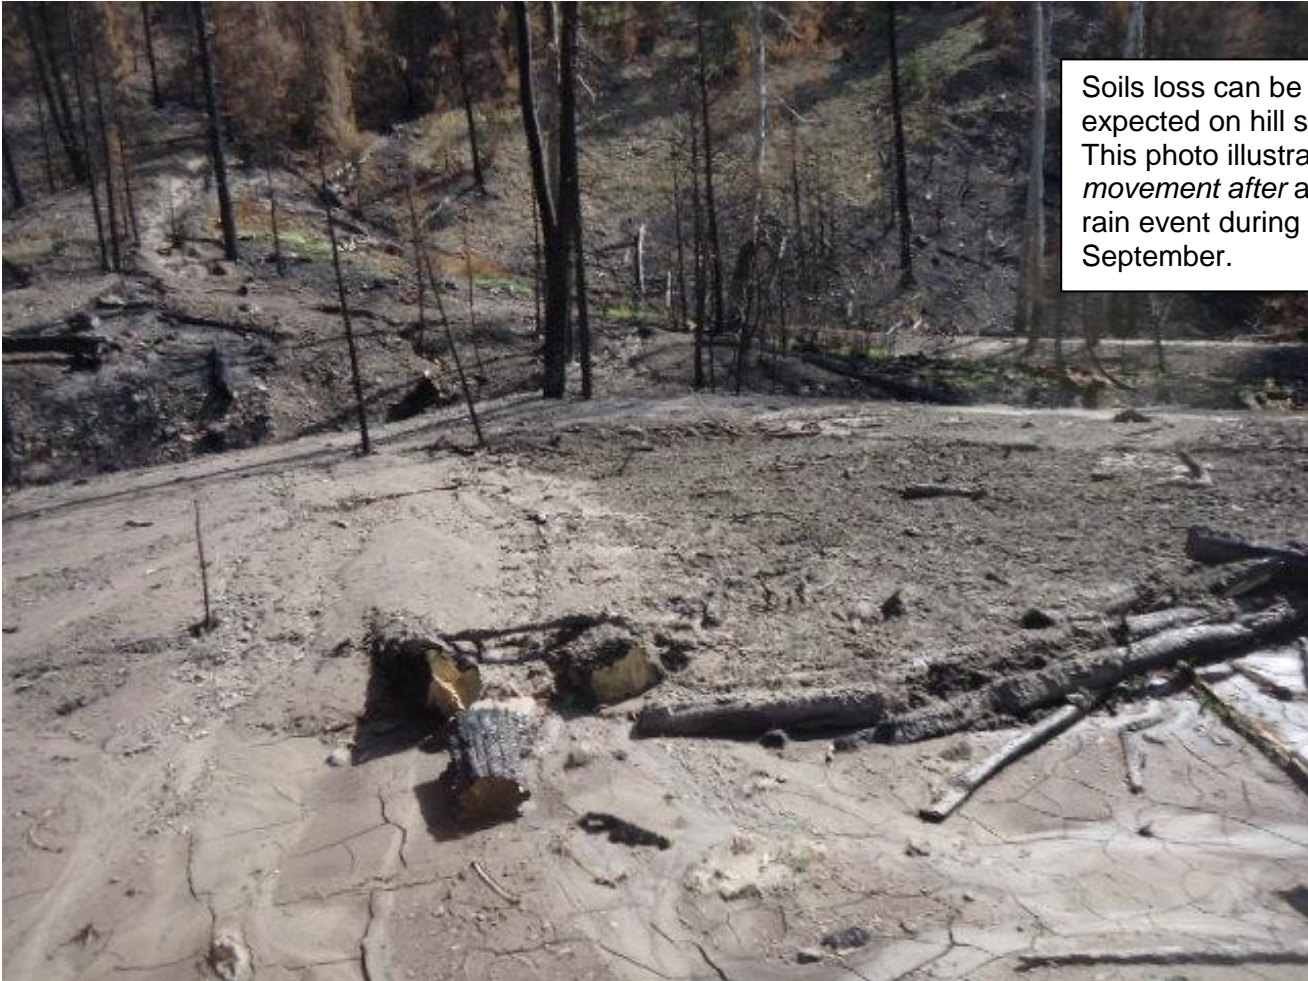
Soils loss can be expected on hill slopes. This photo illustrates soil *movement after* a small rain event during September.

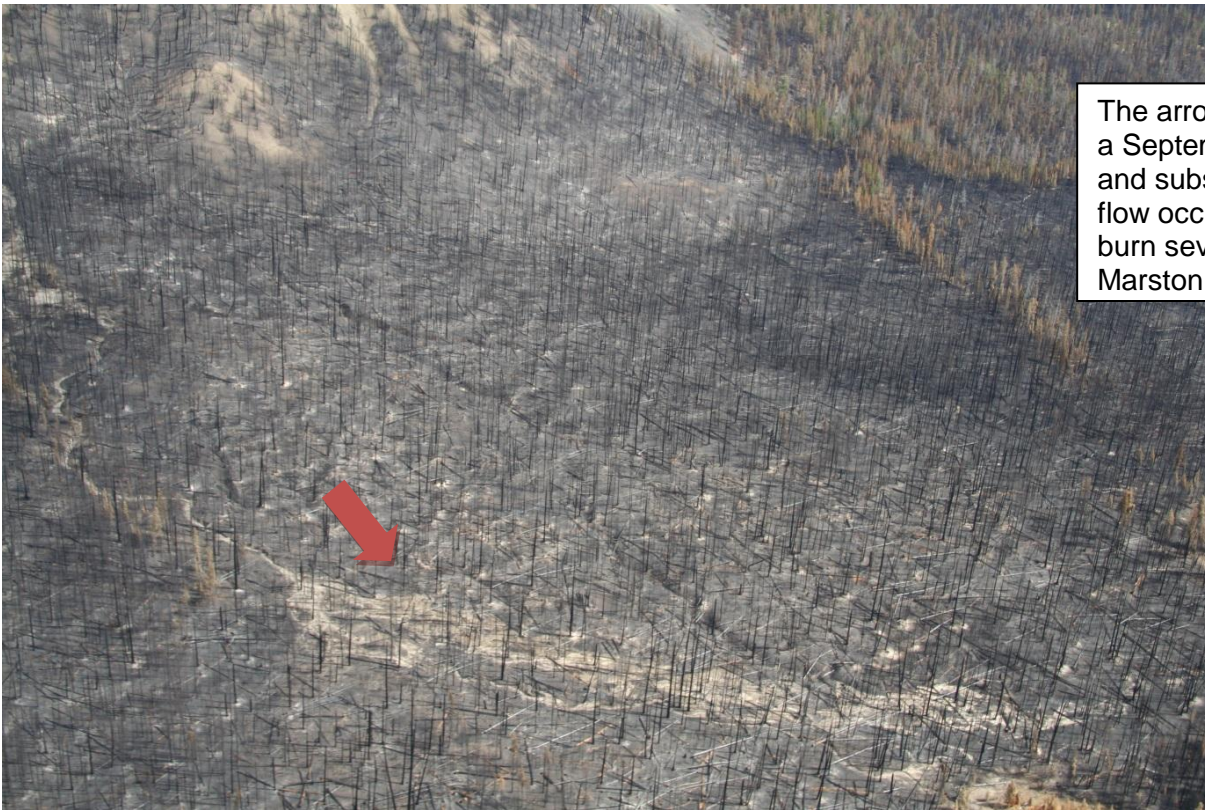
The arrow shows where a September rain event and subsequent debris flow occurred in a high burn severity area in Marston Creek.

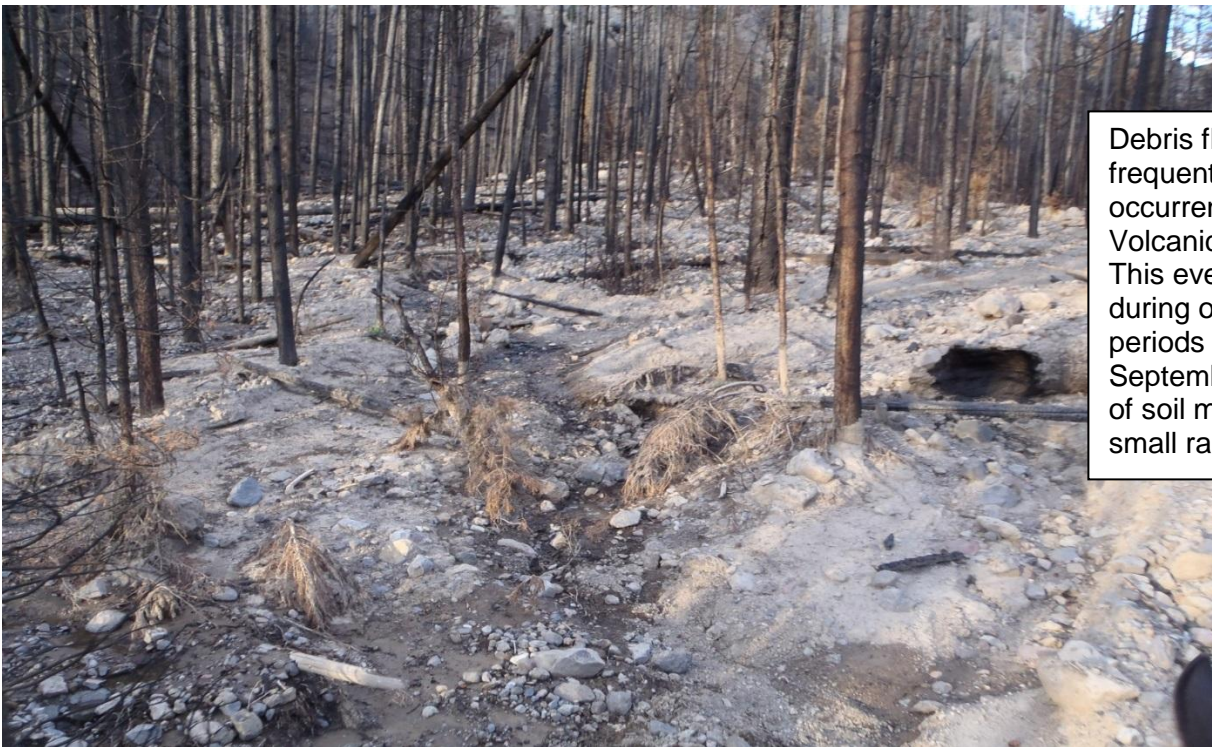
Debris flows are a frequent and common occurrence in Absaroka Volcanic landscapes. This event occurred during one of the slow periods of fire growth in September. Note amount of soil movement from a small rain event.

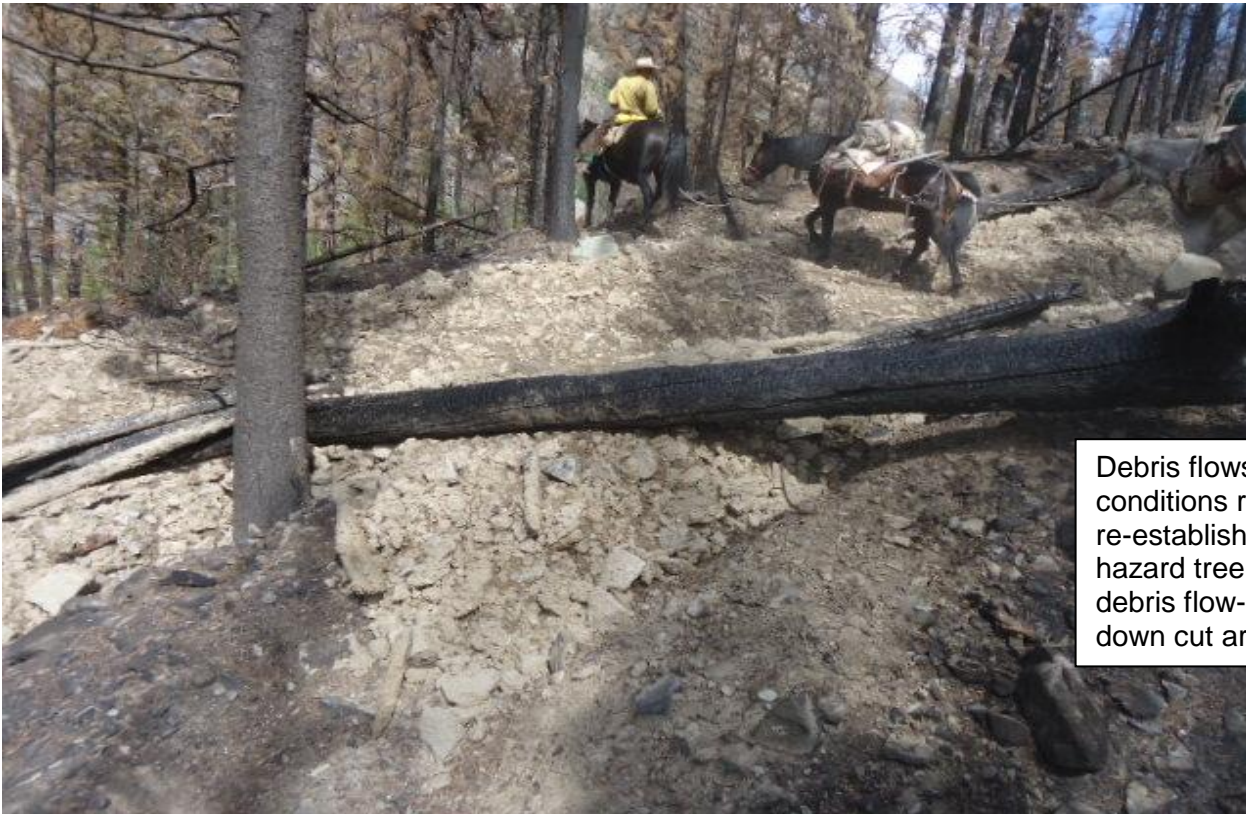
Debris flows create unsafe conditions requiring tread re-establishment and hazard tree removal in debris flow-deposition and down cut areas.

Forest Service or contract labor crews will remove hazard trees, install erosion control devices, localized reconstruction of tread for better surface drainage and slough removal and replace signs at trail junctions.

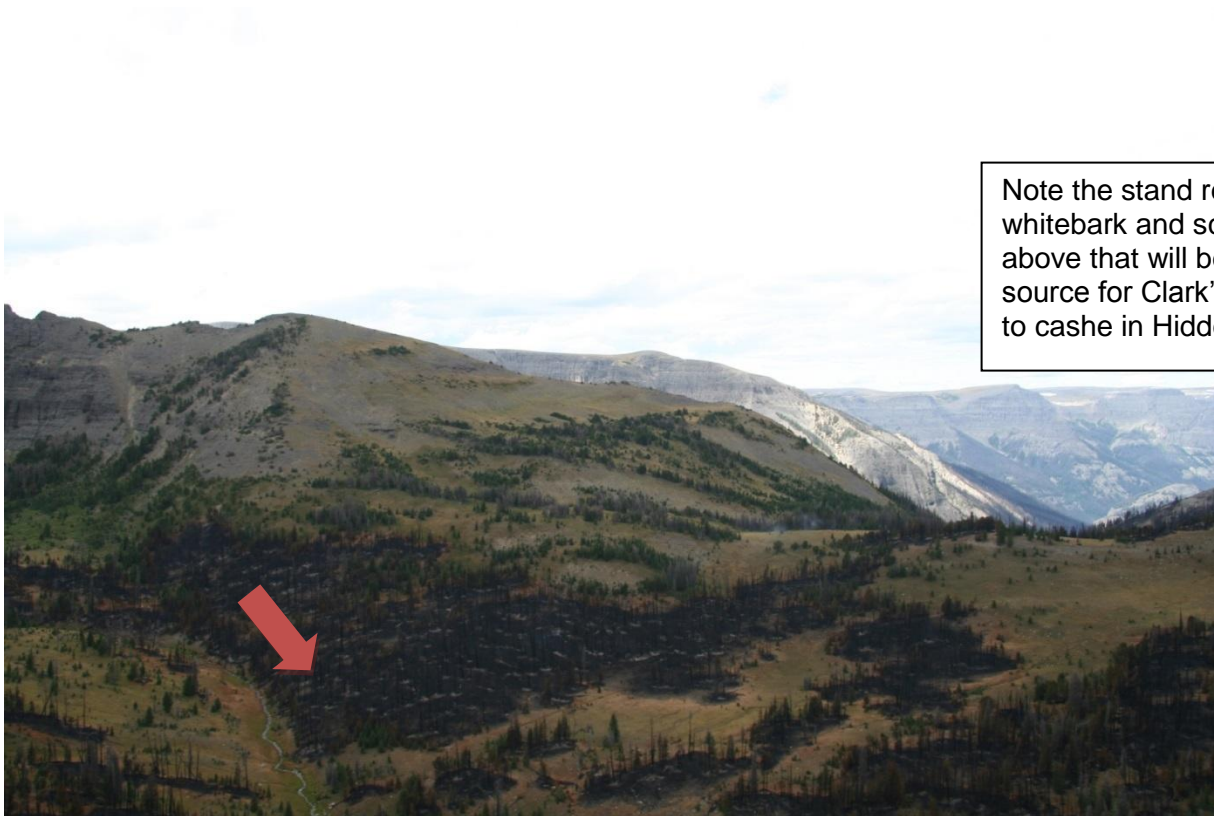
Note the stand replacing fire in whitebark and scattered trees above that will become seed source for Clark's Nutcrackers to cache in Hidden Basin.

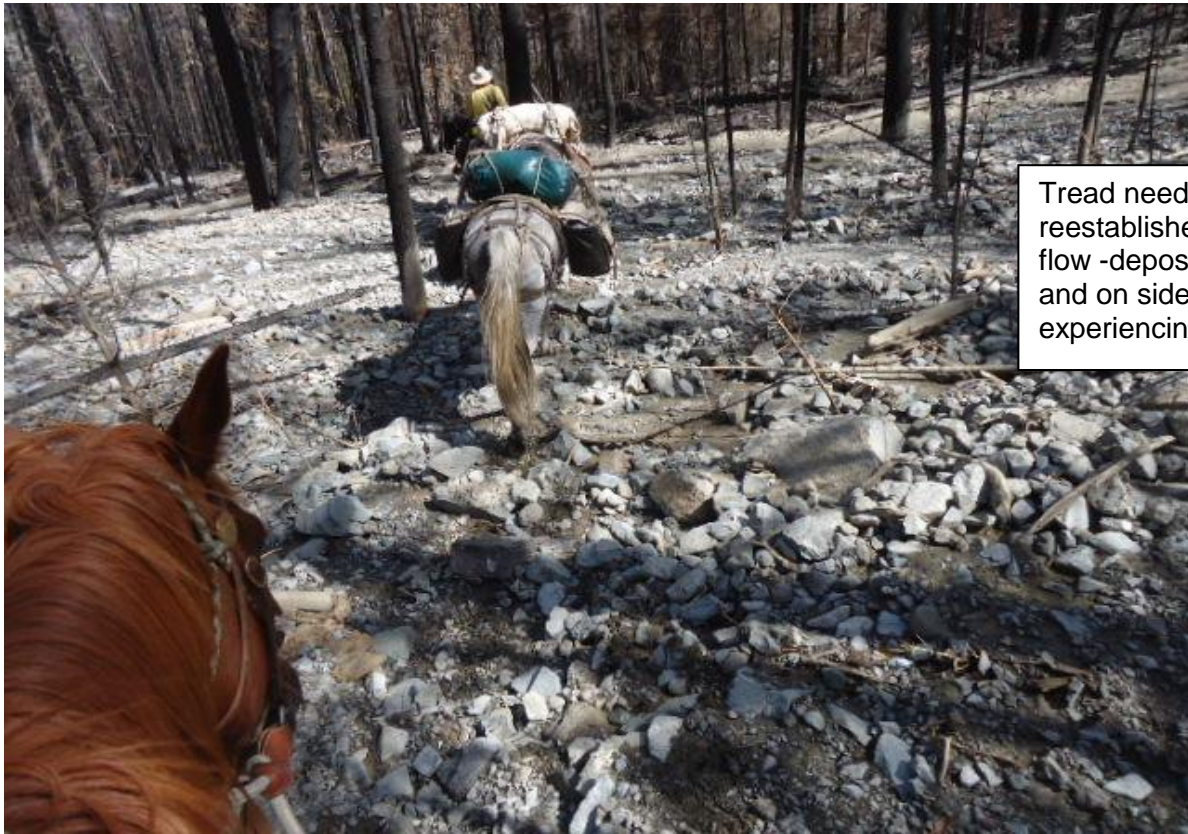
Tread needs to be reestablished in debris flow -deposition areas and on side slopes experiencing sloughing

- 4) In localized areas tread stabilization for surface drainage, tread erosion and upslope slough removal provide for safe travel. Removal of material sloughing from post fire runoff, adequately reduce the risk of further erosion and degradation of trail prism and provide for safe access for BAER rehab crews

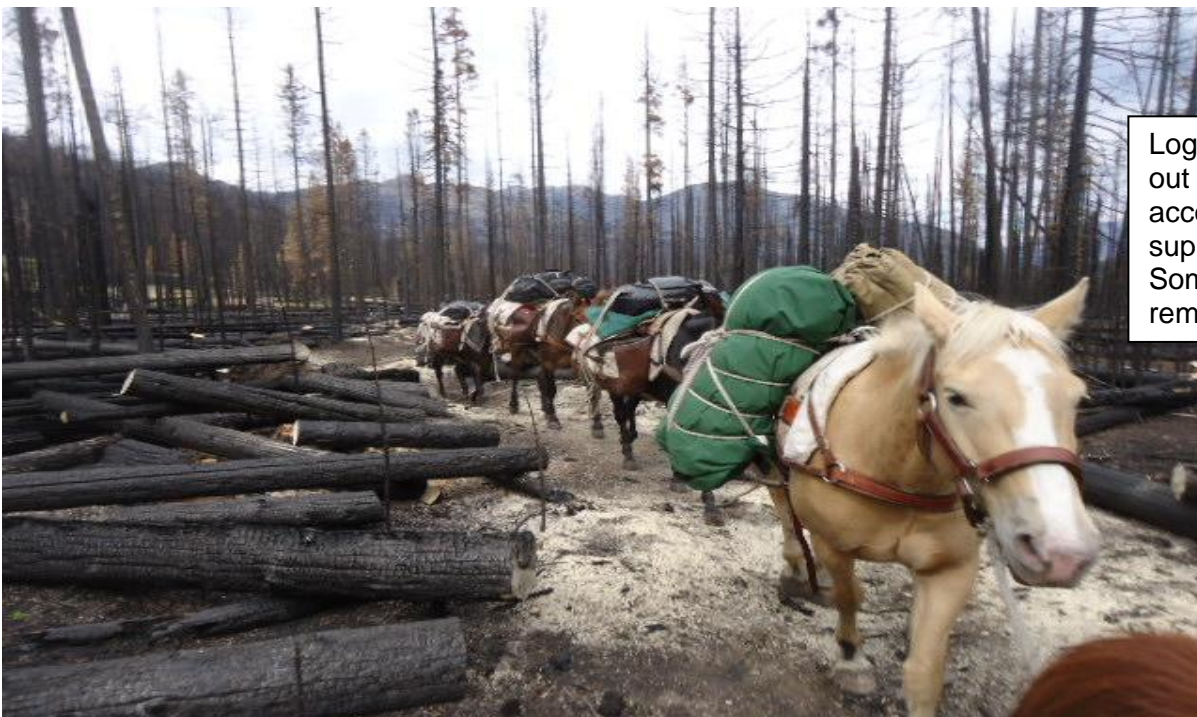
Logging out (clearing out downfall) was accomplished by suppression crews. Some works still remains.

- 5) Log out (clear downfall) is essential for safe passage in burned tree windfall areas.

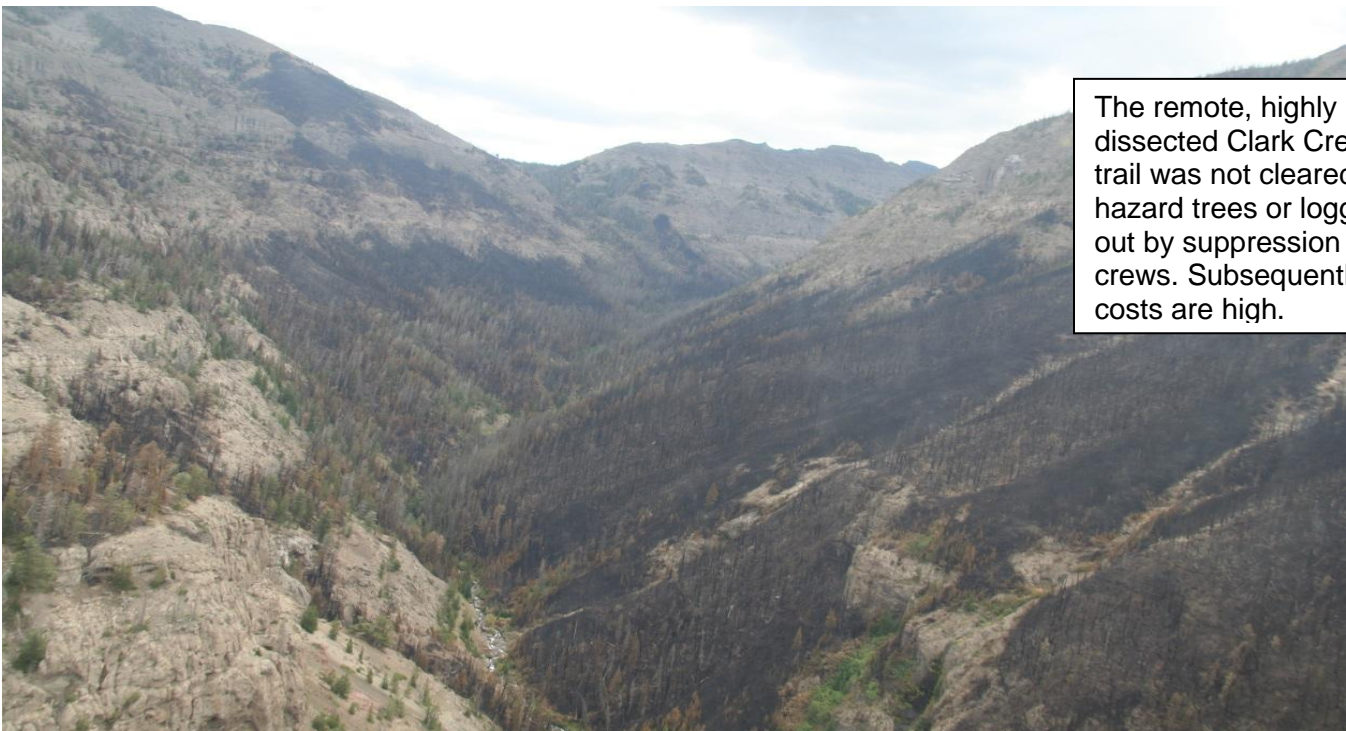
Clark Creek / Hidden Basin Trail #812.3 (Mainline, 8.2 miles)

The remote, highly dissected Clark Creek trail was not cleared of hazard trees or logged out by suppression crews. Subsequently, costs are high.

- Northern edge Bliss Creek Meadows to Clark Creek Cut-Across (1.6 miles)
¾ mile sustained severe tread loss: in need of tread resurfacing/waterbars
30 waterbars/mile (23 waterbars)
3,960 feet tread work
Hazard tree removal and log-out complete
- Clark Creek Cut-Across to Pierpont Pass (4.0 miles) **not yet surveyed**
Estimated 2.0 miles of tread resurfacing (slough and berm removal)
Estimated 20 waterbars/mile (80 waterbars total)
Estimated 1,000 feet of retainer log
Hazard tree and log-out **not complete**
- Pierpont Pass to Cougar Pass (2.6 miles) **not yet surveyed**
Estimated 1.0 miles of tread resurfacing (slough and berm removal)
Estimated 10 waterbars/mile (26 waterbars total)
Hazard tree and log-out **not complete**

Feature	Water-bars	Re-tread Slough & Berm	Debris flow Washout	Retainer Log	Hazard Tree 200/mile	Log-out (clear downfall)	Mobilization
Needed Work	129	3.75 miles	0 ft.	1,000 ft.	6.6 miles	6.6 miles	N/A
Contract Price	\$85 each	\$300/mile	\$10.00/ft.	\$7.00/ ft.	\$60 each	\$500/mile	N/A
Item Total	\$10,965	\$1,125	\$0	\$7,000	\$79,200	\$3,300	N/A
Total Cost	\$101,590
