READING FIRE BURNED-AREA REPORT
(Reference FSH 2509.13)

A. Fire Name: Reading Fire
 B. Fire Number: CA-LNP-G3H7
 C. State: CA
 D. County: Shasta
 E. Region: 5
 F. Forest: Lassen & LNP
 G. District: Hat Creek
 H. Fire Incident Job Code: P5G4HN
 I. Date Fire Started: July 23, 2012
 J. Date Fire Contained: August 22, 2012
 K. Suppression Cost: \$16 million

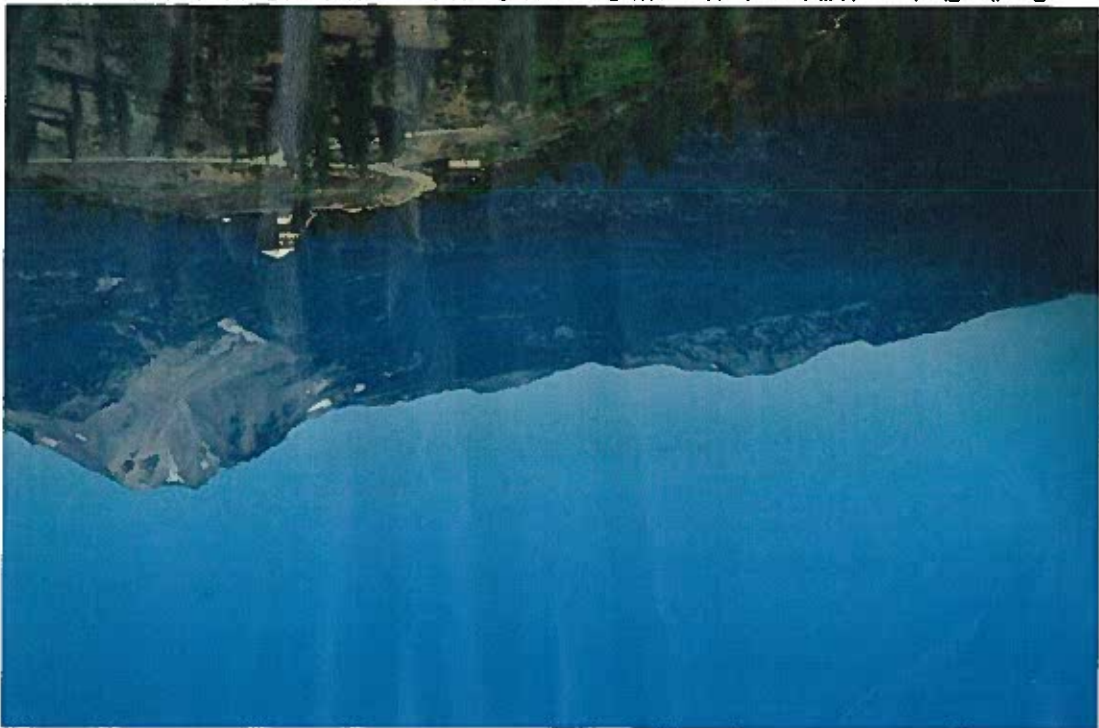
Reading Fire burned hillslopes looking at W. Prospect L.O. with Lassen National Park in the background.

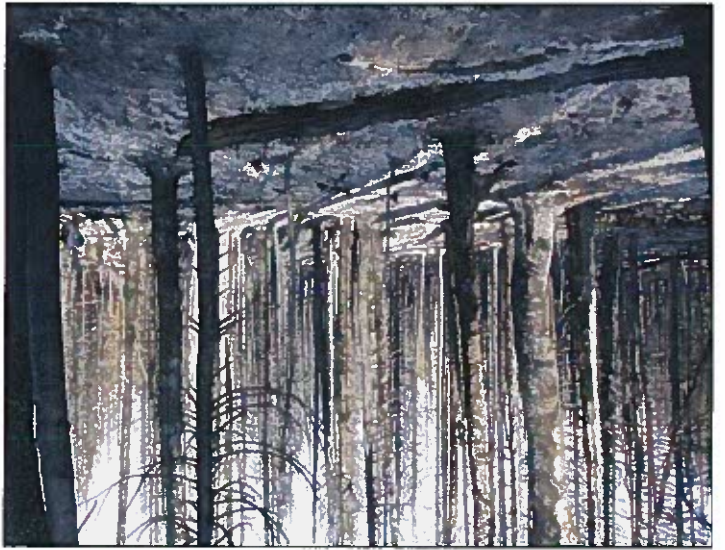
Mod-high soil burn severity in mixed lodgepole in Hat Creek

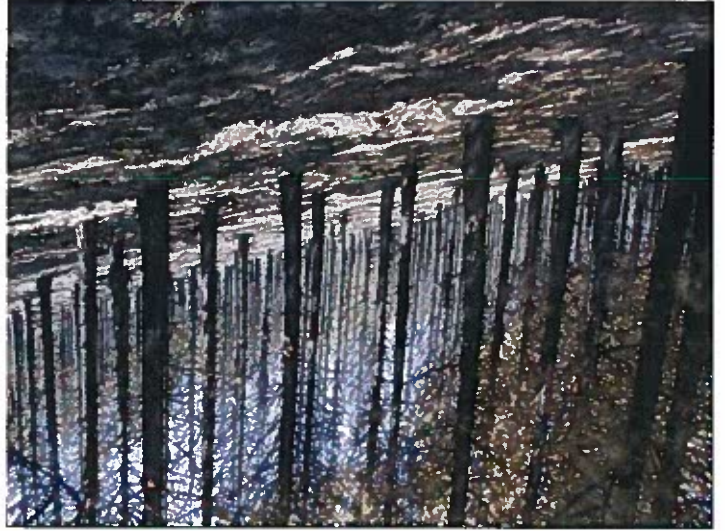
Low soil burn severity, P-Pine plantation along Badger Mtn.

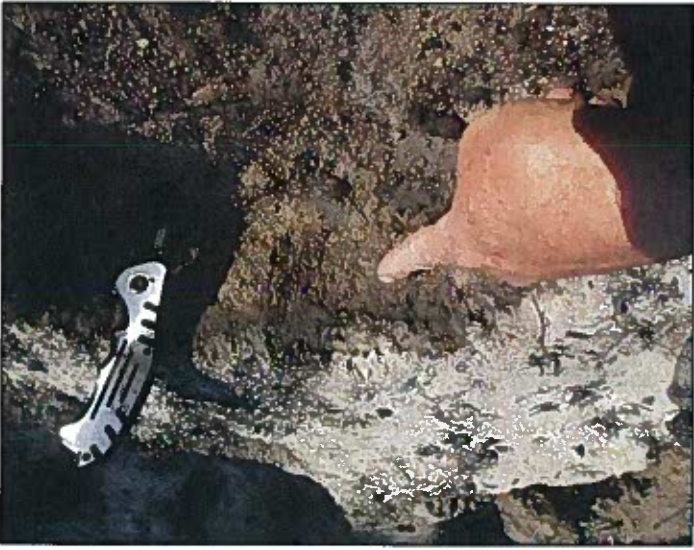
Mod- high soil burn severity char to 2" in mixed lodgepole

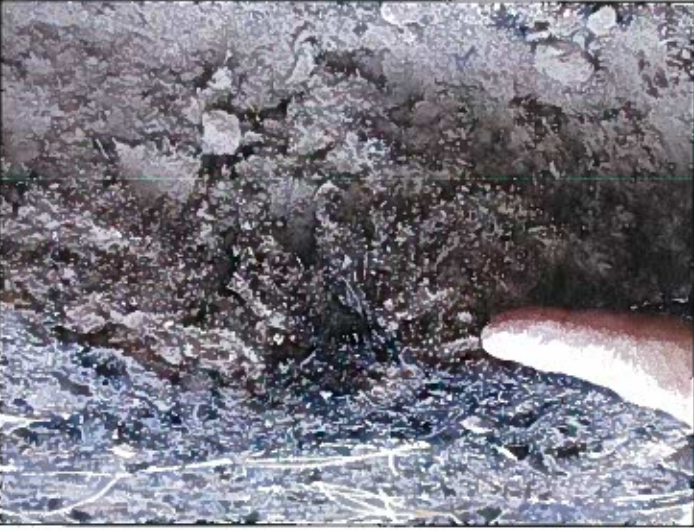
Low soil burn severity with char on surface in Pine plantation

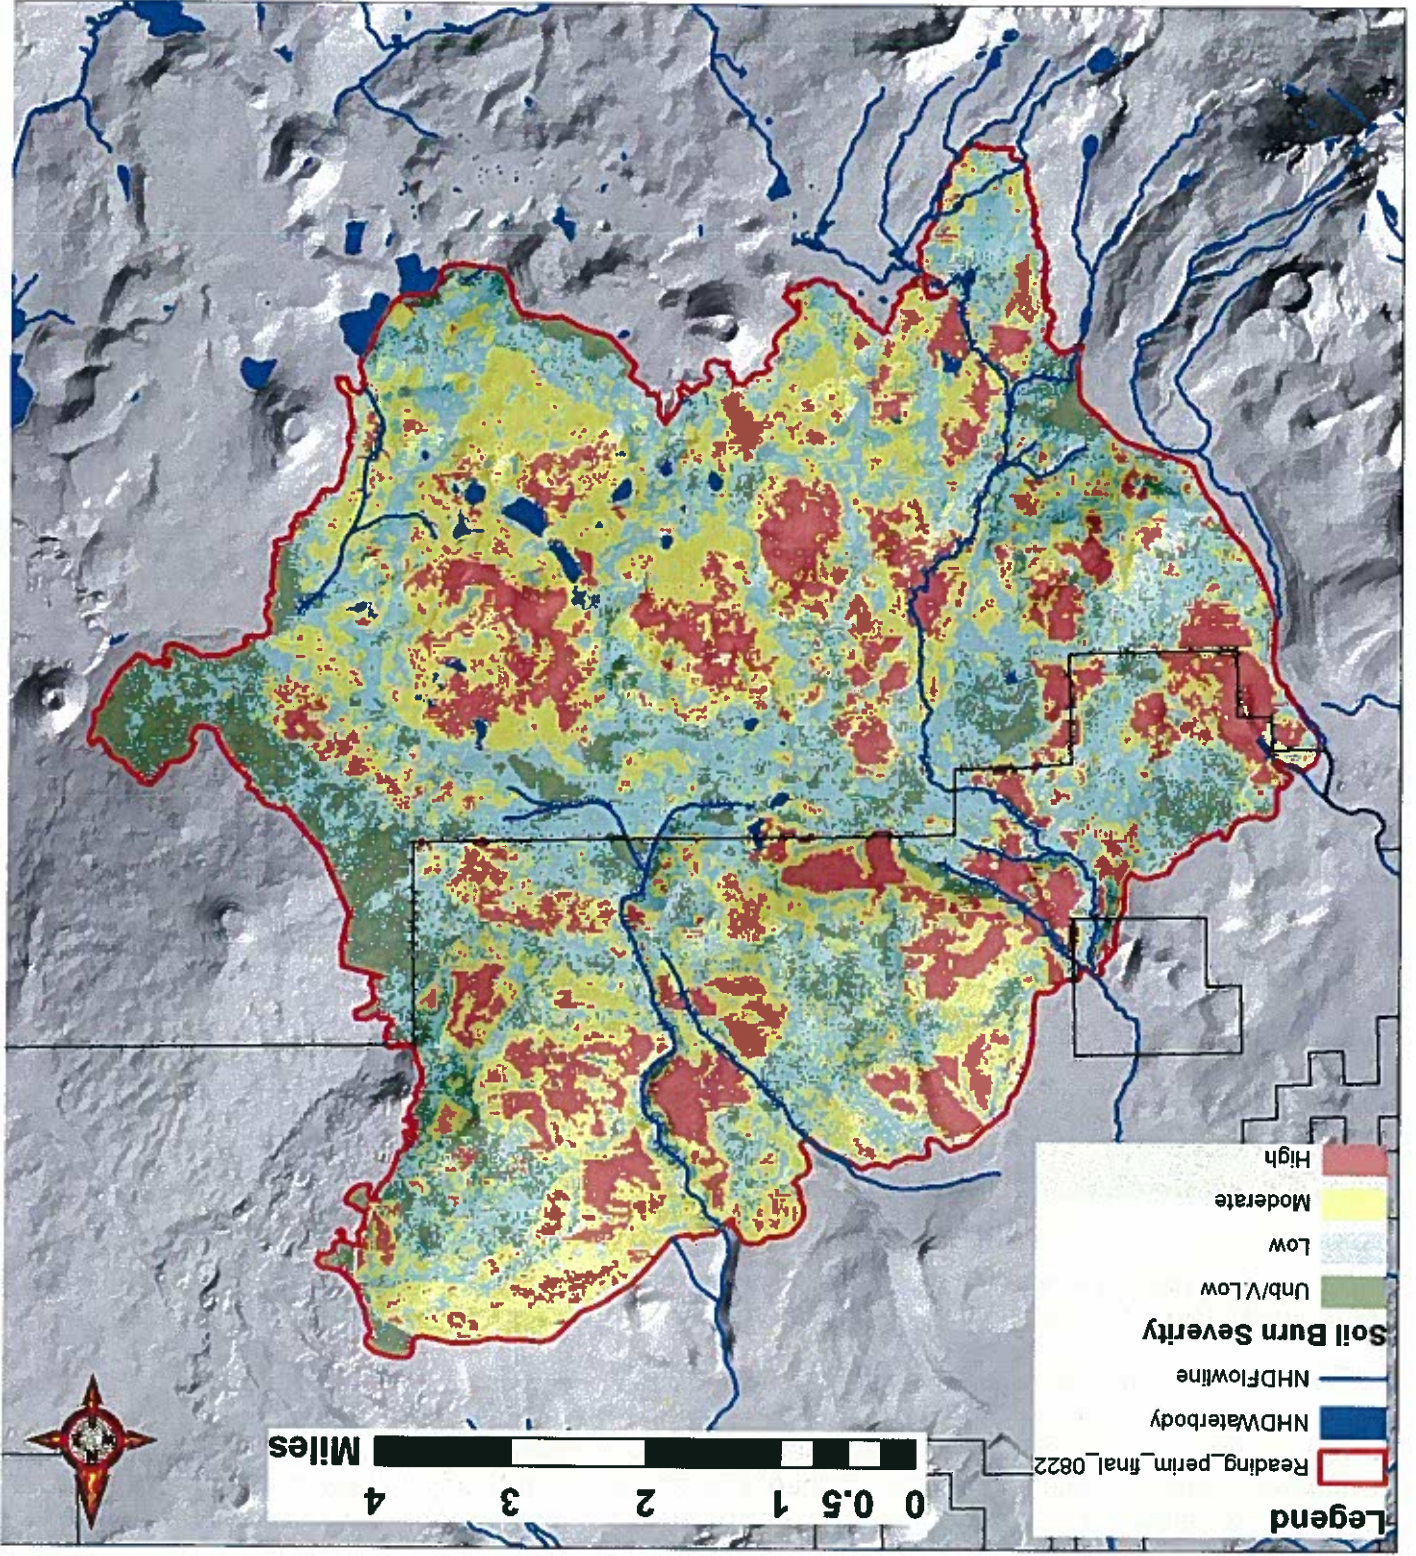
Reading Fire Soil Burn Severity Map:

Looking at the soil burn severity map below shows multiple areas that have the majority of moderate and high soil burn severity. These areas are along Hat Creek and Boxrail Canyon with Hat Creek being at risk due to flooding and sedimentation affecting water quality and fish habitat.
