Date of Report: 9/12/2014

**BURNED-AREA REPORT**  
(Reference FSH 2509.13)**PART I - TYPE OF REQUEST**

- A. Fire Name: Thompson River Complex      B. Fire Number: MT-LNF-005093  
C. State: MT      D. County: Sanders  
E. Region: 01      F. Forest: Lolo  
G. District: Plains Thompson Falls      H. Fire Incident Job Code: P1JAQO  
I. Date Fire Started: 8/01/2014      J. Date Fire Contained: not contained as of 8/26/2014 Rain  
rain slowed fire on August 20,2014  
K. Suppression Cost: As of 8/22/2014 \$8,350,000  
L. Fire Suppression Damages Repaired with Suppression Funds  
    1. Dozer Fireline repaired (miles): 2.38 miles of line repair ongoing as of 9/07/2014  
    2. Hand Fireline repaired (miles): 14.46 repair ongoing as of 9/07/2014  
M. Watershed Numbers: National Forest  
170102130407, 170102130405, 170102130512

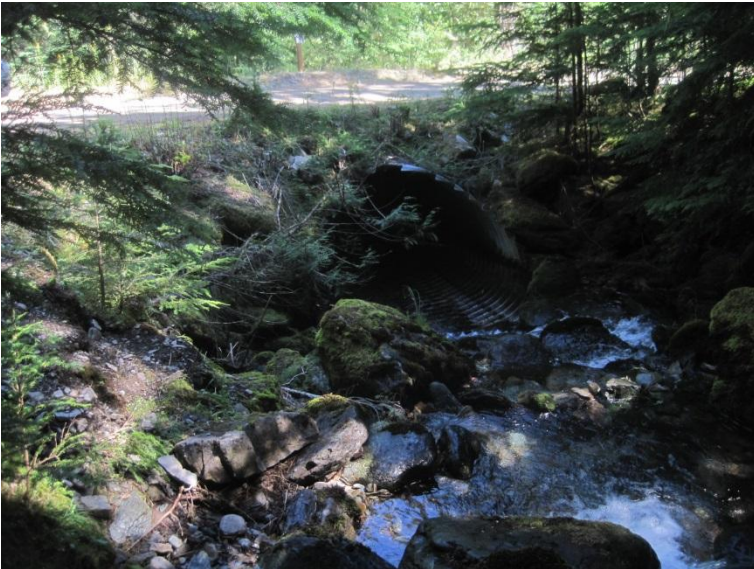
The existing Big Spruce crossing on Road 603 is a 67" x 95" plate arch culvert. With a span of 7.9 feet, the existing culvert restricts the field-measured bankfull width of 18 feet with a constriction ratio of 2.3. The observed rust line was at 33", which indicates that the existing structure has flowed at or above half full for extended durations during pre-fire conditions. As described in the Fisheries report, the structure is also a fish barrier.

**Big Spruce culvert inlet showing rust line and stream constriction.**

Hydraulic modelling results for the Big Spruce culvert are displayed in the Table below. Existing culvert capacity is barely sufficient to pass a pre-fire 100-year flow. It is important to consider that calculated design flows are for unbulked water discharge. Total discharge volumes could be much larger if bulk augmented with mass wasting sediment. The USGS WRI reports in Montana have measured over 400 cfs/mi<sup>2</sup> following 0.41 inches of rainfall in 30 minutes near Helena (USGS WRI 03-4319). When bulked flow and potential for culvert inlet blockage associated with post-fire debris is considered, the Big Spruce culvert is at a moderate risk of failure.

It is recommended that the forest consider other sources of funding to replace the culvert. A replacement structure for the undersized culvert on the West Fork Road 603 at Big Spruce creek should at a minimum span the bankfull width of the stream and pass a pre-fire Q100 flow of 248 cfs with adequate freeboard. A bridge is the recommended replacement structure. The bridge should span the bankfull width of the channel, maintain stream grade and dimensions through the crossing, and be designed to accommodate aquatic organism passage.

An alternative recommendation that is acceptable to fund with BAER is to improve the existing culvert at Big Spruce Creek. The road- stream crossing (culvert) on Big Spruce Creek will be armored to reduce the risk of culvert erosion and channel scour and protection of the road from washing out. The work will consist of placing Class IV riprap at along the headwalls of the culvert inlet and outlet. This alternative is included in the proposed road treatments and the final funding request.

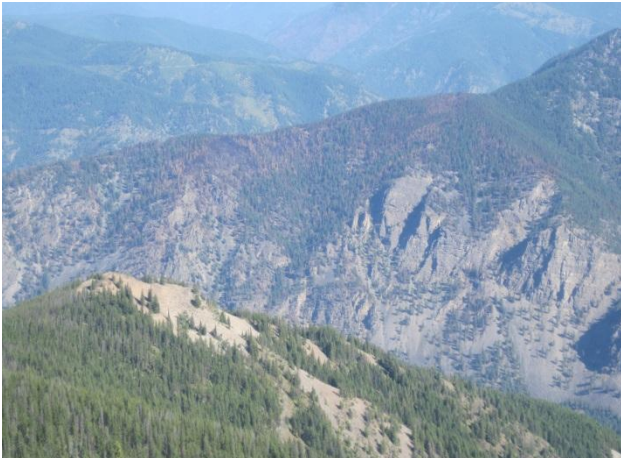
For the Koo Koo Sint fire, increased water delivery and rolling debris from burned slopes above Highway 200 was considered. The lower, unburned portion of the watershed has extensive unburned vegetation, talus and cliffs, and does not have a well-defined drainage bottom. For the design storms considered in this analysis, unburned vegetation and talus piles along with the lack of a defined drainage channel at the bottom of the watershed should be sufficient to buffer increased storm runoff and debris flows before they reach Highway 200. However, debris in burned areas above Highway 200 will be susceptible to movement from rain storm lubrication and freeze-thaw cycles. As a result, increased rolling debris onto Highway 200 from the fire is likely during and after high precipitation events and during freeze-thaw cycles until vegetation is well established over the next three to five years.

**Koo Koo Sint fire showing the extent of the burn as well as vegetative and talus buffer above Highway 200**

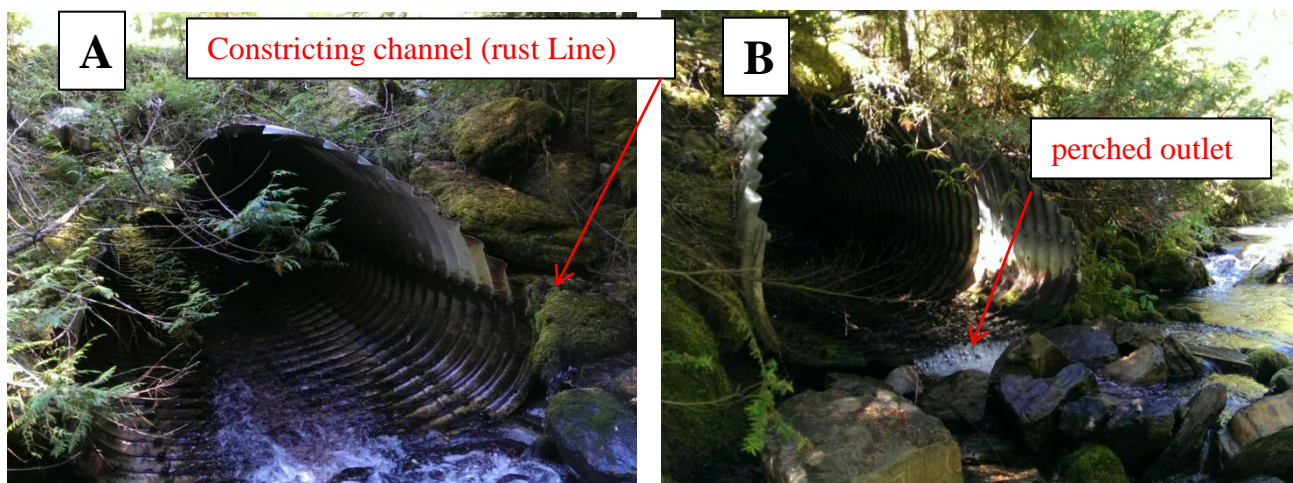
An undersized stream crossing has been identified at M.P. 3.7 where the road crosses Big Spruce Creek. The existing arch culvert is constricting the channel and as a result the outlet is perched slightly. Furthermore, the rust lines on the inside of the culvert provide evidence that the existing culvert is already at maximum capacity on an annual basis. The post fire runoff will cause increased velocities through the culvert and lead to additional scour at the outlet. The culverts will likely plug due to increased movement of woody debris and as a result the culvert may fail. Furthermore, these culverts do not meet USFS stream simulation criteria for accommodating bankfull channel widths and aquatic organism passage.

Constricting channel at inlet(A) and perched outlet(B) in undersized culvert on W.Fk Road #603

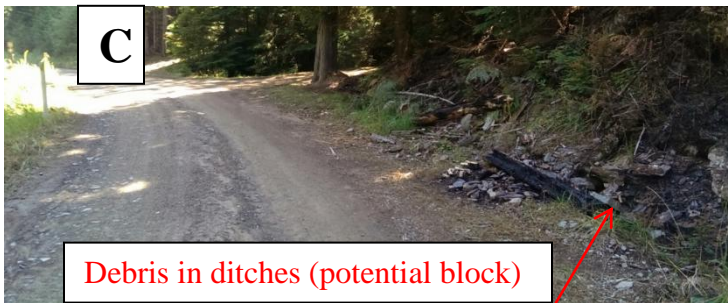
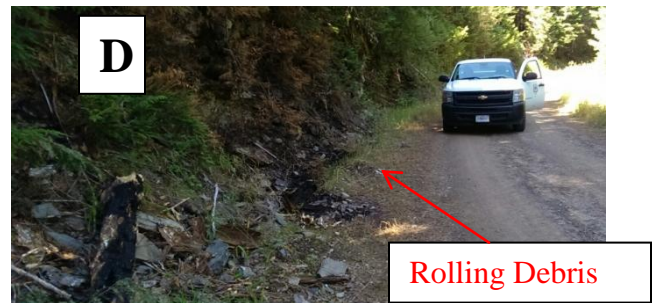
In addition to the undersized stream crossing, the W. Fk. Thompson River Road #603 from MP 2.9 to 5.6 has been identified as moderate risk for failure (See Map Appendix B). In the post-fire condition, road cut slopes are prone to heavy rilling, raveling, and localized cut slope failure. Slope stability, ditch blockage, and culvert plugging are substantive concerns on this moderate risk segment of road. It is evident that substantial effort has been made to provide proper drainage on this road to protect the road and adjacent stream. However, the road drainage features will need to be improved to avoid failure (ie clean culvert inlets and outlets, clean and

Debris in ditches that could cause blockage or plugging culverts (C) and (D)

There is very little vegetation buffer between the road and stream. During run off it is highly likely that there will be increased erosion and sedimentation in the W.Fk. Thompson River.

shape ditches, install cross drainage, construct drain dips, etc).

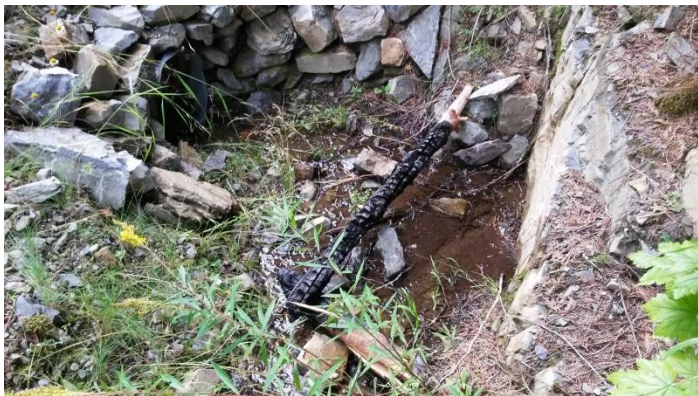
Road #603 runs immediately parallel to WFTR and from MP 2.9 to 5.6 has been identified as a high risk area for delivery of sediment to WFTR. Road drainage features will need to be improved to accommodate the expected increase in flows associated with post fire runoff to avoid impacts to bull trout and bull trout critical habitat. Requested actions include installing proper road drainage structures such as drain dips with appropriate spacing for the expected runoff increases, installing erosion and sediment control measures at drain dips and culvert outlets (slash filter windrows), ensuring ditches are of adequate capacity and unblocked by debris, and protecting and cleaning culvert inlets, outlets, and catch basins to minimize erosion.

Fire debris in culvert inlet of Road #603.
