BURNED-AREA REPORT

☒ 2. Interim Report # 1.

A. Fire Name: Sunflower	B. Fire Number: AZ-KNF-000039
C. State: Arizona	D. County: Maricopa
E. Region: 3	F. Forest: Tonto National Forest
G. Districts: Primarily 03, but also 01 and 06	H. Fire Incident Job Code: P3GUD3
I. Date Fire Started: 05/12/2012	J. Date Fire Contained: Uncontained
K. Suppression Cost: \$6,500,000.00

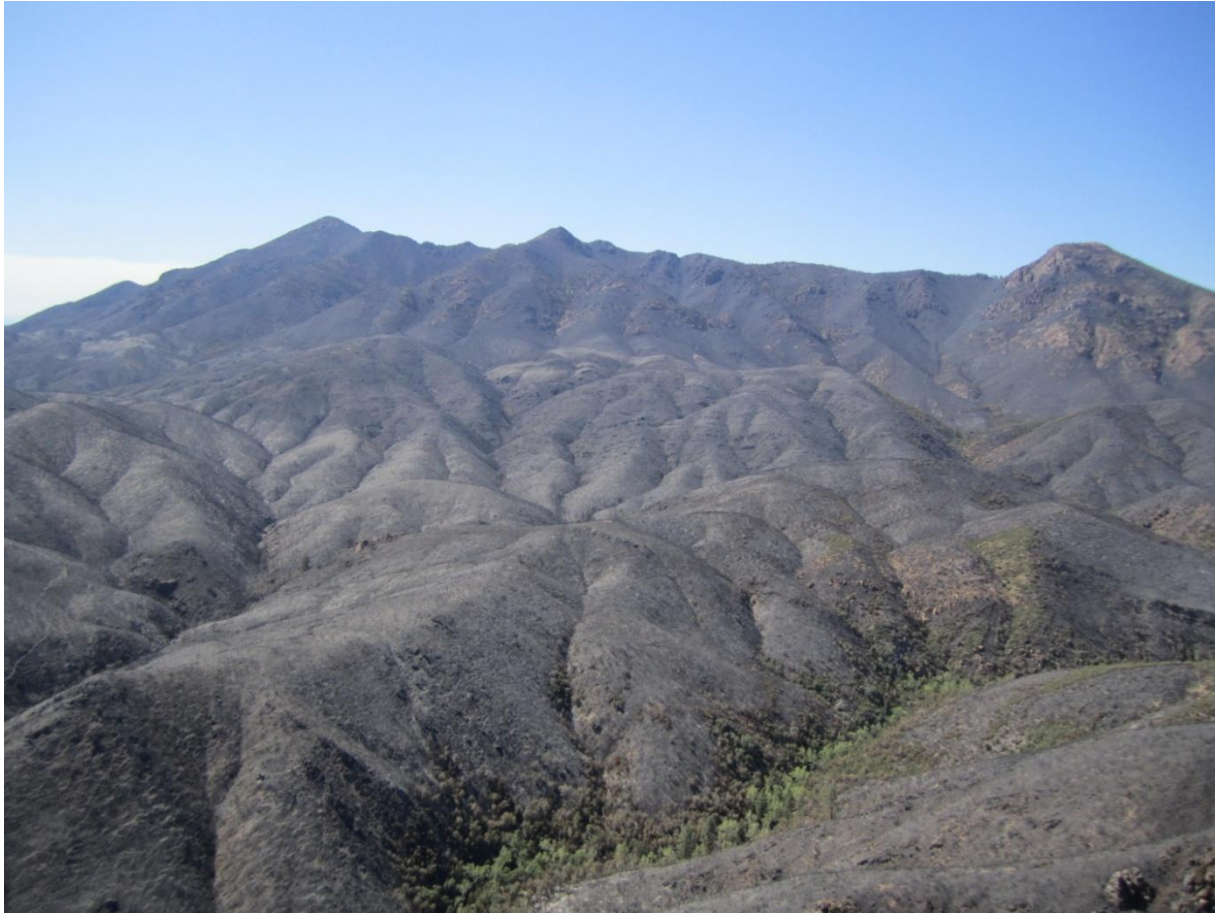
Figure 1. Post-fire conditions of Upper Sycamore Creek following Sunflower Fire.

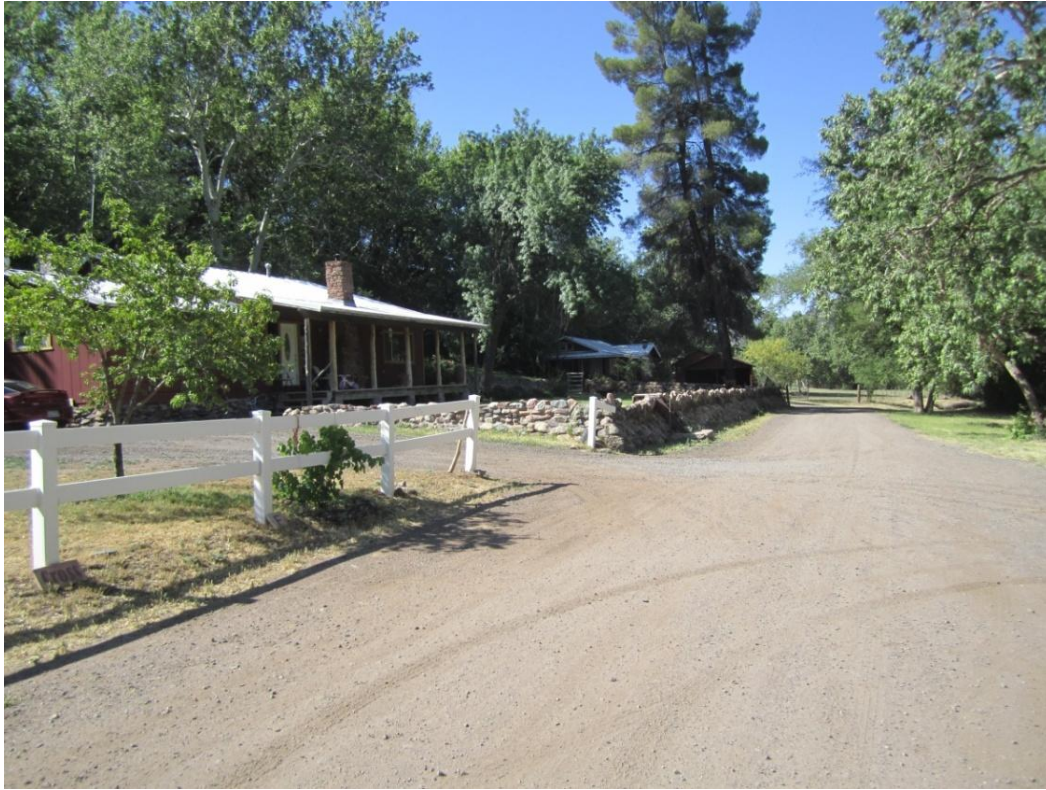
Conditions within the burned area have created a high risk of flooding on National Forest System (NFS) and private lands below the burned area. Occupied homes, outbuildings, and NFS facilities (Sunflower Administrative Site / Work Center) are located in very close proximity to Sycamore Creek, downstream of the fire affected area (Figures 3 through 7).

Figure 3. Private homesite located in close proximity (< 200 feet) to West Fork Sycamore Creek.

Recommendation: Coordinate with NRCS Emergency Watershed Protection (EWP) Program personnel and Maricopa County Flood Control District so that they can address specific landowner needs.

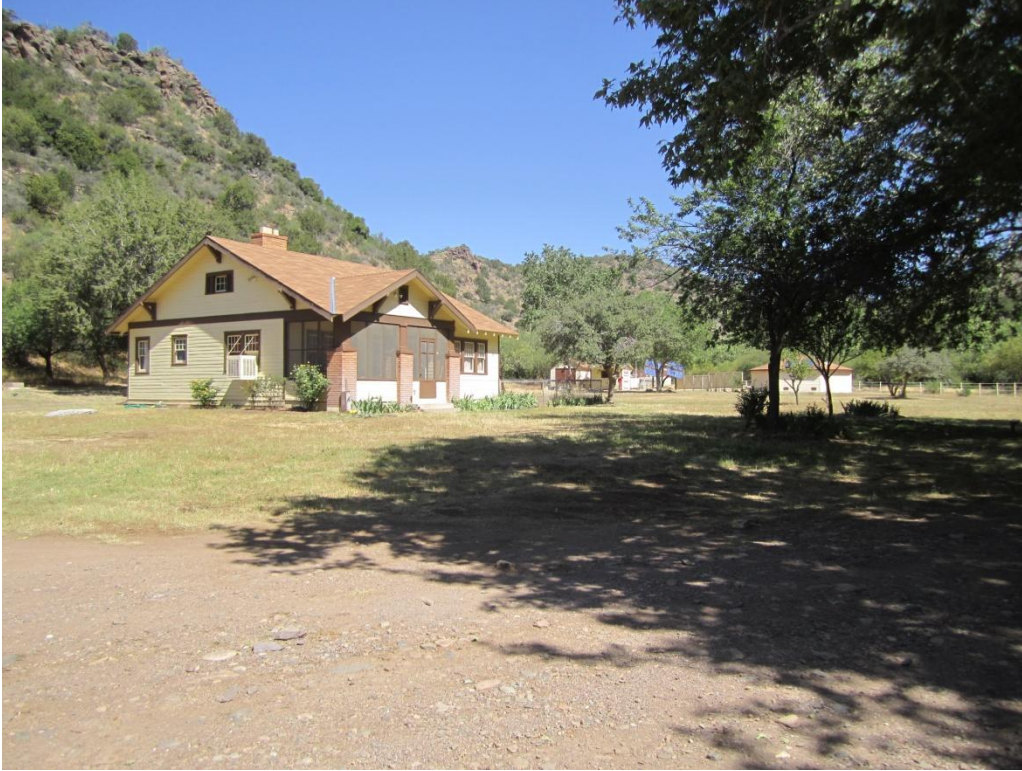
Figure 4. Sunflower Administrative Site located within 300 feet of West Fork Sycamore Creek

Probability of Damage or Loss: Possible. There is risk of flooding of structures

Magnitude of Consequence: Major – potential for significant structural damage.

Recommendation: Conduct channel treatments (debris removal, in-channel tree removal, and channel stabilization measures). Install Jersey barriers/K-rails along road leading to Sunflower Administrative site. Place sand bags around critical Forest Service infrastructure including residence, amphitheater, generator house, fuel storage tanks, etc.

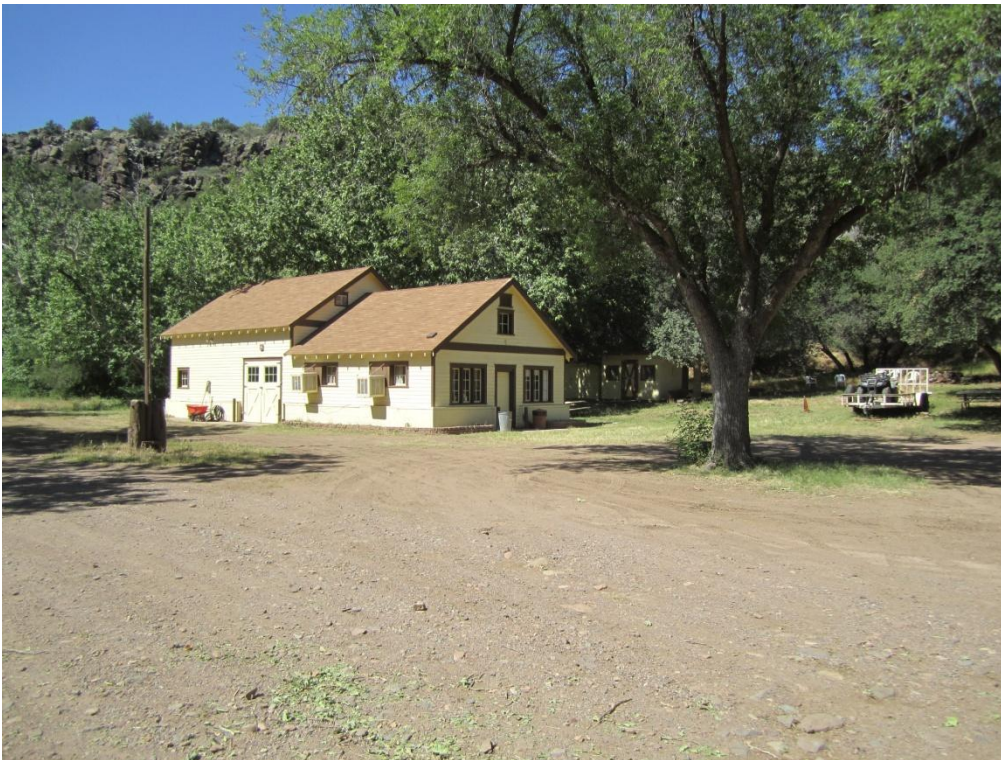
Figure 5. Sunflower Administrative Site located within 300 feet of West Fork Sycamore Creek. This site has experienced flooding prior to the Sunflower Fire.

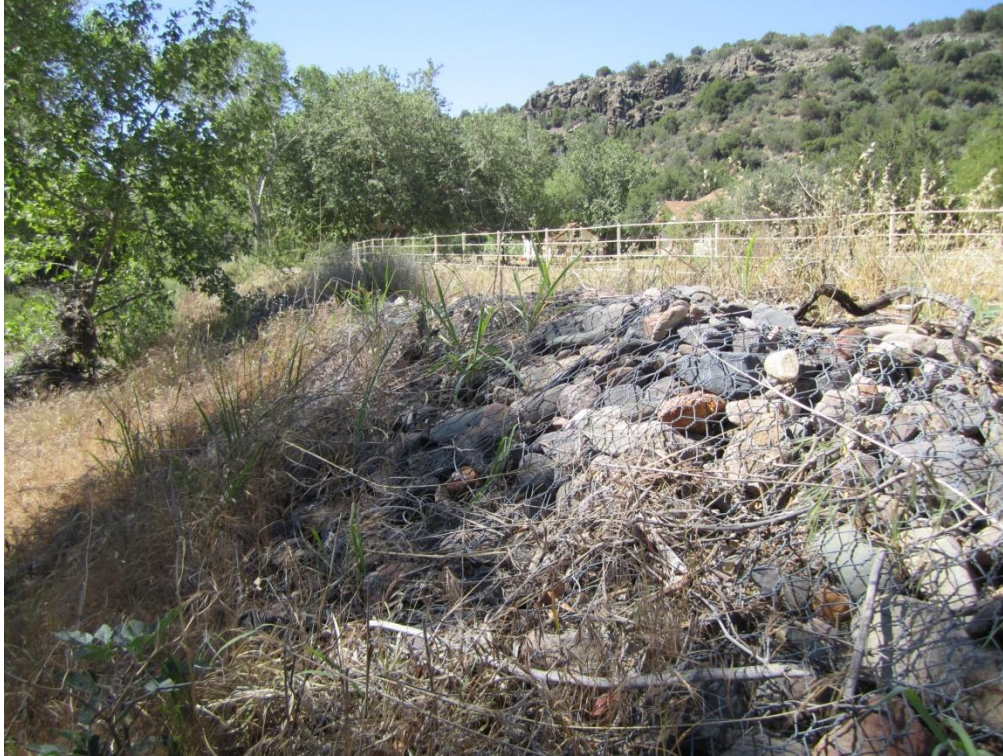
Figure 6. Bank stabilization of West Fork Sycamore Creek using rock baskets. Note Sunflower Administrative Site facilities in background.

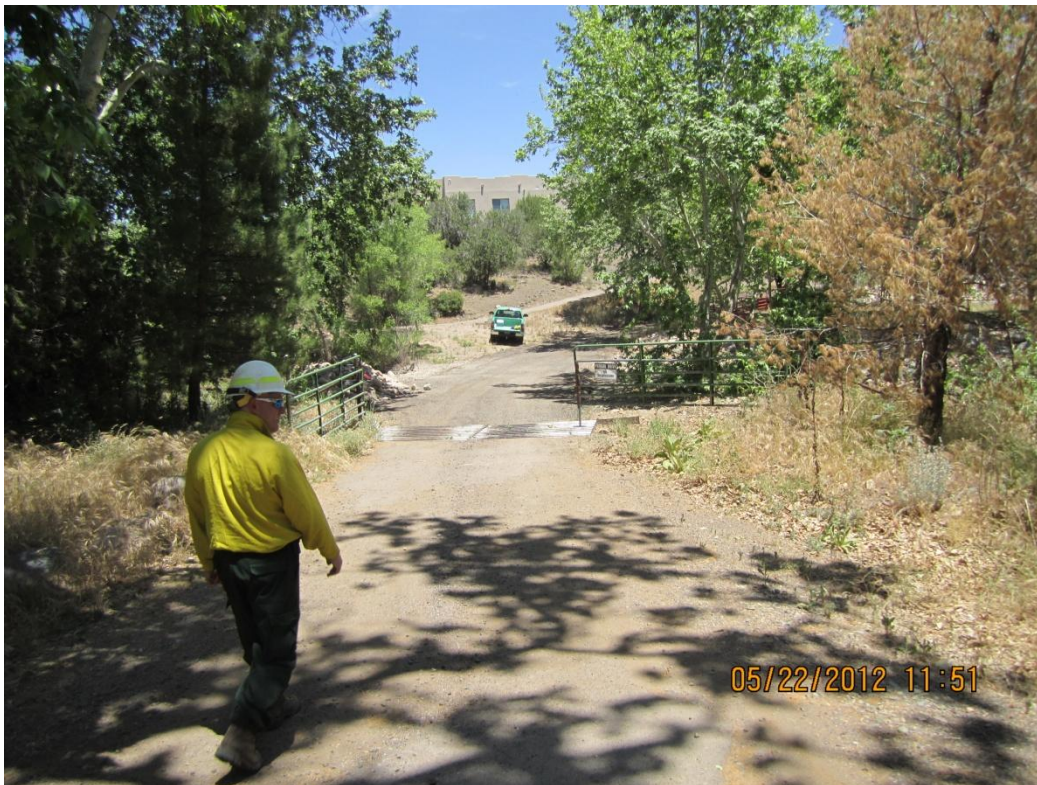
Figure 7. Private homes located within 100 feet of West Fork Sycamore Creek.

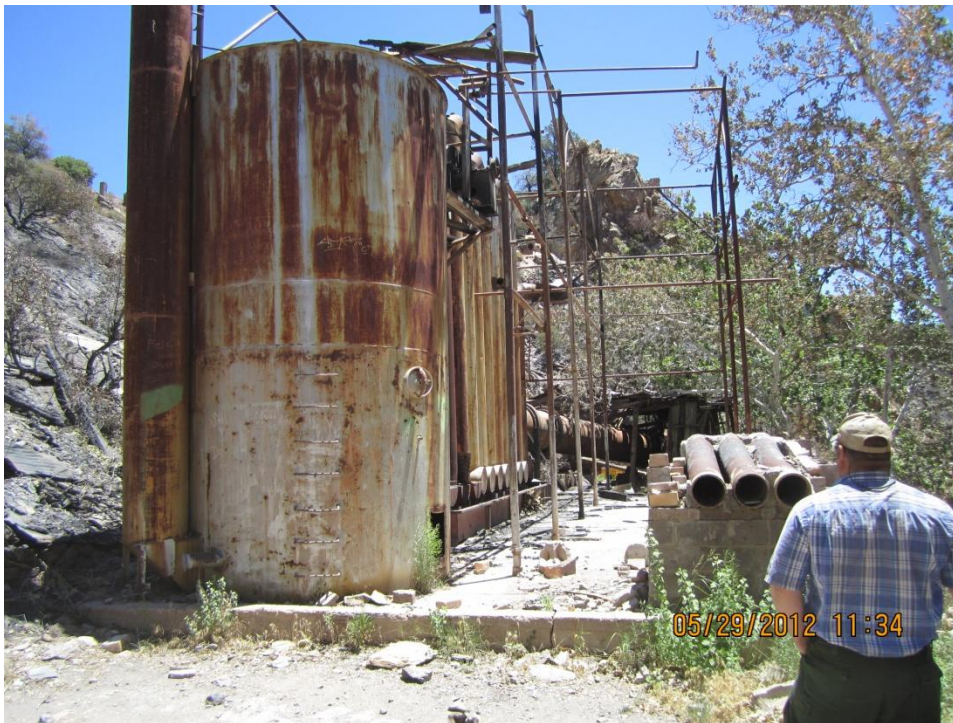
The National Mine Ore Processing Facility was burned during the fire. This abandoned facility includes a large amount of waste and debris (burned and contaminated timbers; steel rotary kiln; condenser system; asbestos insulation, electric motor, contaminated sheet metal; waste rock conveyor system; overturned mine truck, and a small tailings pile (est. <100 cu. yds.) (Figures 8 through 12). The small retort furnace, condenser, storage tank, asbestos insulation, mine truck, sheet metal/steel components, piping, and tailings pile should be removed from the site. The rotary kiln should either be removed from the site or sealed to prevent exposure of contaminated material inside the kiln. The remaining concrete foundation should then be cleaned to remove any contaminated ash or residue.

Figure 8. The National Ore Processing Facility. A large steel storage tank can be seen on the left, with condensers and rotary kiln in the background. A small retort furnace is located on the right above date stamp.

Recommendation: Stabilization or containment of contaminated processing facilities, mine waste, tailings, and waste rock, is recommended at the National, Pine Mountain, Oneida, and Cornucopia sites.

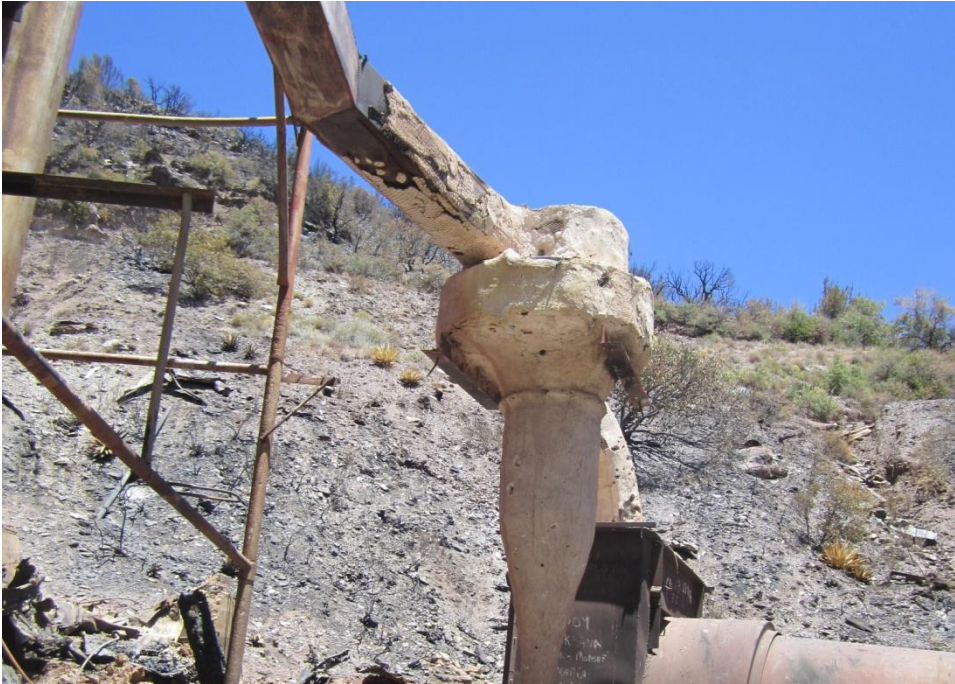
Figure 9. Friable asbestos insulation at condenser inlet above rotary kiln at National Mine Ore Processing Facility. Note burned area above.

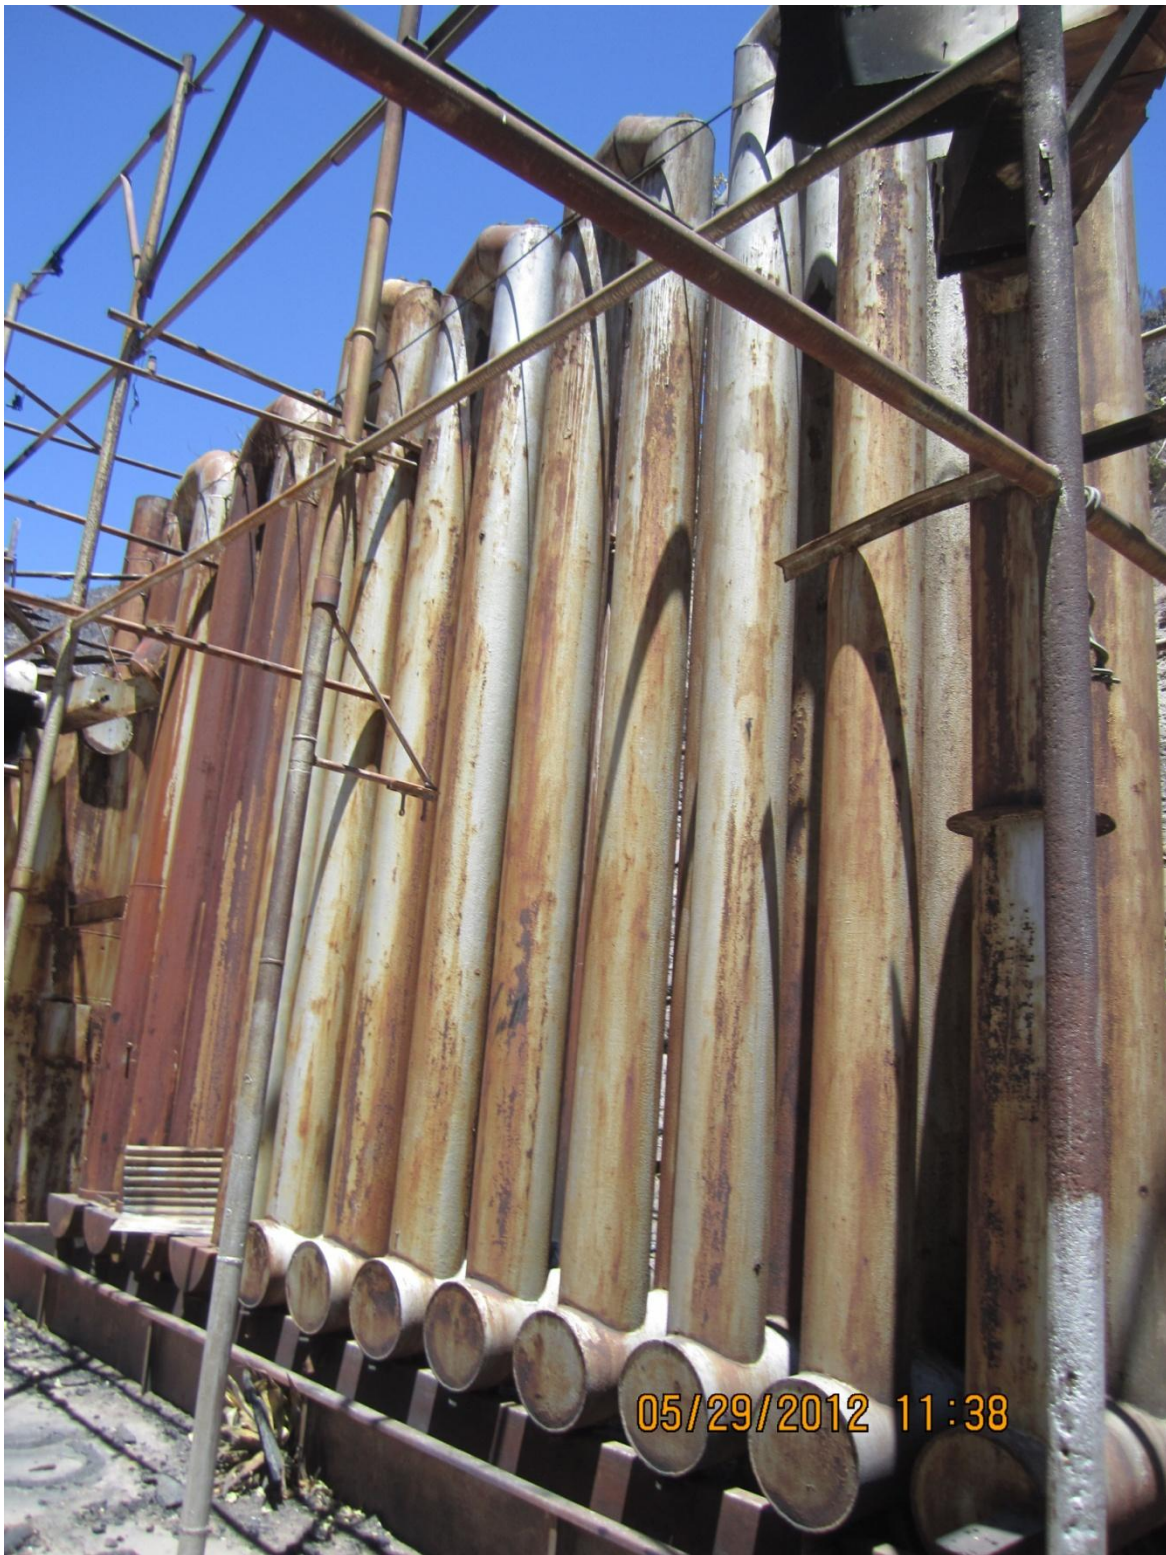
Figure 10. Condensers at National Ore Processing Facility.

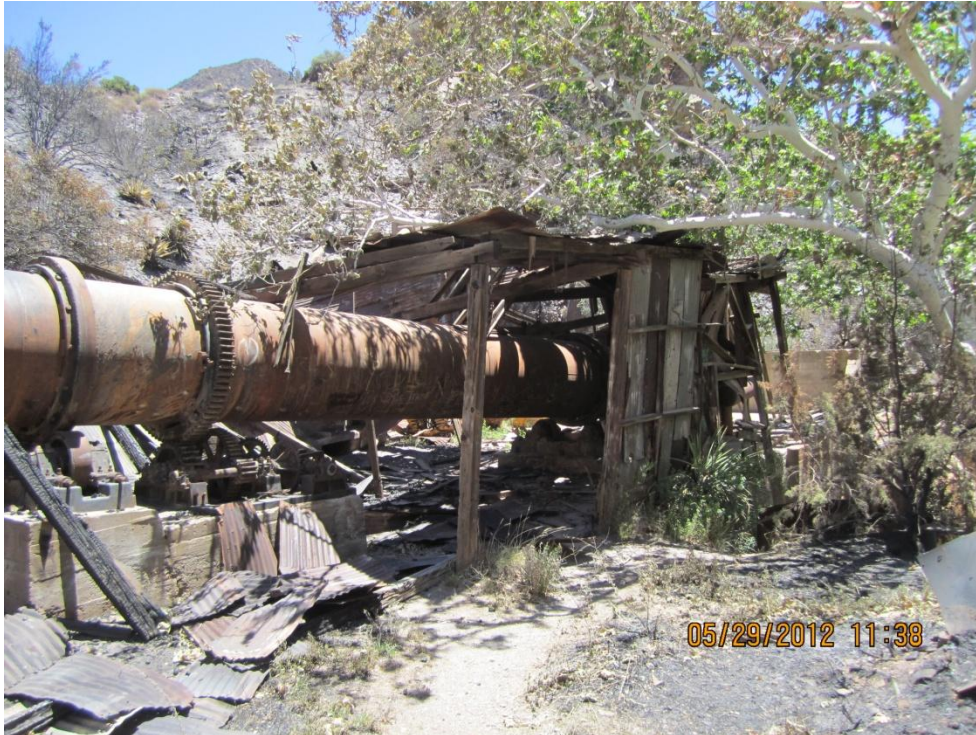
Figure 11. Rotary kiln at National Mine Ore Processing Facility.

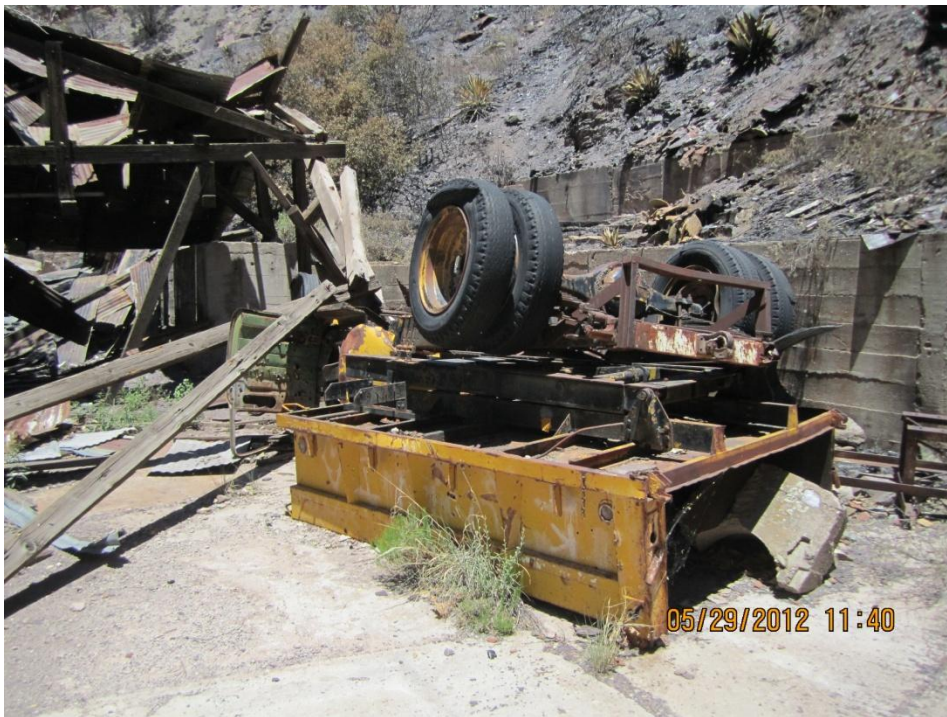
Figure 12. Overturned mine truck and other waste/debris at National Mine Ore Processing Facility.

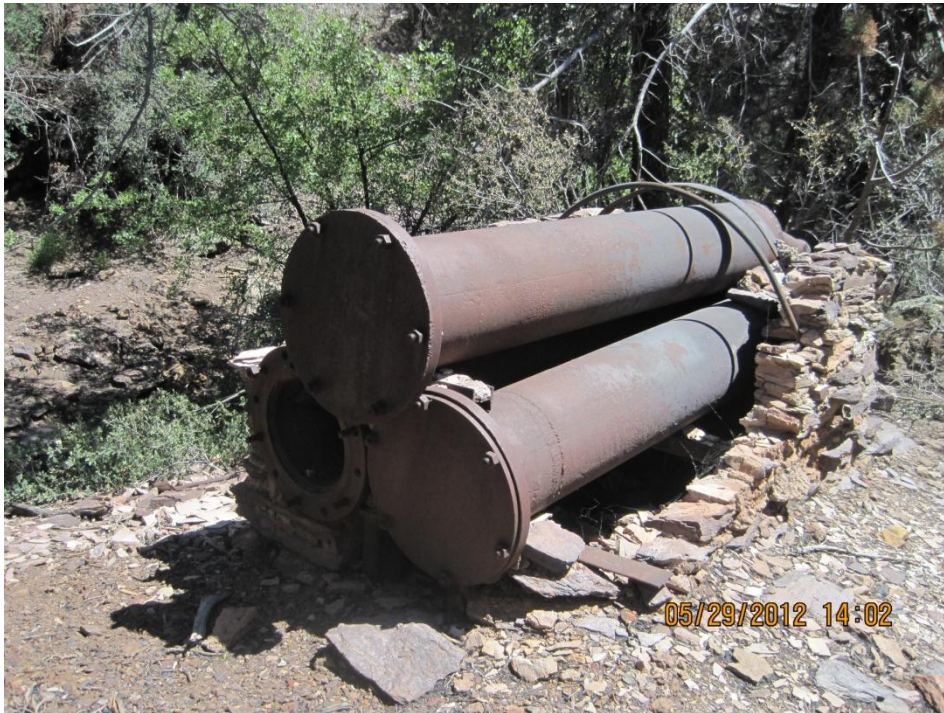
The Oneida and Red Top sites (Figures 13 and 14) contain small retort furnaces and minimal waste material. Removal of retort furnaces and site stabilization is recommended to mitigate potential contamination of surface waters.

Figure 13. Small retort furnace and waste rock at the Red Top site.

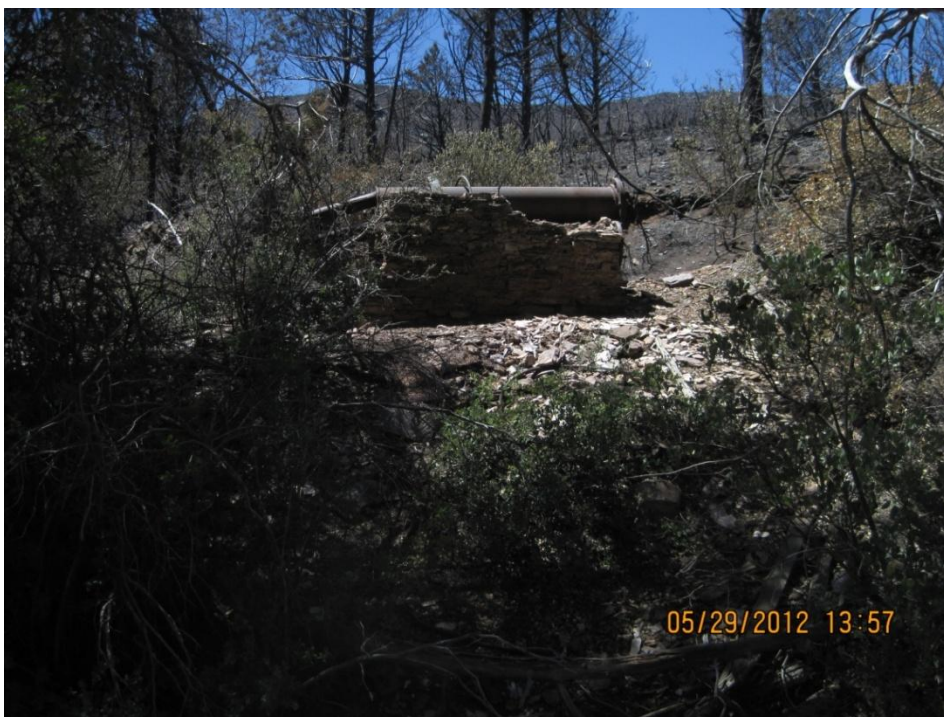
Figure 14. Another view of small retort furnace at Red Top facility. Note burned area above.
