USDA-FOREST SERVICE

FS-2500-8 (7/08)
Date of Report: 8/26/14

DAY, BALD AND EILER FIRES BURNED-AREA REPORT
(Reference FSH 2509.13)

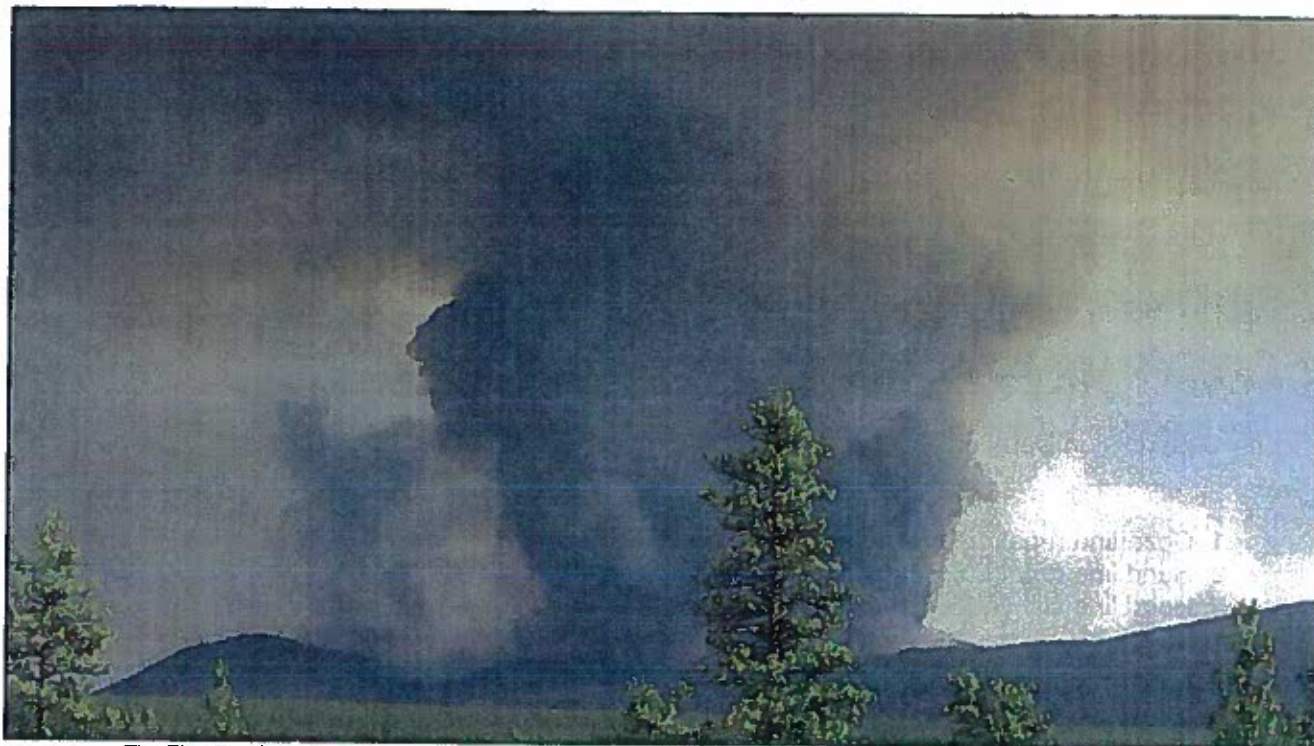
The Eiler Fire from California State Highway 299 on August 2nd 2014. Burney Mountain lies to the right of the image.

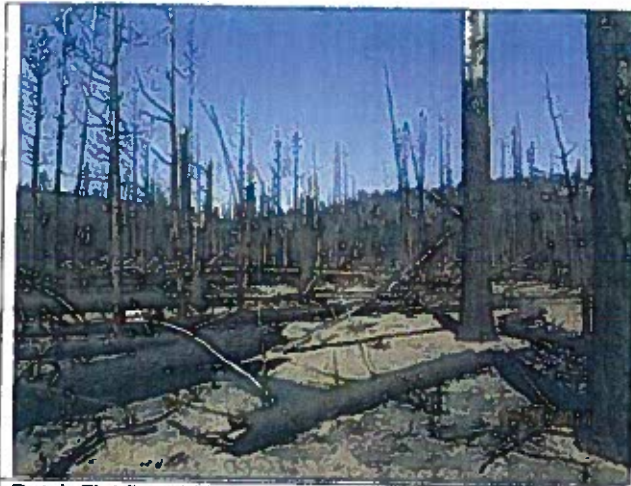
On August 2 prevailing southwest winds, channeled by the Hat Creek Valley topography moved the fire northward to 22,788 acres. Extreme fire behavior on this day produced a substantial column with swirling winds, fire and updrafts (fire whirls) that snapped trees off 30 feet above the ground, wrapped sheet metal around tree trunks, twisted barbed wire into long braids and sand blasted trees in the Dutch Flat area.

Dutch Flat fire whirl area with flattened trees

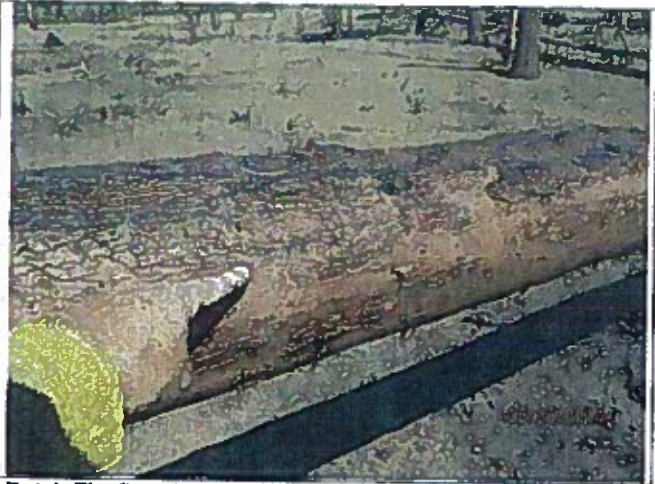
Dutch Flat fire whirl area with sandblasted tree

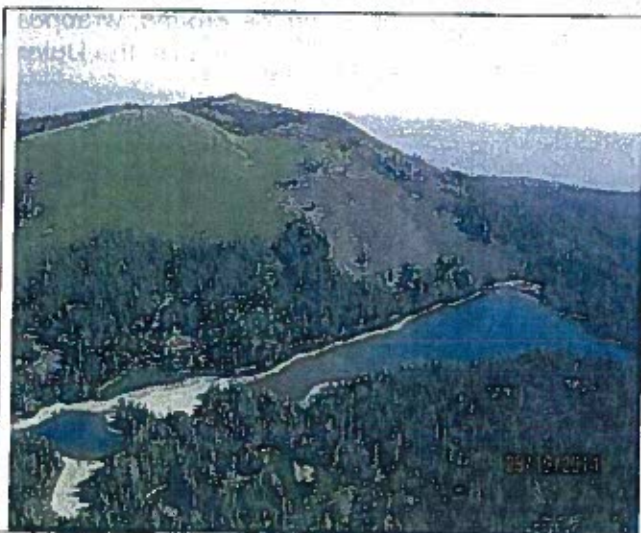
Lake Eiler point of ignition shown on the right of the lake.

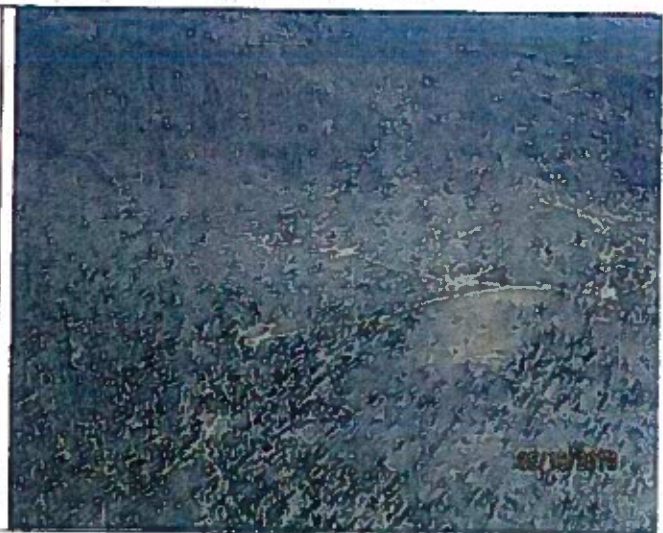
Dutch Flat fire whirl with trees laid flat in circular pattern.

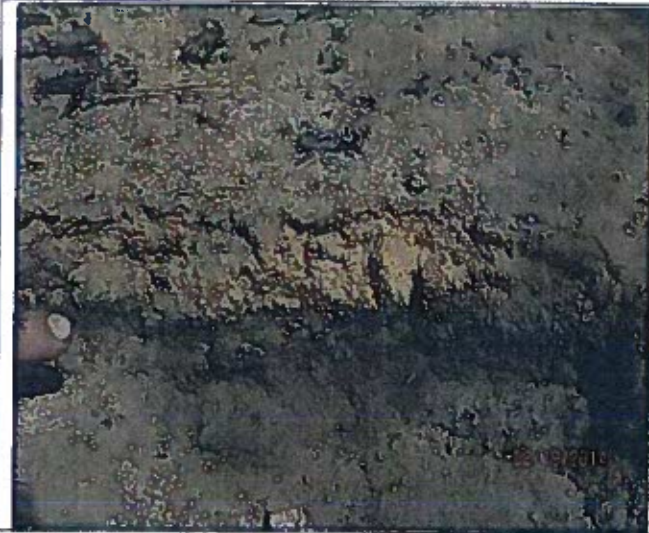
High soil burn severity in mixed conifer off Tamarack Trail

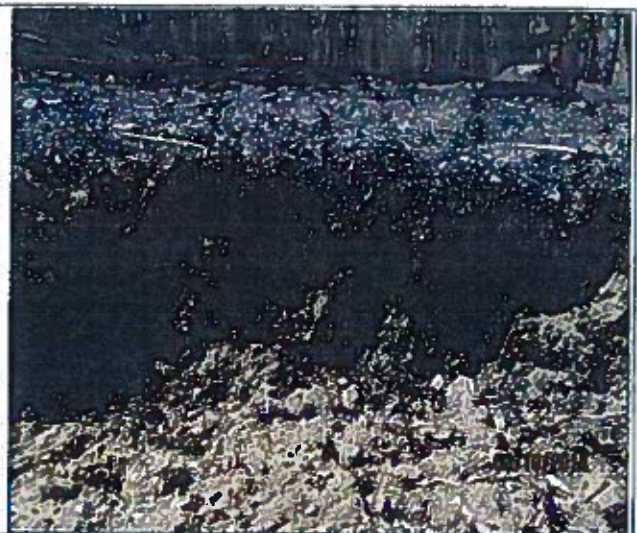
Low soil burn severity in mixed conifer off Tamarack Trail

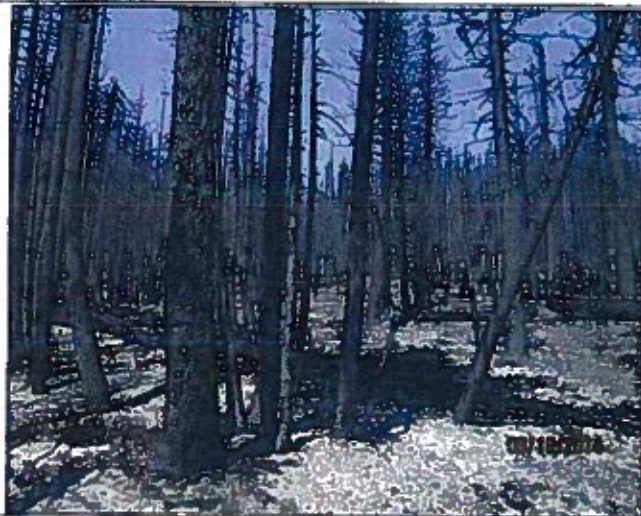
High soil burn severity in mixed conifer along Tamarack

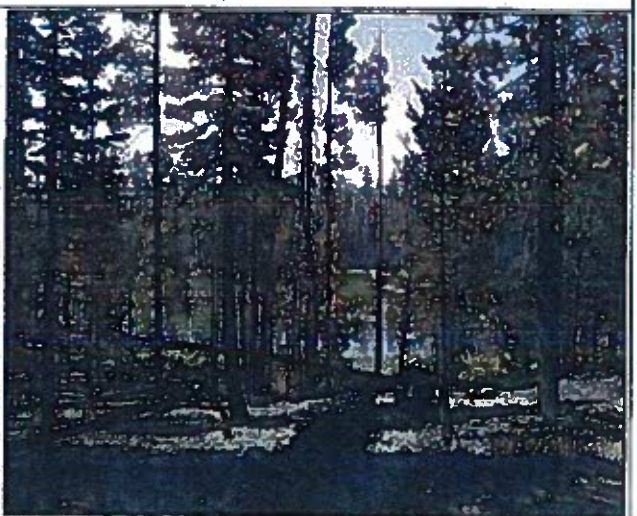
Low soil burn severity m-conifer in wilderness

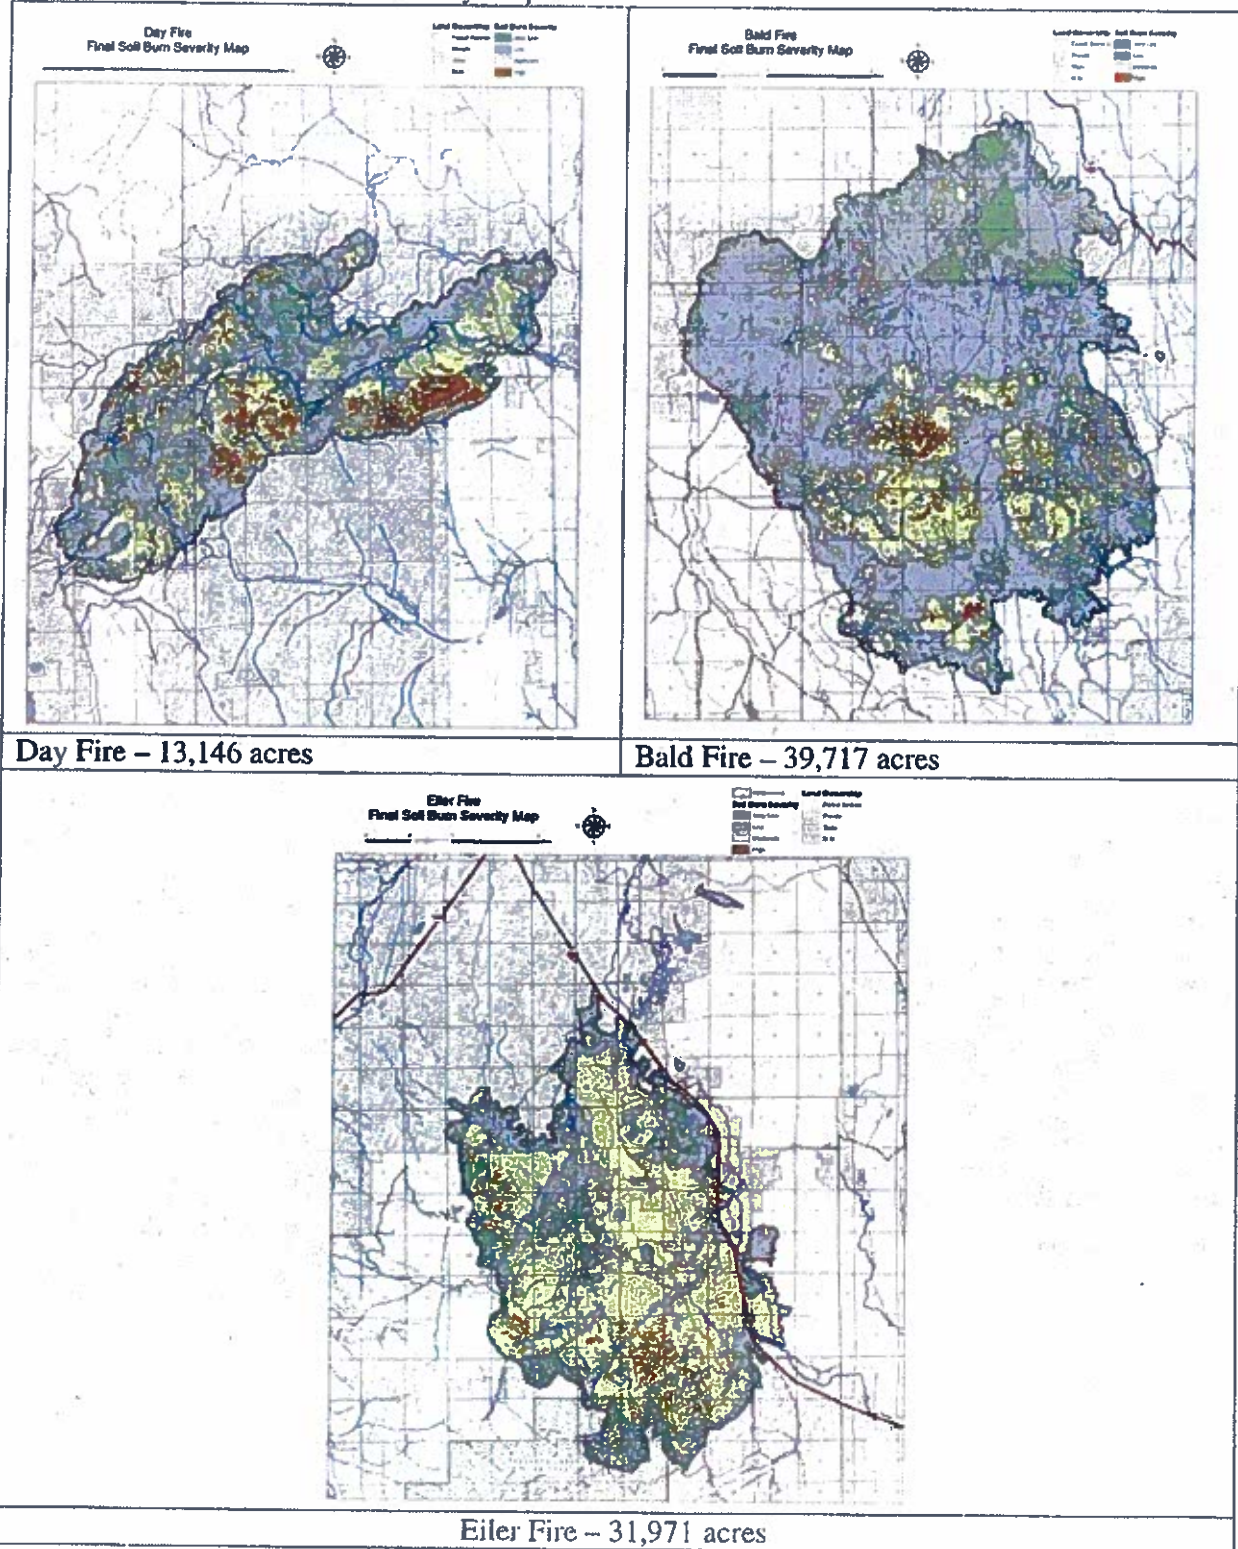
Day, Bald, Eiler Fire Soil Burn Severity Maps:

Approximately 45.4% (Day) 24.6% (Bald) and 62% (Eiler) burned at high and moderate soil burn severity (see soil burn severity maps below). The rest of the fire was either low or very low soil burn severity. It is very important to understand the difference between *fire intensity* or *burn severity* as discussed by fire behavior, fuels, or vegetation specialists, and *soil burn severity* as defined for watershed condition evaluation in BAER analyses. Fire intensity or burn severity as defined by fire, fuels, or vegetation specialists may consider such parameters as flame height, rate of spread, fuel loading, thermal potential, canopy consumption, tree mortality, etc. For BAER analysis, we are not mapping simply vegetation mortality or above-ground effects of the fire. Soil burn severity considers additional surface and below-ground factors that relate to soil hydrologic function, runoff and erosion potential, and vegetative recovery. Pictures below show the ignition point for the Eiler fire and mixed mortality where the picture on the right shows high mortality due to high burn intensities caused by a large fire whirl on August 2, 2014 in Dutch Flat of the Eiler fire.

Looking at the soil burn severity maps below shows the majority of soil burn severity was moderate to low across all fires. Areas that burned the hottest were south Taylor Creek for the Day Fire, Negro Mountain area for the Bald Fire, and the east Eiler butte area for the Eiler Fire.
