USDA-FOREST SERVICE

FS-2500-8 (7/08)
Date of Report: 9/8/14

OREGON FIRE BURNED-AREA REPORT
(Reference FSH 2509.13)

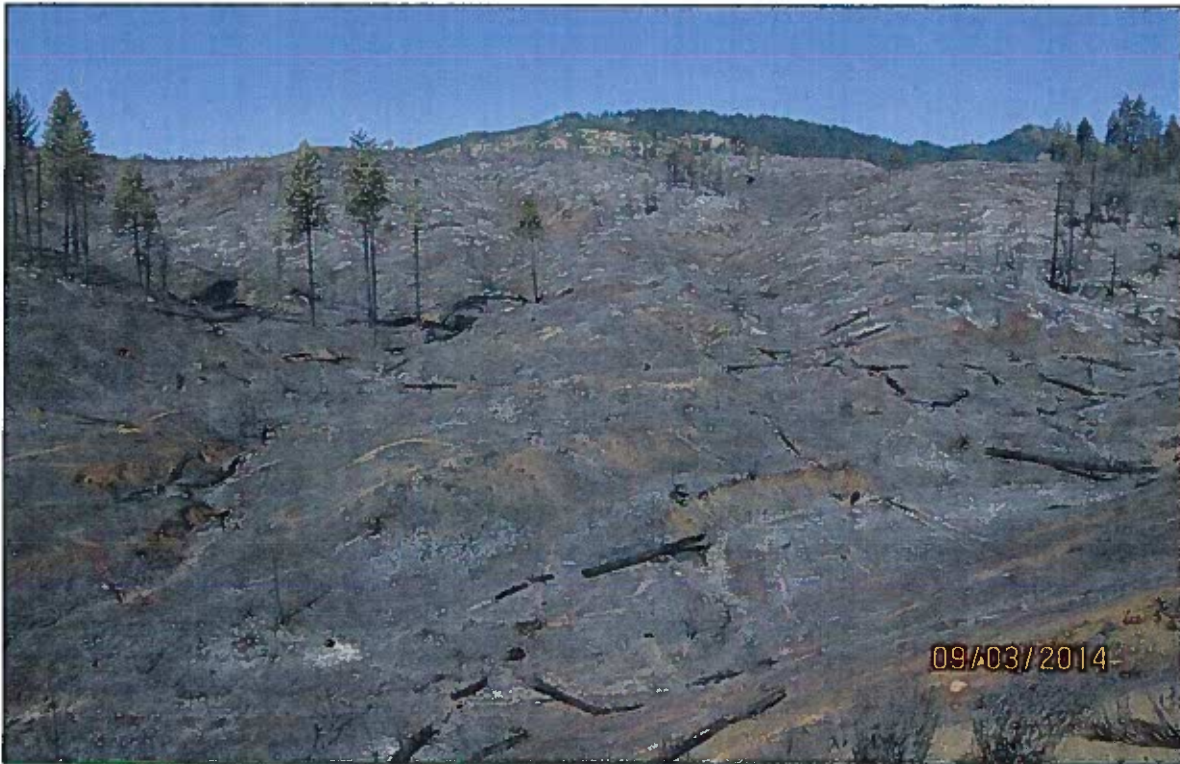
The Oregon Fire of 2014 looking into McKenzie Gulch area reburned since Oregon Fire of 2001.

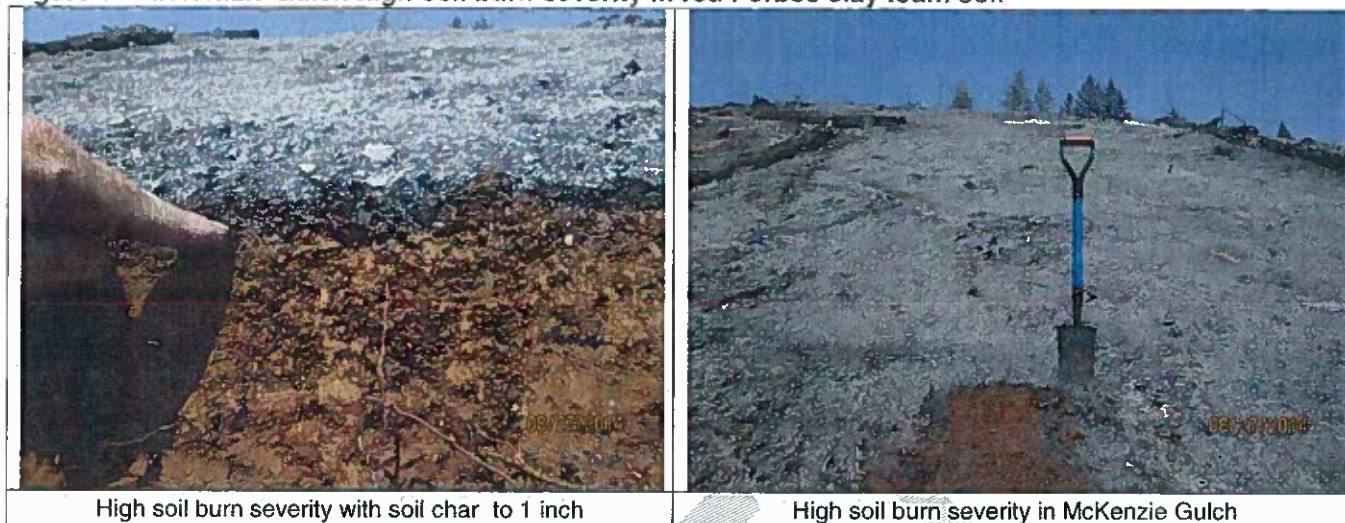
Figure 1 – McKenzie Gulch high soil burn severity in red Forbes clay loam soil

Approximately 40% burned at high and moderate soil burn severity (see soil burn pictures above). The rest of the fire was either low or very low soil burn severity (see below soil burn severity map). It is very important to understand the difference between *fire intensity* or *burn severity* as discussed by fire behavior, fuels, or vegetation specialists, and *soil burn severity* as defined for watershed condition evaluation in BAER analyses. Fire intensity or burn severity as defined by fire, fuels, or vegetation specialists may consider such parameters as flame height, rate of spread, fuel loading, thermal potential, canopy consumption, tree mortality, etc. For BAER analysis, we are not mapping simply vegetation mortality or above-ground effects of the fire. Soil burn severity considers additional surface and below-ground factors that relate to soil hydrologic function, runoff and erosion potential, and vegetative recovery.

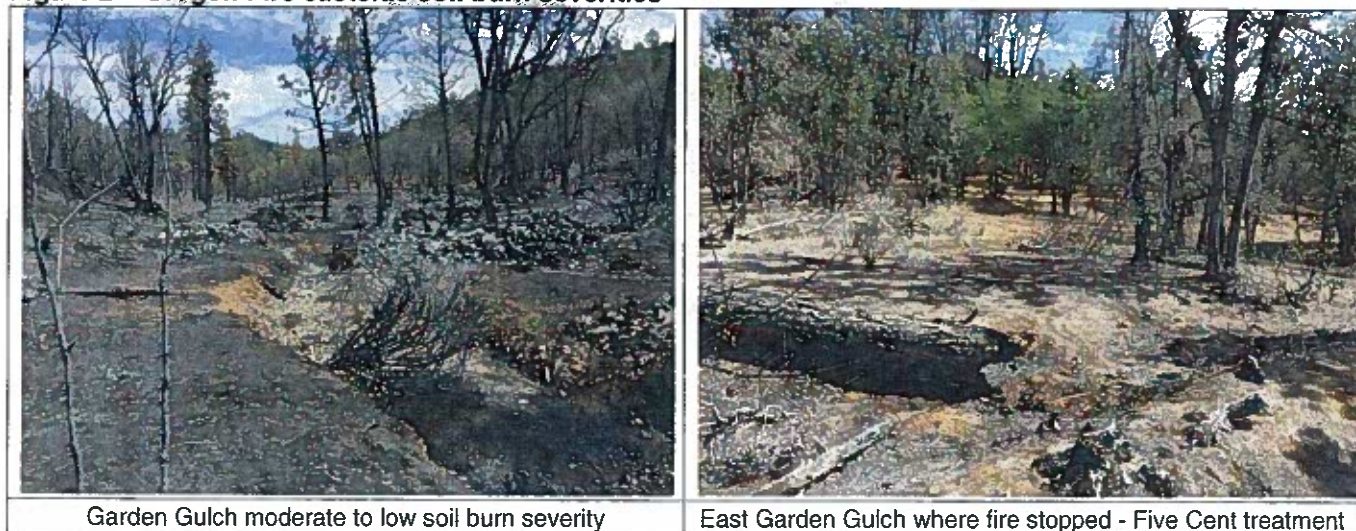
Figure 2 – Oregon Fire eastside soil burn severities

Pictures below show Garden Gulch mixed mortality where the picture on the right shows low to very low soil burn intensities due to the fire stopping at the 5-cent fuels treatment on the east side of the Oregon fire.

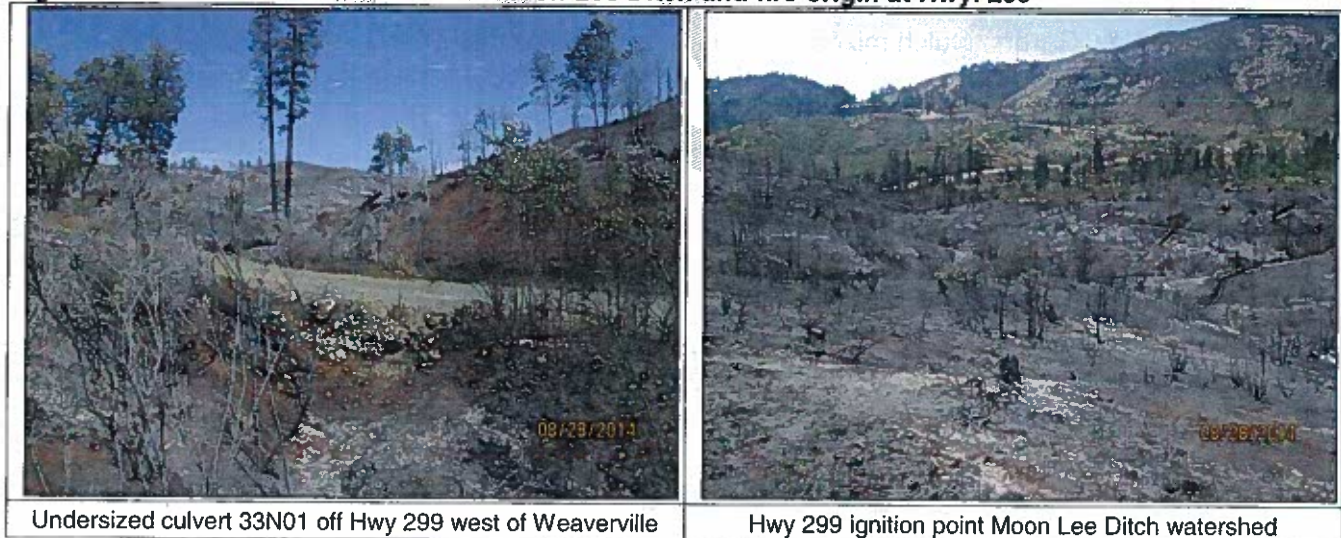
Figure 3 – West Weaver Creek area of Moon Lee Ditch and fire origin at Hwy. 299

Undersized culvert 33N01 off Hwy 299 west of Weaverville

Hwy 299 Ignition point Moon Lee Ditch watershed

Treatment	Quantity	Estimated Cost	Justification
NFSR 33N01-Reconstruct Rolling Dip	1	\$ 1,500.00	Minimize damage to the road surface and template by diverting storm water run-off flow off the road
NFSR 33N01- Culvert Replacement (Upsizing) 24" X 40'	1	\$ 2,800.00	Increase the capacity of the drainage structure to handle the expected increased flows from the burned area. Decrease the probability of road failure
NFSR 33N42- Culvert Replacement (Upsizing) 24" X 40'	1	\$ 2,800.00	
Total Cost=		\$ 7,100.00

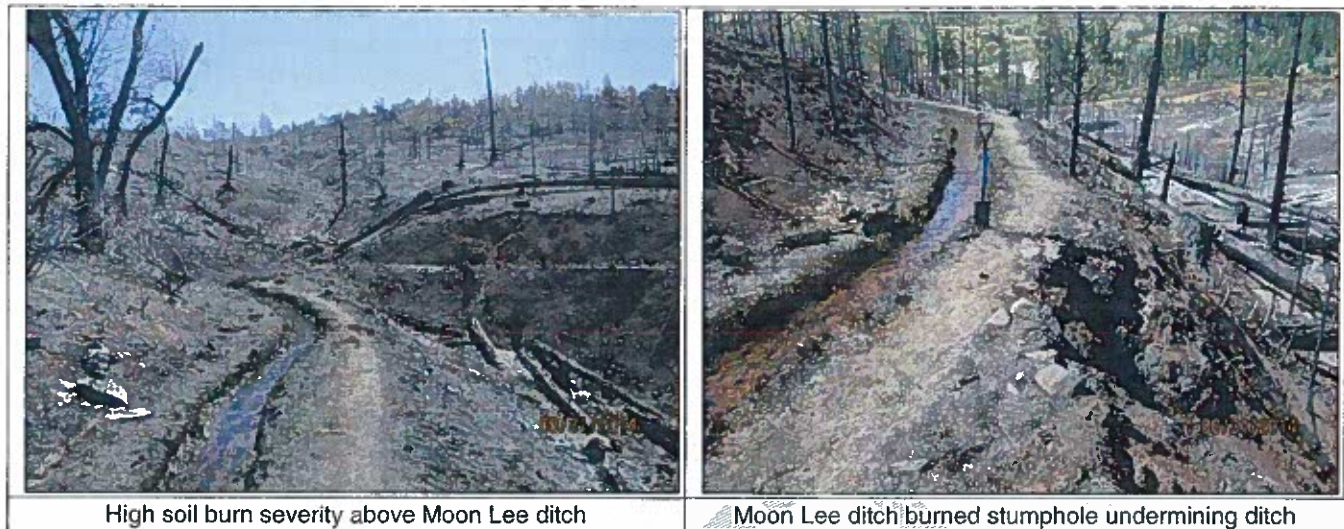
High soil burn severity above Moon Lee ditch

Moon Lee ditch burned stump hole undermining ditch

The fire burned with high intensity the area in and adjacent to the Moon Lee Ditch (see pics above). This ditch is a diversion off of West Weaver Creek initiating on USFS land in the NW ¼ of section 2 and moves onto private ownership land in the NE ¼ of section 11. Just north of the section line common to sections 2 and 11 an underground piped diversion off the ditch belongs to the Weaverville Community Services District which feeds a holding tank and water treatment system. During the six month warm season period, demands for water increase and this system provides ten to fifteen percent of the towns domestic water supply, where the remaining water (in the open ditch) services 17 private ownerships with water rights. Water rights for all users exist prior to 1866. The primary water user off the open ditch is the Weaverville Cemetery. The ditch is a registered historical site. After consultation with FS Special Uses, only portions of the ditch system are under permit and most either predates the need or is currently not under permit. The portions in section 11 have been historically maintained by the private ownerships. It is unclear exactly who has responsibility for maintenance on USFS ownership although the Weaverville Community Services District has performed emergency repairs as needed in the past. The Proposed BAER treatments are listed below in the Treatment Narrative for 2,215 feet of USFS lands only.

Straw bale check dams with rock dissipators are proposed in treatment area 4. The purpose of a small straw bale check dam with rock dissipators is to temporarily capture sediment in the upper reaches of stream channels. Wood or rock is used to dissipate the overflow of water on the downstream side of each dam and to provide a longer term storage capacity once the straw has decomposed. Straw dams have been proven effective in similar burned areas. The dams are effective at catching sediment in the first two years after the fire and allow the sediment to be metered out at a lower rate in subsequent years. This treatment will be used above the Moon Lee Irrigation Ditch and selected locations in McKenzie Gulch.

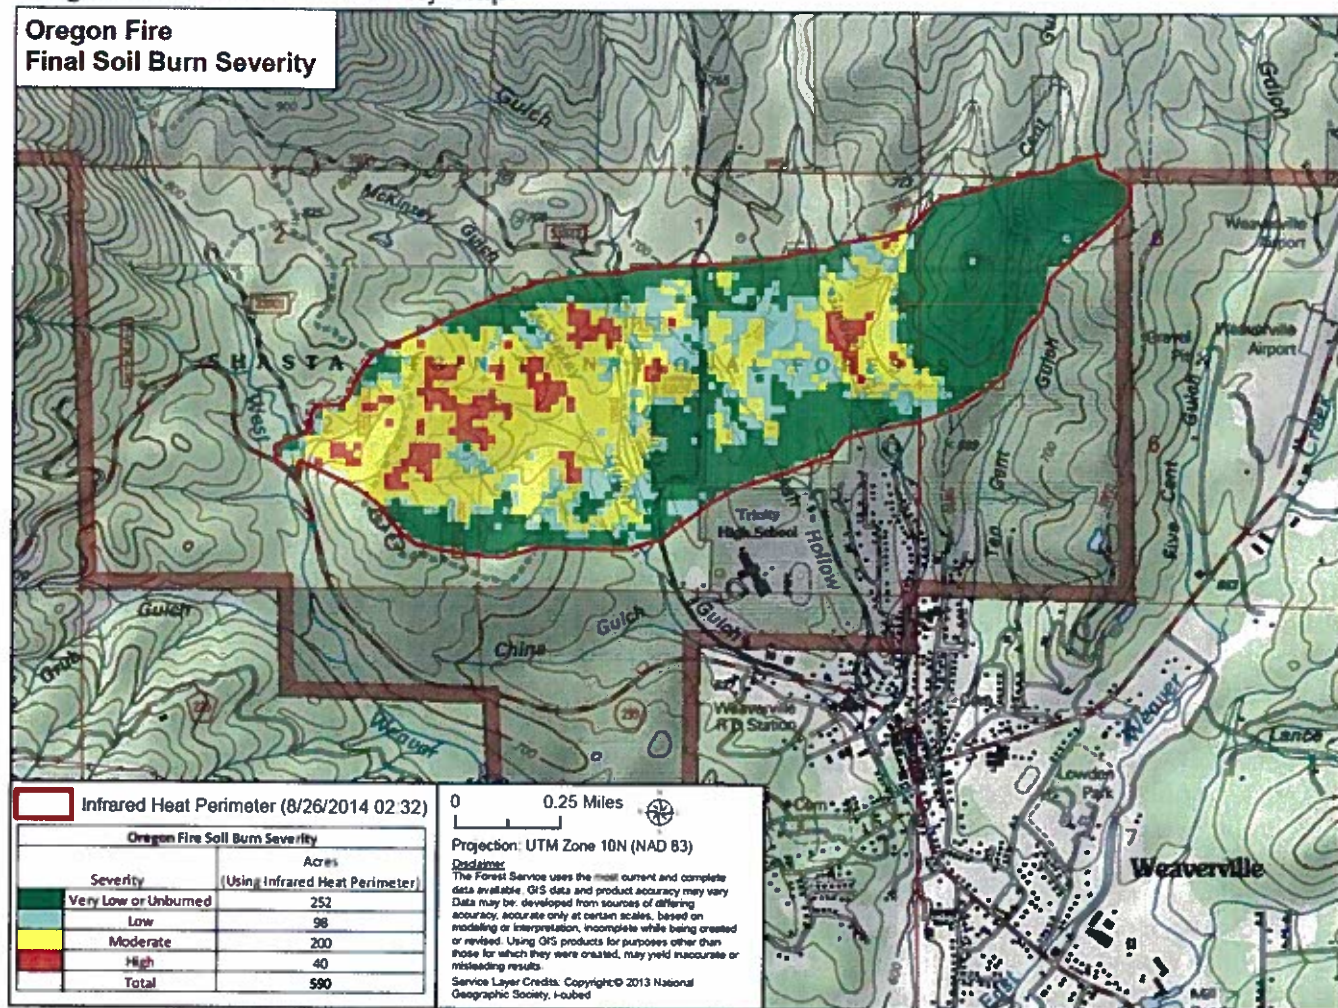
Oregon Fire Soil Burn Severity Map:

Twenty soil burn samples were taken in the field to confirm the soil burn severity mapping (see Appendix E). Looking at the soil burn severity maps below shows the majority of soil burn severity was moderate to low east of Sidney Gulch. Areas that burned the hottest were the west portion of the fire above West Weaver Creek, McKenzie and Sidney Gulches. This was due to heavy accumulations of dead and down timber left from the Oregon fire of 2001.
