BURNED-AREA REPORT
(Reference FSH 2509.13)

- A. Fire Name:** Umpqua North Complex **B. Fire Number:** OR-UPF-000406
C. State: Oregon **D. County:** Douglas
E. Region: Pacific Northwest **F. Forest:** Umpqua

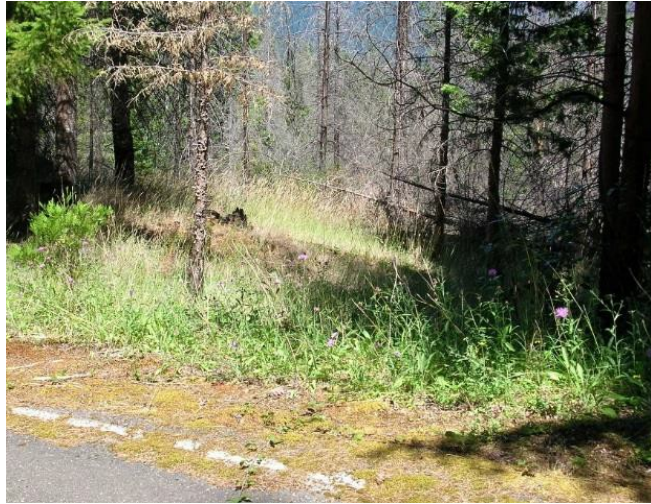
Figure 4. Meadow knapweed with pink flowers lines FS road 4714 two years after the Apple Fire. The tall grass in the background is seeded blue wildrye.

Seeding and Mowing - Seeding with native grasses is recommended to occur along an approximately twenty foot width between existing roadside weed infestation and areas blackened by fire where there is potential for spread. This is particularly a concern for areas with meadow knapweed which has a demonstrated capacity for spreading under by rhizomes under low severity burn conditions as long as there is sufficient canopy opening. Approximately 7.7 miles have been identified as being of particularly high risk of weed movement. Although studies have shown mixed results with seeding after fire (Peppin et al. 2010, Peppin et al. 2011), recent seeding trials on the Tiller Ranger District after the Whisky fire conclude that seeding with native grasses had up to 60% more vegetative cover than unseeded areas, and is an effective treatment to prevent non-native species from colonizing post-fire on the Tiller Ranger District (Report by Wijayratne and Baker 2015). Scott Riley, regional restoration specialist has had great success in post fire seeding using native grass seed in high severity areas and those areas identified at risk for invasive plant colonization. Recommended seeding rates are 20 lbs/acre, raking seed in where possible will improve seed to soil contact and improve germination and establishment success. Blue wildrye (*Elymus glaucus*) is the preferred species over all the areas except for Oak Flats where a dry meadow grass species mix should be employed. Roemer’s fescue (*Festuca roemerii*), California oatgrass (*Danthonia californica*) and Prairie Junegrass (*Koeleria cristata*) are the generally preferred species for this habitat. Current seed supplies (native, local genetics) would be utilized to meet Regional policy and reduce costs of treatment.

Mowing of areas badly infested with meadow knapweed to reduce seed production and hand pulling or smaller infestations should accompany the areas where seeding occurs. This method was successfully employed after the 2002 Apple Fire (Figure 4). We mowed the meadow knapweed just prior to the plant’s flowering. Unfortunately we found that the plants were able to recover to produce flowers a few weeks later on the now much shorter statured plants. Despite this, the combination of mowing and seeding resulted in very few plants moving from the roads into the burned areas to this day. For the Umpqua North Complex we recommend doing two mowings about three weeks apart to more successfully reduce the production of knapweed seed. Implementation of this treatment in the Apple Fire was more cost effective than early detection rapid response in similar areas. It is expected that the same will be true for the Umpqua North Complex. Additionally, meadow knapweed is rhizomatous which means that it can progress into burn areas even if mowed as it doesn’t need to seed. Thus both seeding to out compete rhizomatous propagation and mowing to limiting meadow knapweed propagating through seed.

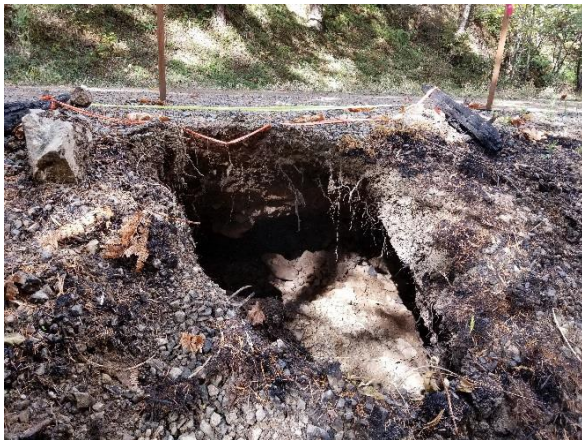
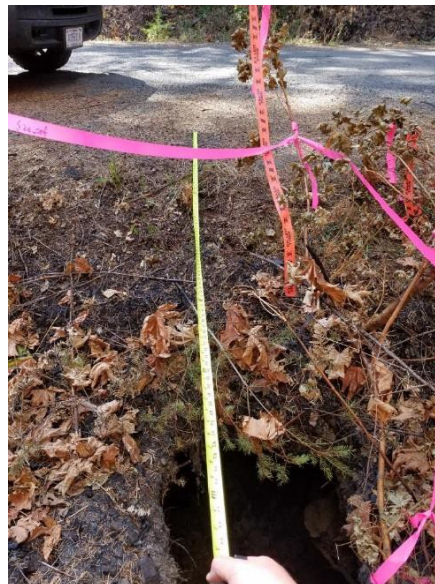
There are three areas where the fill and roadbed has been damaged by fire burning out logs in the road fill. While this is not a critical BAER value at risk by itself the high potential for localized post-fire erosion and ravel of the remaining roadbed and potential loss of the remaining adjacent road is a BAER values at risk. These areas are at risk of such erosion and since they are near the highway the loss of the road would have significant impacts on access.

Excavate burned out material and rebuild roadbed where wooden material burned beneath the road surface, the road prism should be excavated down until a stable base. The prism should be built back up in compacted layers until the grade matches the elevation of the adjacent road prism. In the instance where the fill slope was compromised by fire, unstable material should be removed from the fill slope to prevent raveling and gullying that could destroy the remaining roadbed making the road impassable during a post-fire storm event, and rip rap should be placed on the fill slope in order to protect the road prism. This treatment will protect the remaining roadbed and limit the impact of post-fire precipitation and overland flow from further damaging these road segments making large areas of the Forest inaccessible.

- 2800-000 MP 1.5 (measured from HWY 138): Excavate and rebuild road prism.
- 4750-000 MP 0.25 (measured from 4750-040): Excavate and rebuild road prism.
- 4760 from MP 0.67 (measured from 4760-045): Remove unstable material on fill slope, and armor with rip rap.
