DRAFT SOBERANES 2 BURNED AREA REPORT
(Reference FSH 2509.13)

A. Fire Name: Soberanes 2 Fire

B. Fire Number: CA-BEU-003422

F. Forest: Los Padres

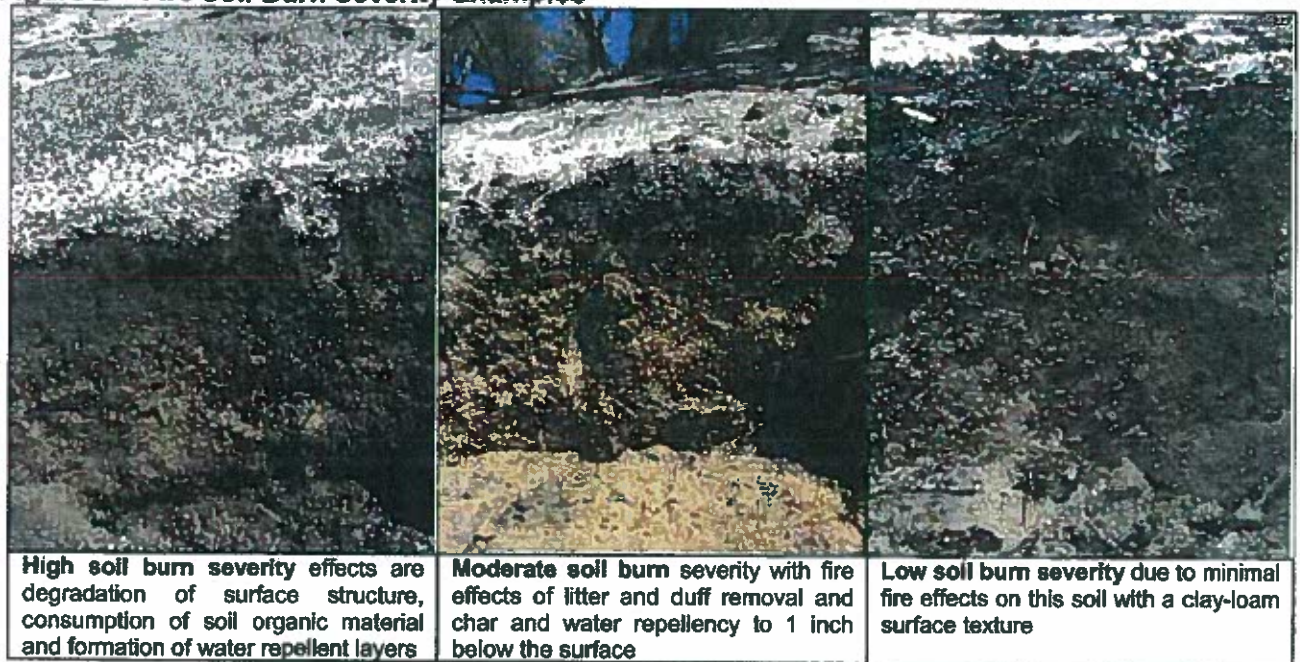
Figure 2 – Fire Soil Burn Severity Examples

The following pictures (Figures 2 & 3) are companion pictures to show typical soil burn severity and landscapes with mixed mortality due to differing vegetation types, slopes, aspect, and location.

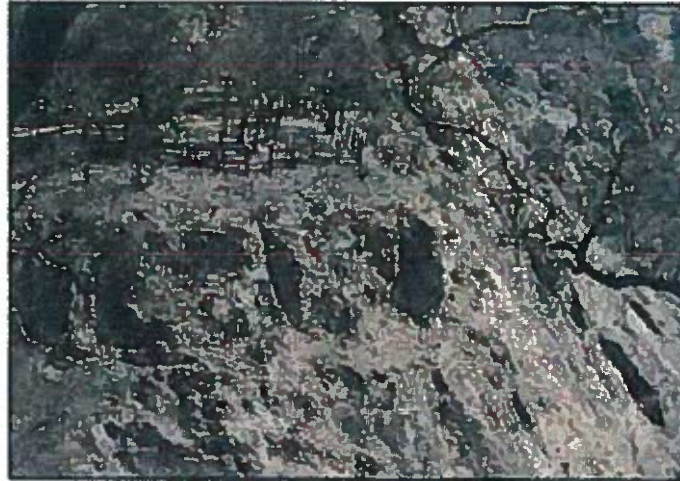
Figure 7 – Botchers Campground

Safety fencing at Botchers Campground to protect campers from dangerous cliff overlook area that was burned up and in various locations needs replacing (Figure 7).

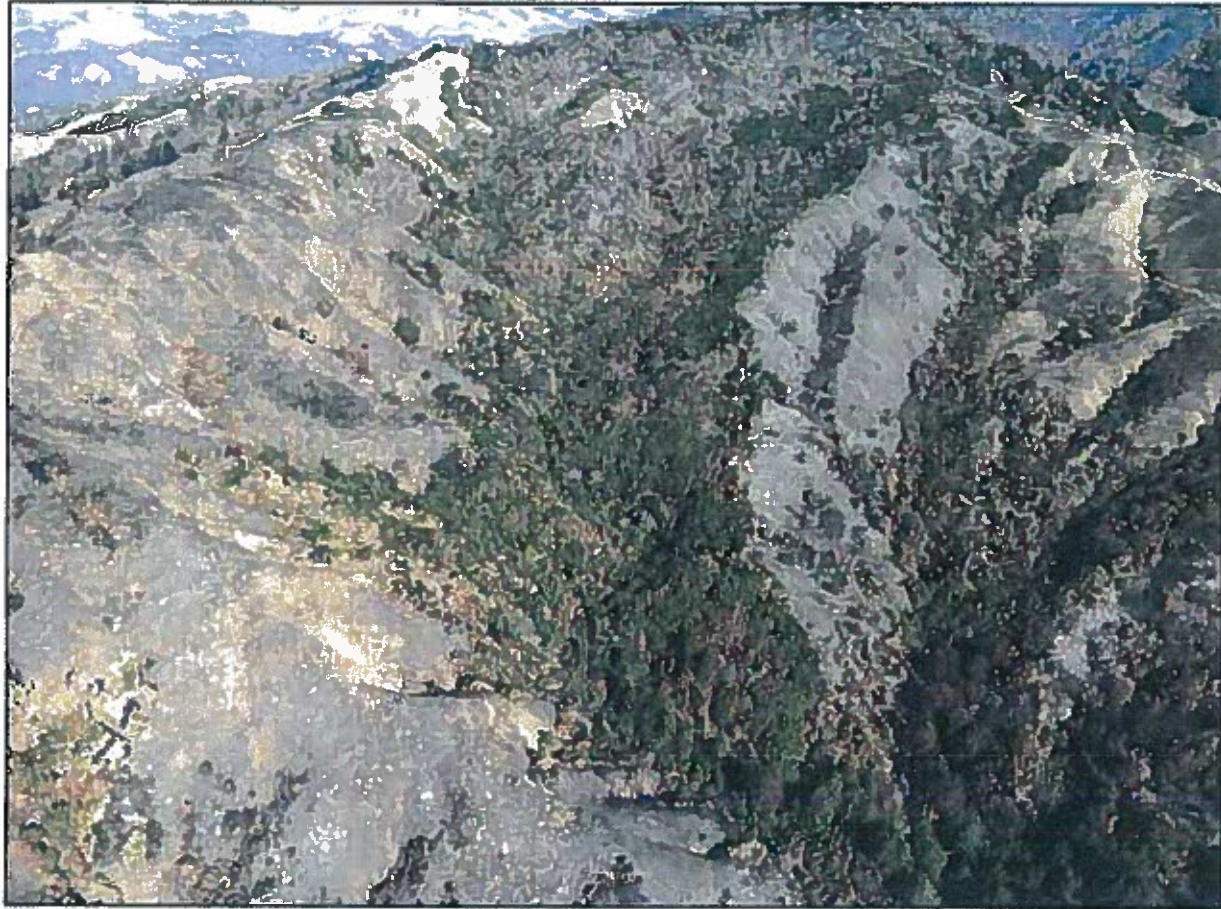
Figure C-2: North versus south aspect vegetation differences as shown in Turner Creek.

either were browned or remained intact. It is expected that natural needle fall will provide enough soil cover to lessen the hydrologic response of the first damaging storm. In addition, mulch applied to a forested stand with high canopy retention results in mulch interception in needles and branches greatly decreasing the efficacy of mulch applications. Figure C-2 depicts the burn characteristics differences between north and south aspects with *moderate* soil burn severity.
