Date of Report and Type: Interim 11/15/2017**BURNED-AREA REPORT**

PART II - BURNED-AREA DESCRIPTION**A. Fire Name:** Park Creek**B. Fire Number:** MT-HLF-0001460115**C. State:** Montana**D. County:** Lewis and Clark, Powell**E. Region:** 01 - Northern**F. Forest:** 15 - Helena-Lewis and Clark**G. District:** Lincoln**H. Fire Incident Job Code:****I. Date Fire Started:** 07/14/2017**J. Date Fire Contained:** 10/09/2017**K. Suppression Cost:** \$20,050,123**L. Fire Suppression Damages Repaired with Suppression Funds** (estimates):

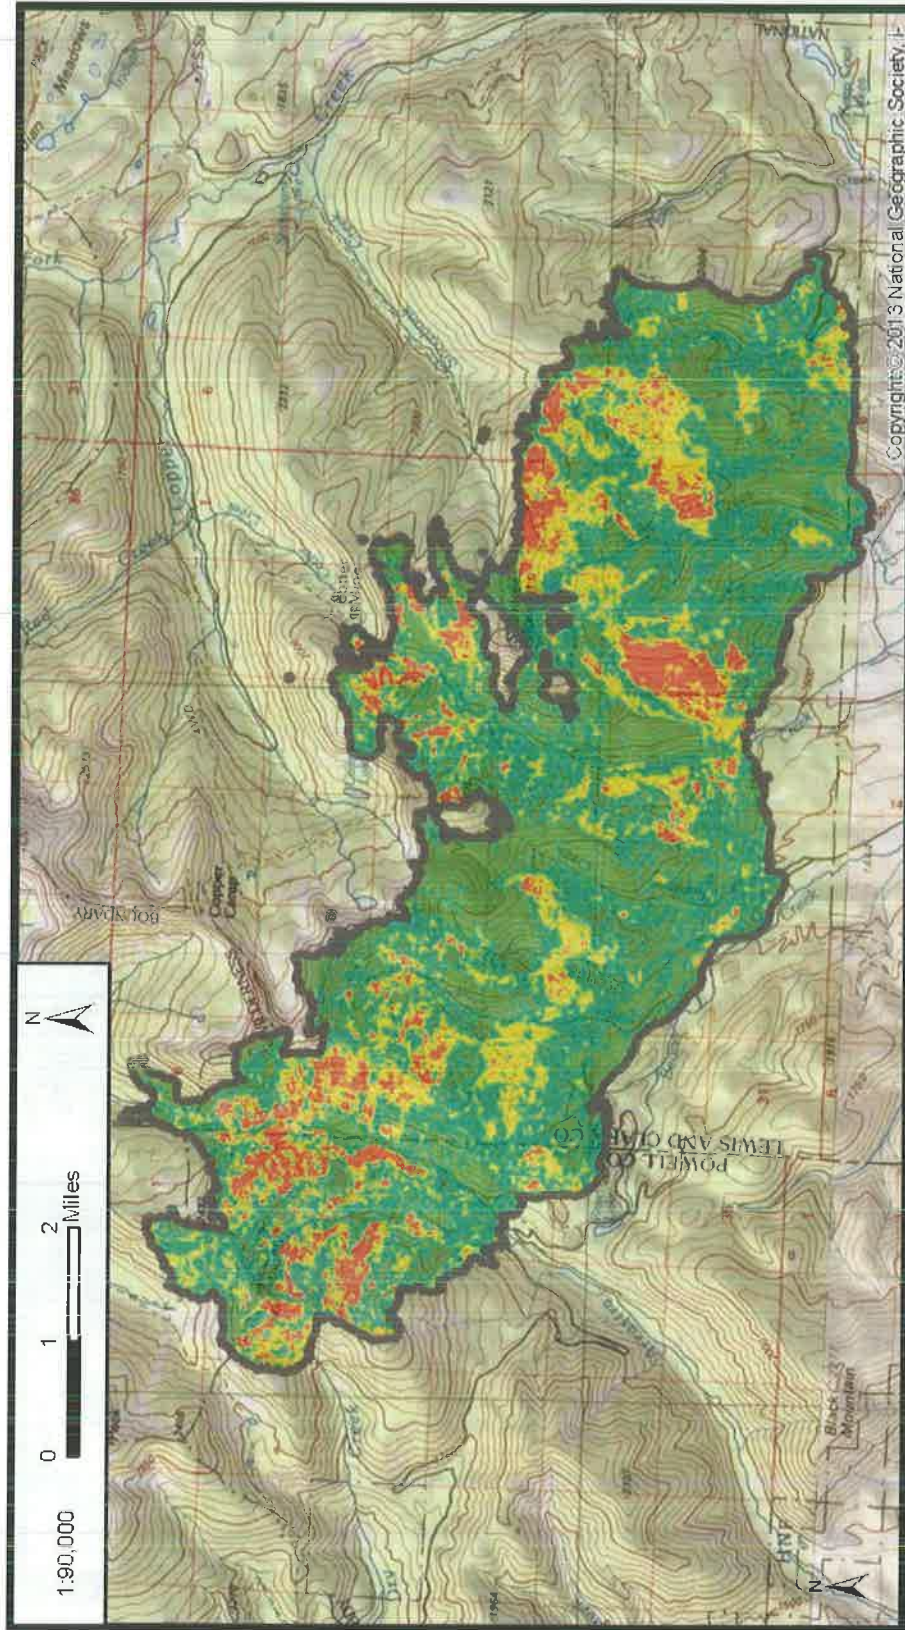
SOIL BURN SEVERITY

PART III - WATERSHED CONDITION**A. Burn Severity (acres):***Table 4: Burn Severity Acres by Ownership*

Soil Burn Severity	NFS	State of Montana	Private	Total	% within the Fire Perimeter
Low	6908	50	11	6969	38.8
Moderate	3988	3	2	3993	22.2
High	1392	0	0	1392	7.7
Unburned	5575	32	26	5633	31.3
Total	17,863	74	39	17976	100.0

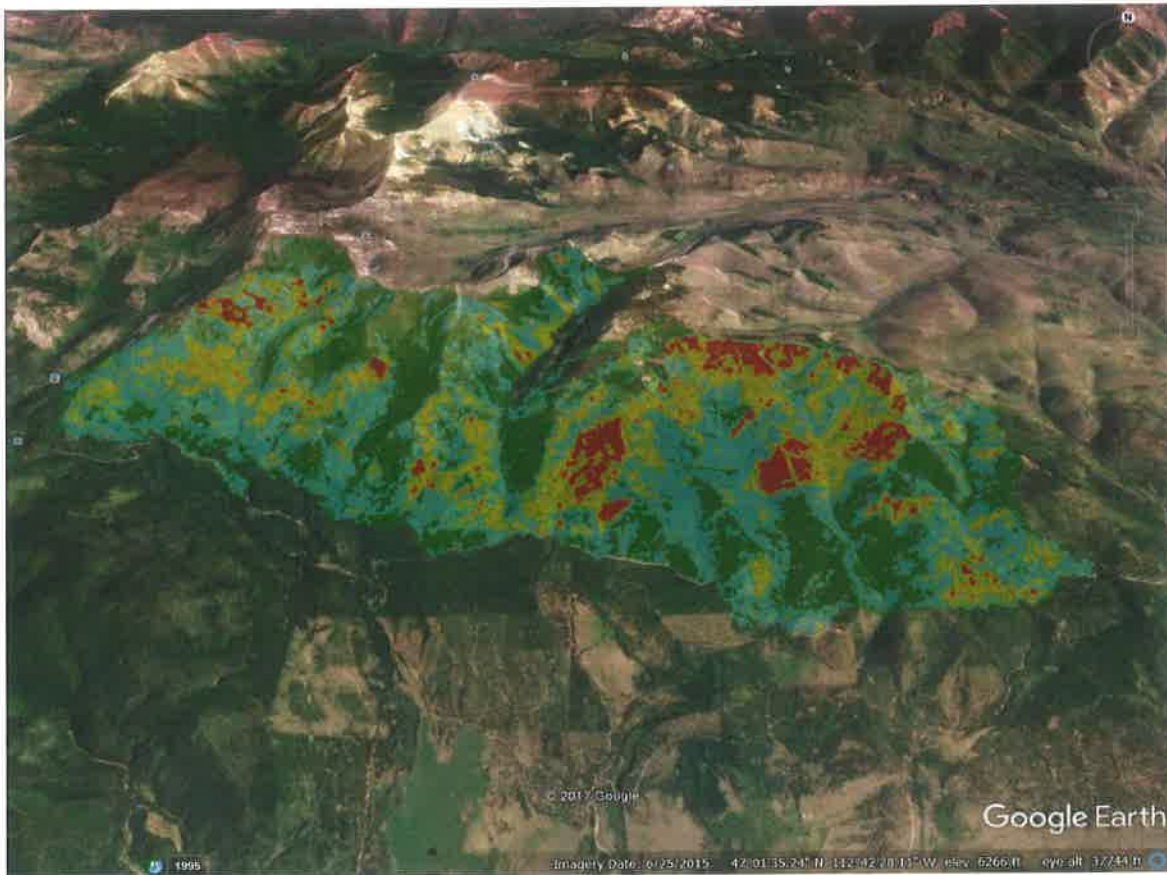
Areas of high Soil Burn Severity (SBS) were infrequent. Areas of moderate SBS were characterized based on the following properties: Heat-altered soil structure, non-viable roots, ash present where soil litter was present pre-fire) and strong/deep hydrophobicity being common. Areas of low SBS were characterized by: intact native soil structure; flexible, viable roots; litter only being charred or partially consumed; and heterogeneous patches of moderate hydrophobicity at the soil surface.

Risk Assessment – Threats to loss of site productivity through post-fire erosion, weed invasion, and altered soil community structure.

Probability of Damage or Loss: Likely – Thirty percent of the area is impacted by moderate severity fire.
