Date of Report: 10/20/2021**BURNED-AREA REPORT****PART I - TYPE OF REQUEST****A. Type of Report**

PART II - BURNED-AREA DESCRIPTION**A. Fire Name:** Devils Knob Complex**B. Fire Number:** OR-UPF-000450**C. State:** Oregon**D. County:** Douglas**E. Region:** 6**F. Forest:** Umpqua NF**G. District:** Tiller RD, North Umpqua RD**H. Fire Incident Job Code:** P6N7ND**I. Date Fire Started:** August 3, 2021**J. Date Fire Contained:** Est. Oct. 31, 2021**K. Suppression Cost:** 59.5M as of 10/05/2021**L. Fire Suppression Damages Repaired with Suppression Funds (estimates):**

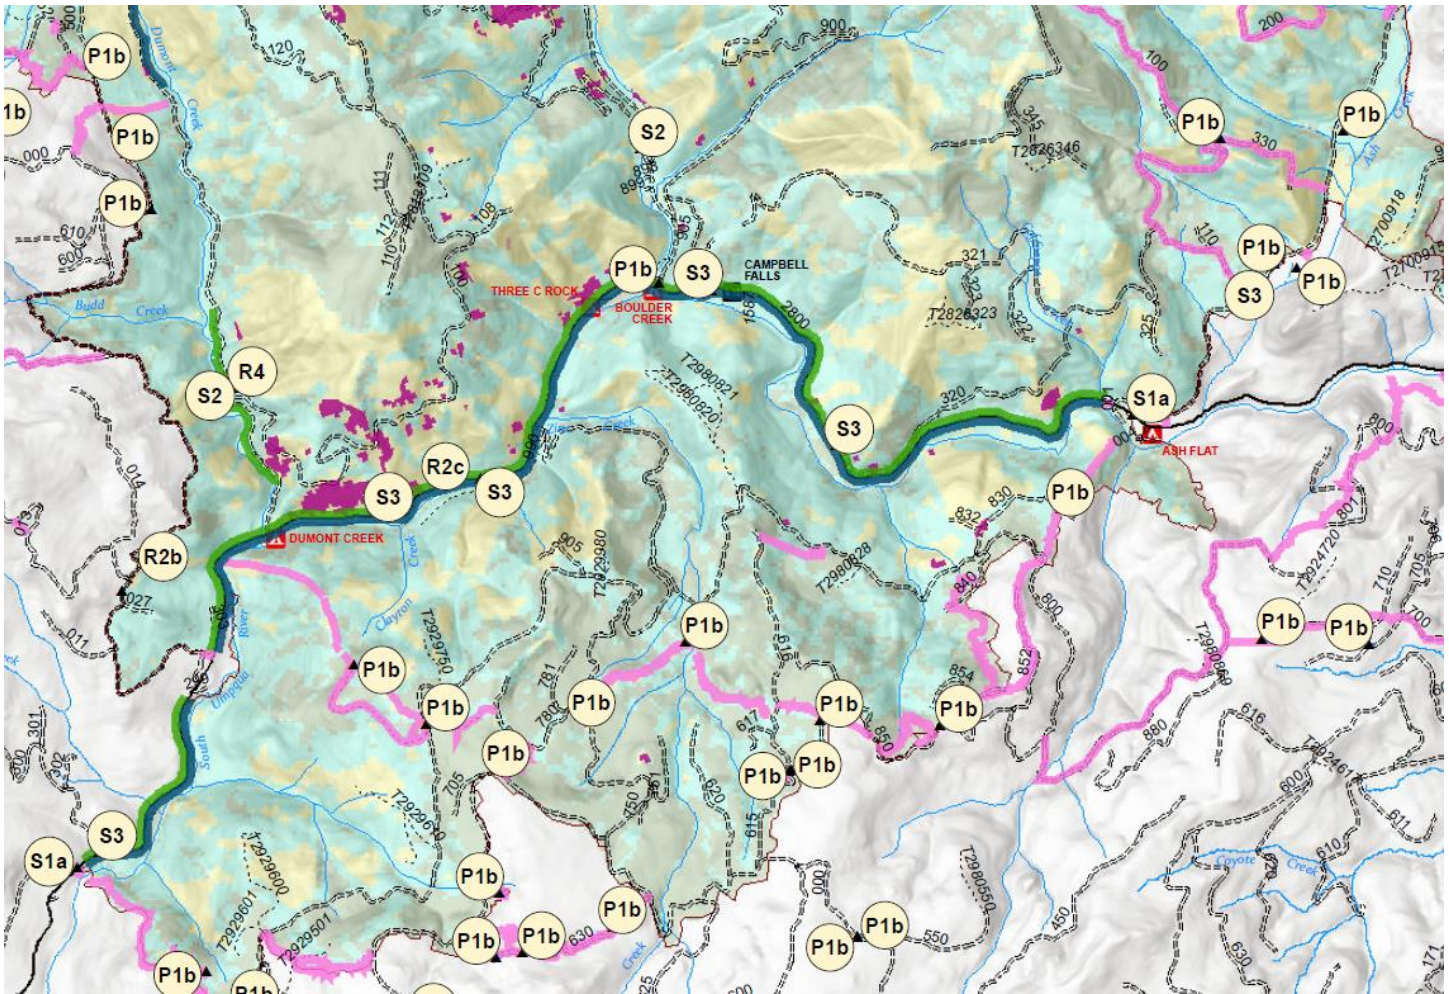
S3. Hazard Tree Felling: Danger tree felling along FSR 2800 and 2826 is being proposed in strategic locations along these routes where there is an imminent risk to human life and safety. These routes are major access routes, and also have numerous areas along them where people park and congregate for river access, and are access routes to private communities. Road closure is not possible because of the importance of the roads for access to either private lands or access to critical Forest management activities including implementation of BAER treatments. Six locations along 2800 and 2826 have been targeted for treatment (see map below). At these sites, pockets of danger trees exist near road pullouts or areas where visitors are known to stop or congregate. These are 100% fire killed, with compromised roots or other defects and are leaning towards the pullouts.

Locations of the S3 Danger tree treatment along the FS 2800 and 2826 roads
