BURNED-AREA REPORT
(Reference FSH 2509.13)

- A. Fire Name: Canyon Fire
- B. Fire Number: CA-ORC-105068
- C. State: CA
- D. County: Orange/Riverside Counties
- E. Region: 05
- F. Forest: Cleveland National Forest
- G. District: 52
- H. Fire Incident Job Code: PNLD5B17
- I. Date Fire Started: September 25, 2017
- J. Date Fire Contained: October 1, 2017
- K. Suppression Cost: \$11 million
- L. Fire Suppression Damages Repaired with Suppression Funds
 - 1. Fireline waterbarred (miles): 5.5 miles Hand Line, 5.3 miles of dozer line on FS
 - 2. Fireline seeded (miles): None
 - 3. Other (identify): 0.5 mi Road repairs
- M. Watershed Number: HUC 12: 180702031002 (Aliso Creek-Santa Ana River), 180702031003 (Lower Santiago Creek)
- N. Total Acres Burned: 2662
NFS Acres (655) State (525) Private (1482)
- O. Vegetation Types: Coastal Sage Scrub, Chamise Chaparral, Scrub Oak Chapparal, Coast Live Oak.

2017 Canyon Fire BAER Assessment

Cleveland National Forest

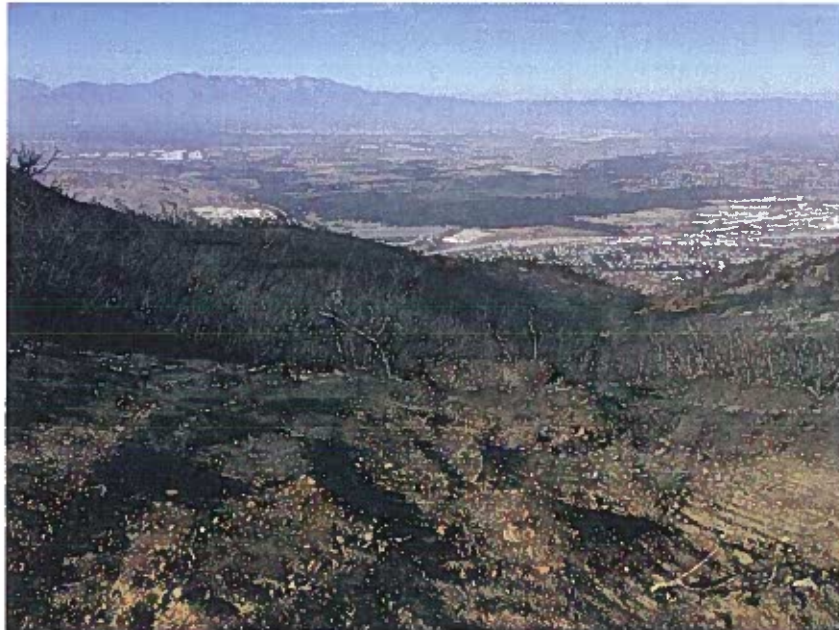
Canyon Fire – view looking north from fire

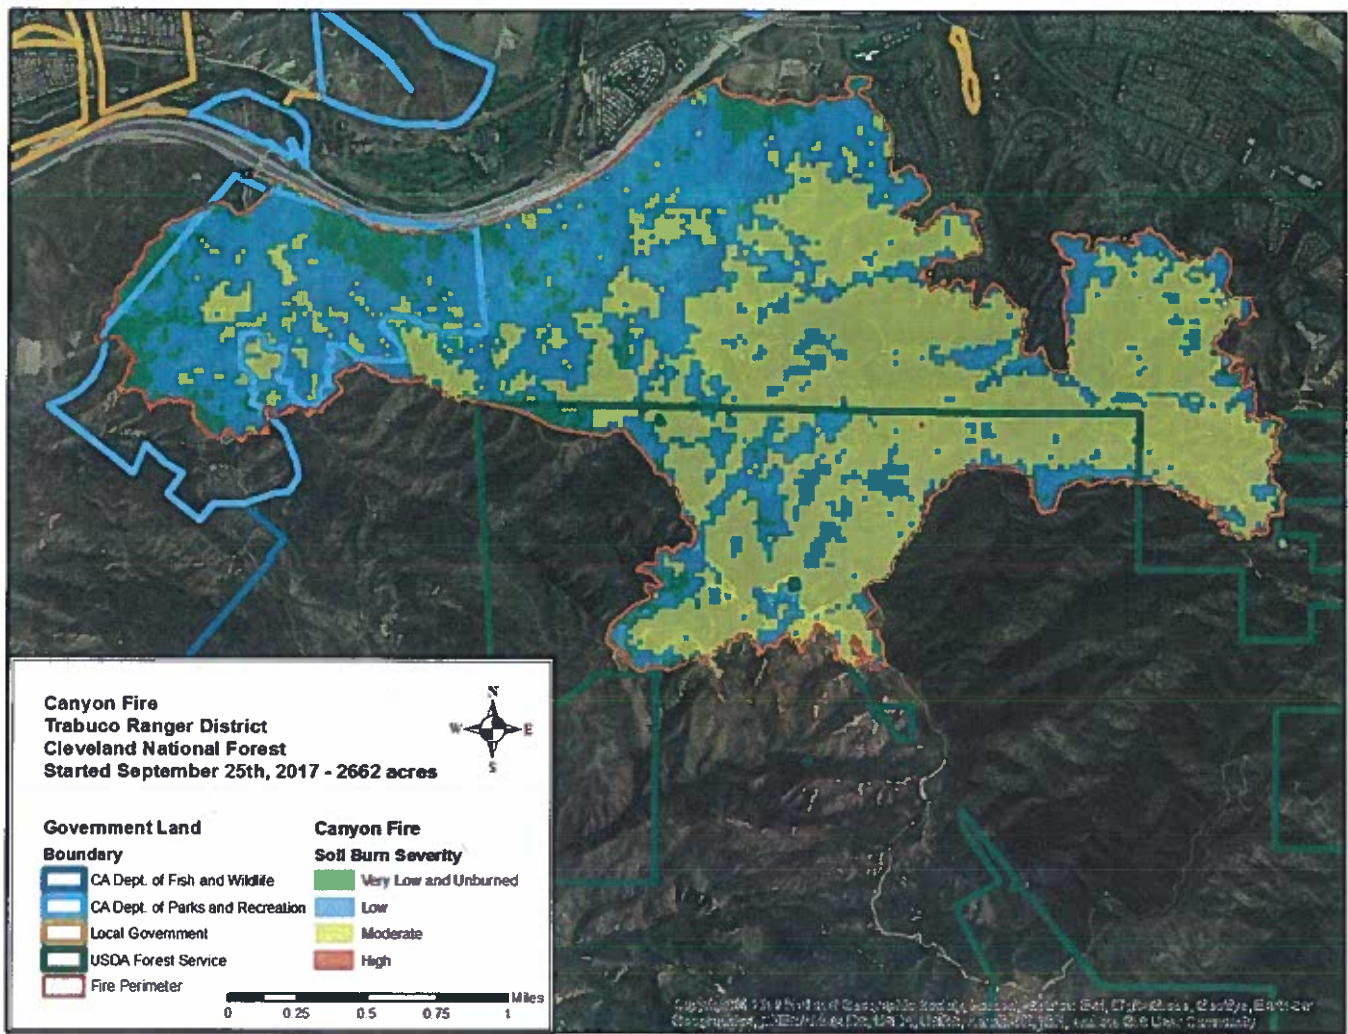
Figure 2 Soil Burn Severity Map

Approximately 49% of the burn area burned at a high and moderate soil burn severity (see soil burn severity map below). The rest of the fire was either low or very low soil burn severity. It is very important to understand the difference between *fire intensity* and *burn severity* as discussed by fire behavior, fuels, or vegetation specialists, and *soil burn severity* as defined for watershed condition evaluation in BAER analyses. Fire intensity or burn severity as defined by fire, fuels, or vegetation specialists may consider such parameters as flame height, rate of spread, fuel loading, thermal potential, canopy consumption, tree mortality, etc. For BAER analysis, we are not mapping simply vegetation mortality or above-ground effects of the fire, but soil burn

severity. Soil burn severity considers additional surface and below-ground factors that relate to soil hydrologic function, runoff and erosion potential, and vegetative recovery.
