BURNED-AREA REPORT
(Reference FSH 2509.13)

Rich Fire BAER

A. Fire Name: Rich Fire

B. Fire Number: CA-PNF-000784

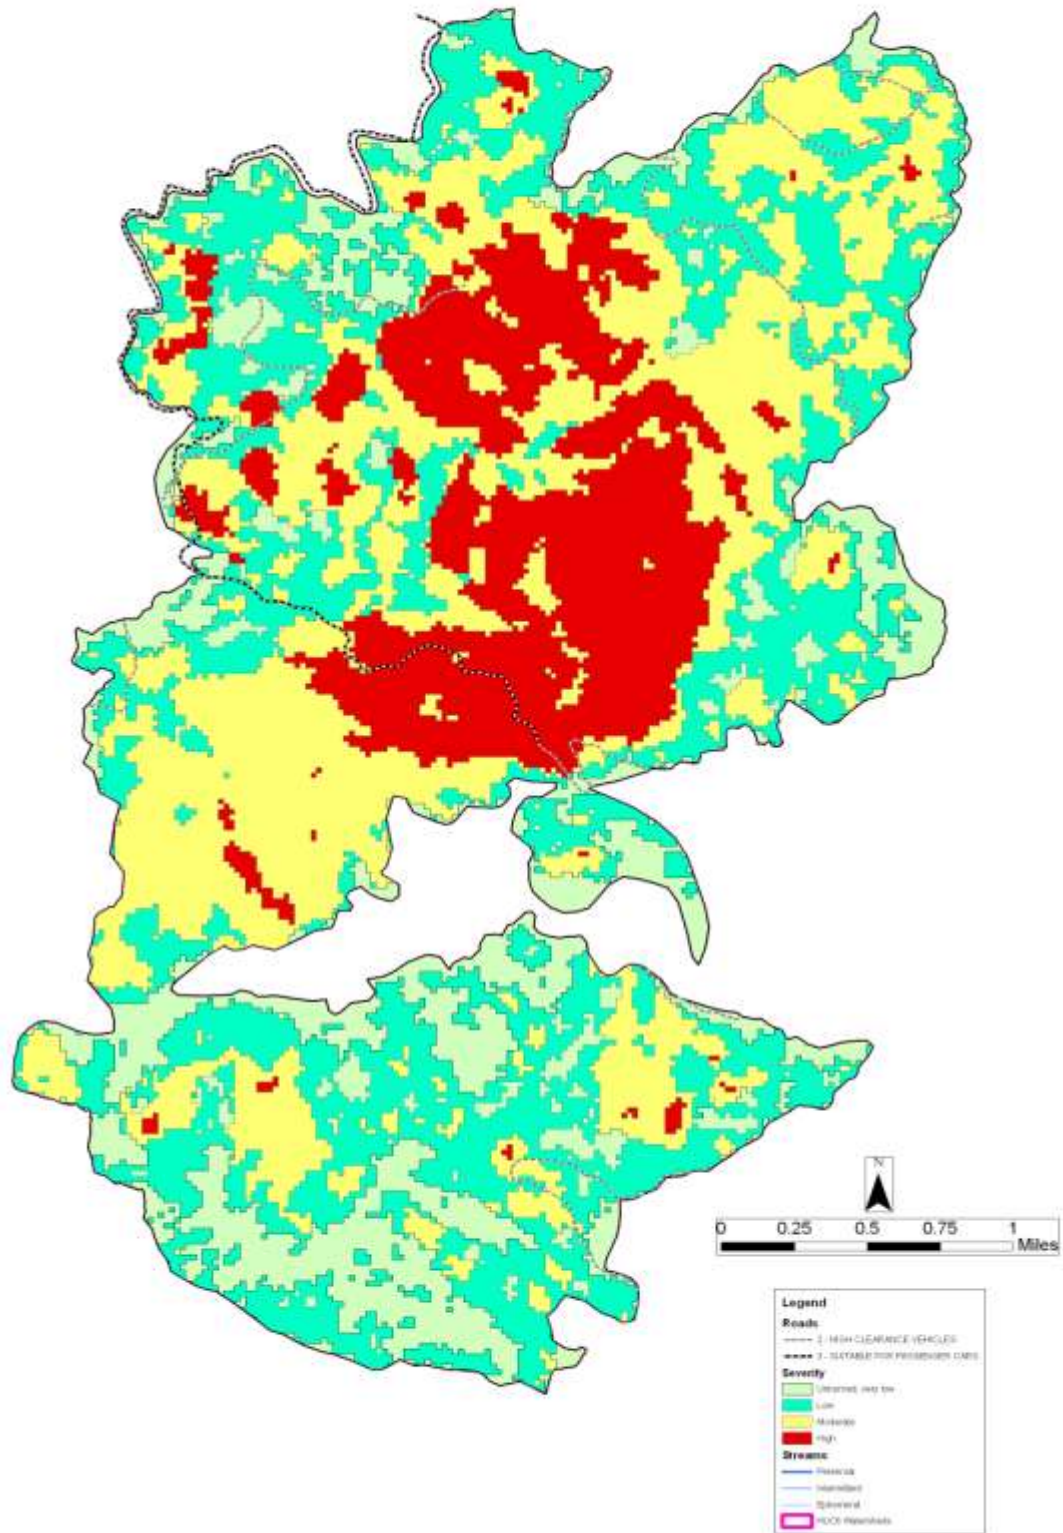
Rich Fire Soil Burn Severity Map

Red=High Yellow=Moderate Green=Low
