Date of Report: 9/28/2020**BURNED-AREA REPORT**

PART II - BURNED-AREA DESCRIPTION**A. Fire Name:** Ranch 2**B. Fire Number:** CA-ANF-003289**C. State:** CA**D. County:** LA County**E. Region:** Five**F. Forest:** Angeles**G. District:** San Gabriel
Mountains National Monument**H. Fire Incident Job Code:** P5NE4520 - 0501**I. Date Fire Started:** 8/13/2020**J. Date Fire Contained:** 96% as of 9/12/2020**K. Suppression Cost:** 5.8m**L. Fire Suppression Damages Repaired with Suppression Funds (estimates)**

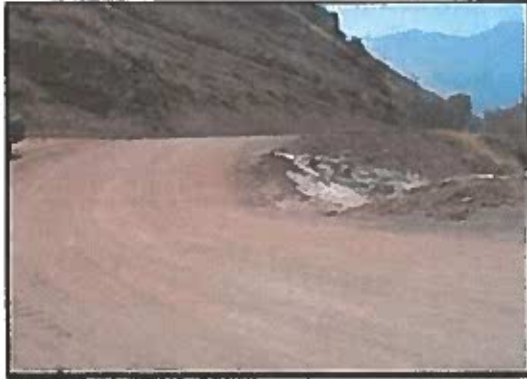
Big MAC concrete low water crossing
