Date of Report: 10/20/2021**BURNED-AREA REPORT****PART I - TYPE OF REQUEST****A. Type of Report**

PART II - BURNED-AREA DESCRIPTION**A. Fire Name:** Cougar Peak Fire**B. Fire Number:** OR-FWF-210452**C. State:** Oregon**D. County:** Lake**E. Region:** Pacific Northwest (06)**F. Forest:** Freemont-Winema**G. District(s):** Lakeview and Paisley Districts**H. Fire Incident Job Code:** P6N9MG - 0602**I. Date Fire Started:** Sept. 7th, 2021**J. Date Fire Contained:** Expected Oct. 5th, 2021**K. Suppression Cost:** \$26 million**L. Fire Suppression Damages Repaired with Suppression Funds (estimates):**

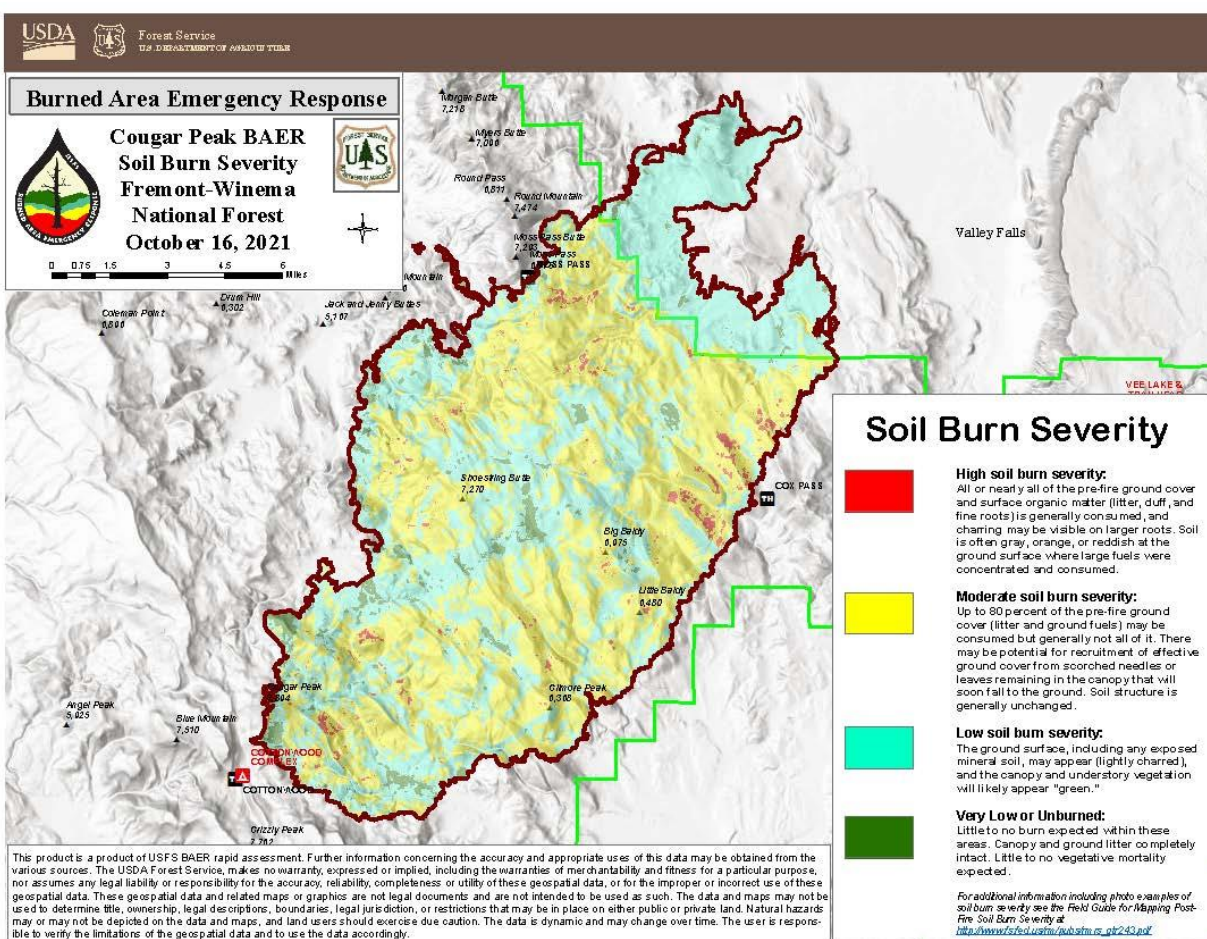
Figure 1. Soil Burn Severity Map

Soil Burn Severity	USDA Forest Service	Non-Forest Service	Grand Total	Soil Burn Severity %
High Soil Burn Severity	1,213	113	1,326	1.4%
Moderate Soil Burn Severity	30,596	14,631	45,227	49.3%
Low Soil Burn Severity	19,264	22,184	41,448	45.2%
Unburned or Underburned	2,095	1,651	3,746	4.1%
Grand Total	53,168	38,578	91,746	
Ownership %	58%	42%

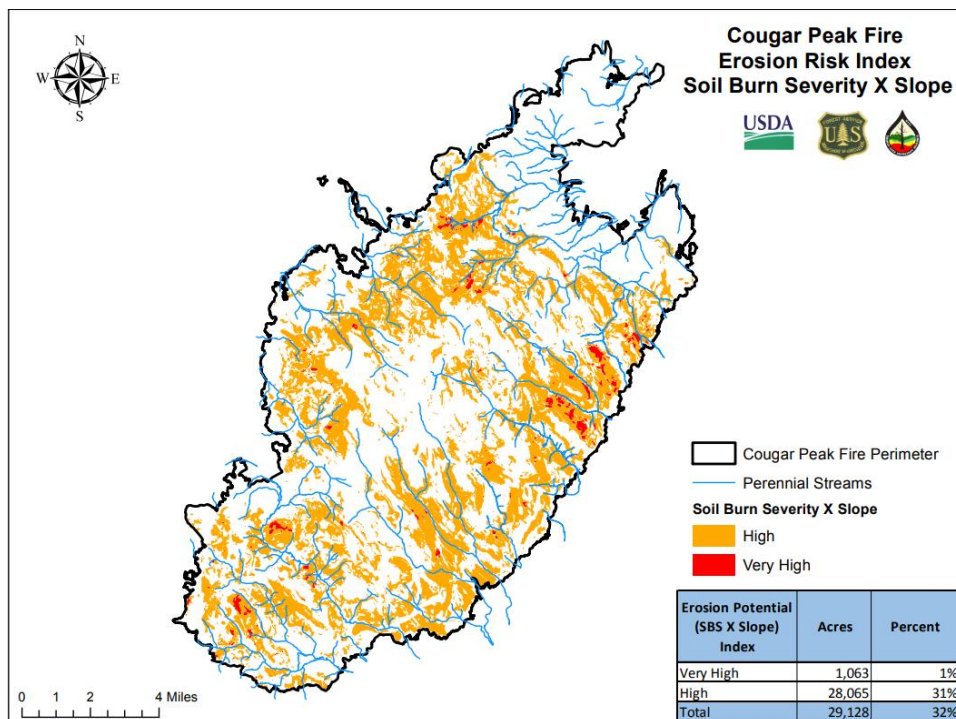
Figure 2. Soil Erosion Index Map

A map is provided showing areas of increased risk for soil erosion. Slope breaks of 0 to 5 percent in all SBS ratings have little risk of soil erosion. Slope breaks 6 to 20 percent and greater than 20 percent on moderate and high SBS areas are presented in the map, "Erosion Risk Index, Soil Burn Severity X Slope". Areas less than 5 percent slope, no matter the SBS rating, are considered similar to background soil erosion potential.
