Date of Report: 4/30/09

BURNED-AREA REPORT

- A. Fire Name: Buckweed B. Fire Number: CA-LAC-0723185
C. State: CA D. County: Los Angeles
E. Region: 5 F. Forest: Angeles
G. District: Santa Clara-Mojave RD H. Fire Incident Job Code PND1RF
I. Date Fire Started: 10/21/07 J. Date Fire Contained: 10/24/07
K. Suppression Cost: 7.4 millon
L. Fire Suppression Damages Repaired with Suppression Funds
1. Fireline waterbarred (miles): 23.6 miles
2. Fireline seeded (miles):
3. Other (identify):
M. Watershed Number: 180920601 – Santa Clara River
N. Total Acres Burned: 38,348
NFS Acres(27,526) Other Federal (128) State () Private (10,694)
O. Vegetation Types: Coast live oak, sage scrub, chaparral bisected with riparian cottonwood

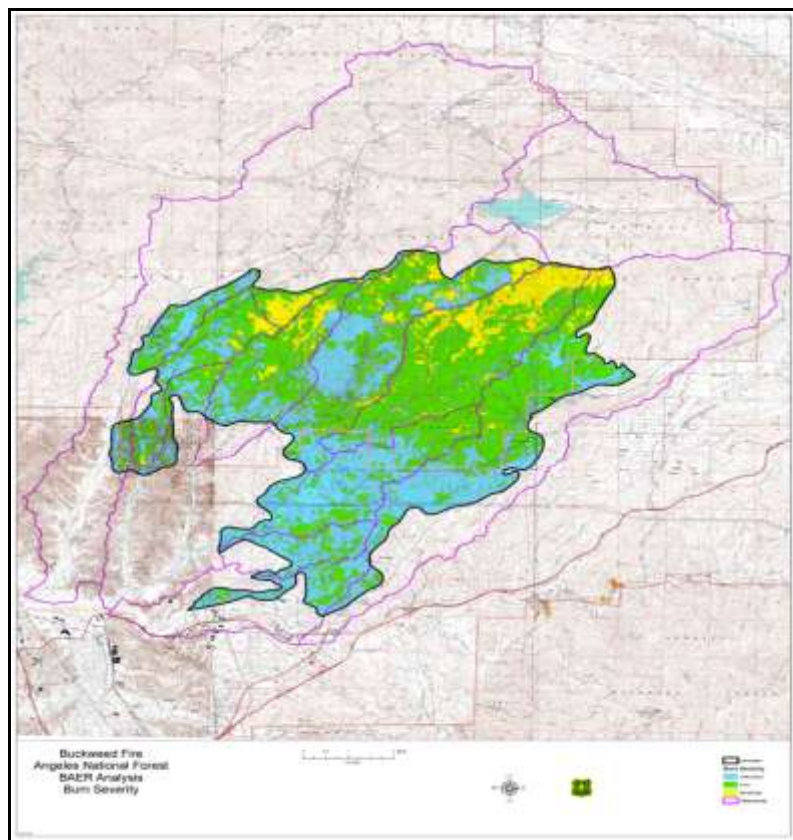
Figure 1 Buckweed Soil Burn Severity Map

Approximately 10% burned at high and moderate severity (see soil burn severity map below). Forest service lands that burned were 72% and the rest was private ownership. The BAER Team coordinated with NRCS, Los Angeles County agencies, and the City of Santa Clarita in the fire assessment.
