Date of Report: Aug 22, 2013

**BURNED-AREA REPORT**  
(Reference FSH 2509.13)

A. Fire Name: West Mullen

B. Fire Number: MT-SWS-000056

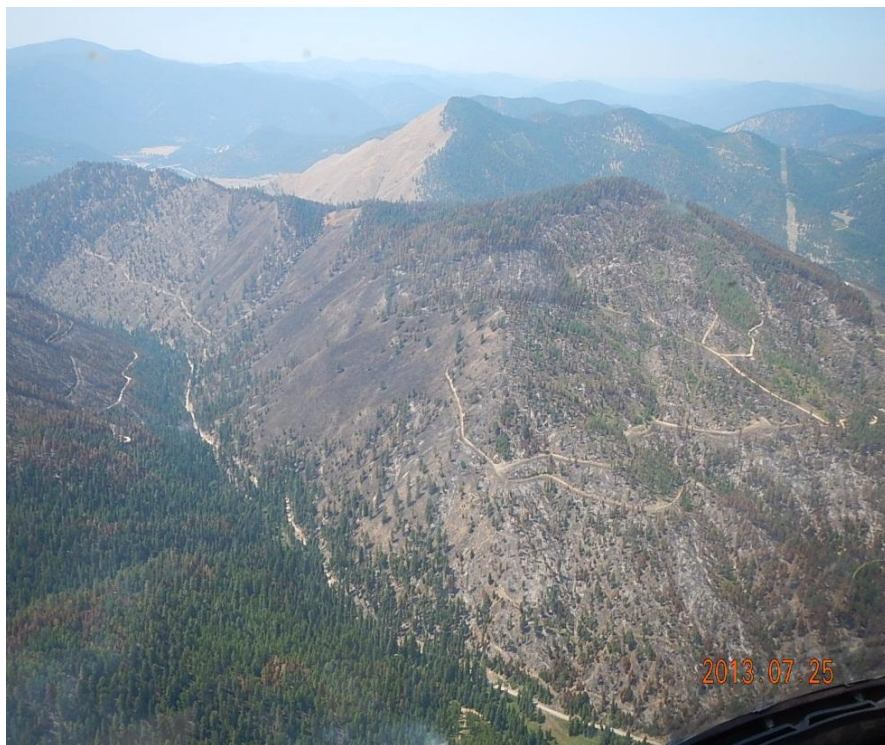
Photo 1. Looking Northeast into Pardee Drainage

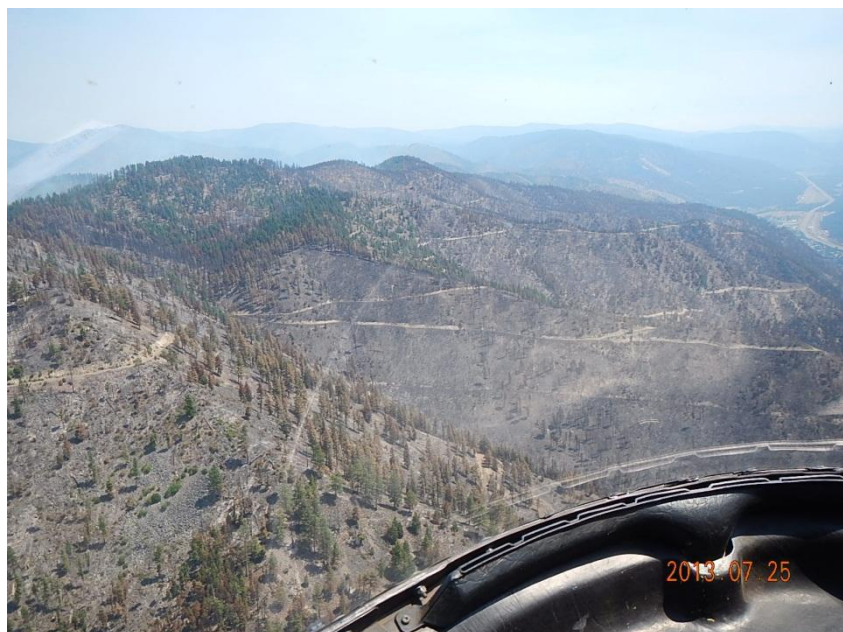
Photo 2. Looking east across Charette Gulch and the “face drainages” on Plum Creek Ownership.

Severely burned areas in Charette Gulch and Shaw Gulch are in lands with Plum Creek Ownership. These face drainage watersheds are at higher risk of increased flows and debris torrents. These small watersheds have values at risk in the form of life and property, as there are private residences at the base of these drainages. Undersized culverts in the fire area are at increased risk for failure. Increased runoff response to precipitation will likely remain elevated in all drainages in the fire area for at least 2 years. Culverts will be at risk for failure. The National Weather Service has been made aware of this anticipated increased risk and will lower the level of Doppler Radar rainfall estimates needed to issue flood warnings in this area. Coordination with the County, NRCS, and individual private land holders will be required to accomplish any protective measures on private lands such as seeding or flow diversion structures. Contact has been made with representatives from both the County and the National Weather Service with regard to the elevated risks of flooding and debris torrents.

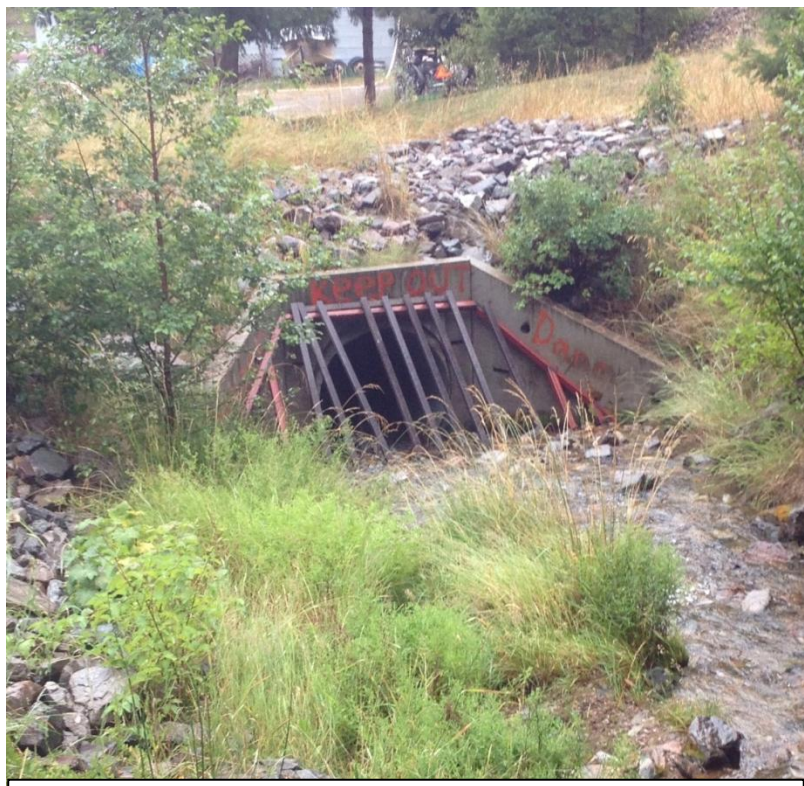
High peak flows and debris torrents are common causes of resource damage following wildfires. This threatens infrastructure such as roads, culverts, bridges, buildings, and other developments. For the West Mullan fire, there are multiple values at risk at the mouth of Flat Creek. This stream enters an undersized 48" culvert (Photo 3) in the town of Superior and is piped into the Clark Fork River under the town. Therefore, a large flood event would endanger several buildings within this municipality. The trash rack placed for public safety increases the risk of the culvert inlet being plugged by organic debris and sediment.

Photo 3. Undersized culvert inlet for Flat Creek in the municipality of Superior, MT.

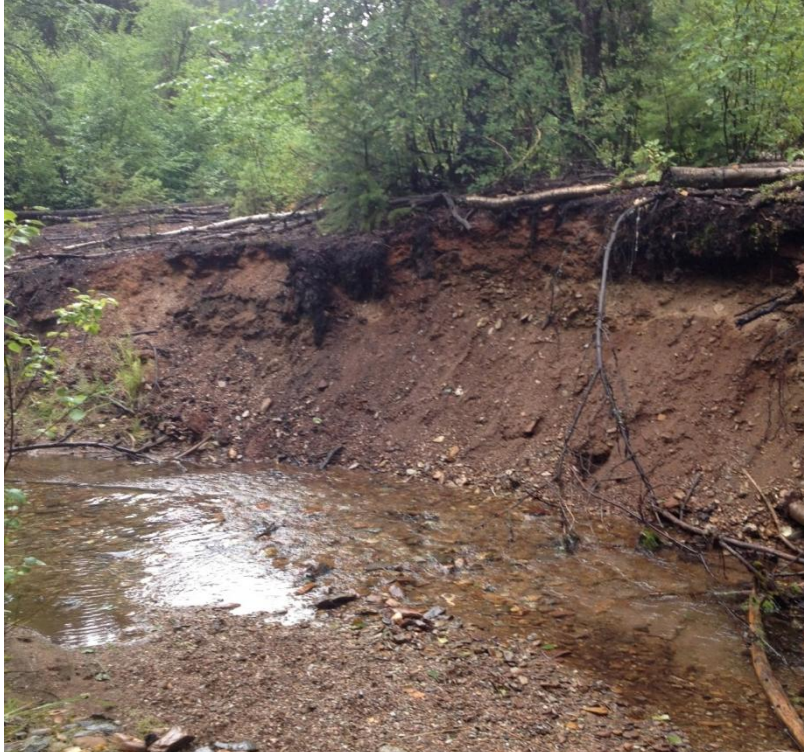
In addition, the portion of Flat Creek in the fire perimeter is a superfund site with tailing piles contaminated with arsenic and lead in the stream channel (Photo 4). As can be seen in Photo 4, these tailing piles are currently raw cut banks in the stream channel that are undermined and contaminate the stream at bankfull flow. Other than the chronic contamination from bank erosion, these piles are in a relatively stable status. These tailing piles are currently scheduled for removal and have gone through extensive survey and analysis. However, in the case of a large flood, the piles could be re-arranged, making them more difficult to remove, requiring re-analysis and surveying, and depositing contaminated tailings in downstream locations, including the municipality of Superior and the Clark Fork River.

Photo 4. Tailing piles containing lead and arsenic in Flat Creek

Severely burned areas in Flat Creek are primarily on lands with State of Montana ownership. Although large increases in runoff from the Flat Creek Watershed are not anticipated due to the lack of water repellent soils and the minor amount of high severity burn within the watershed, some increased flow volumes are anticipated and roads and any culverts found to be undersized in this drainage should be enlarged or otherwise storm proofed. Exposed legacy mine waste material lying along Flat Creek is also at increased risk of being eroded and should be moved out of the floodplain as soon as possible.

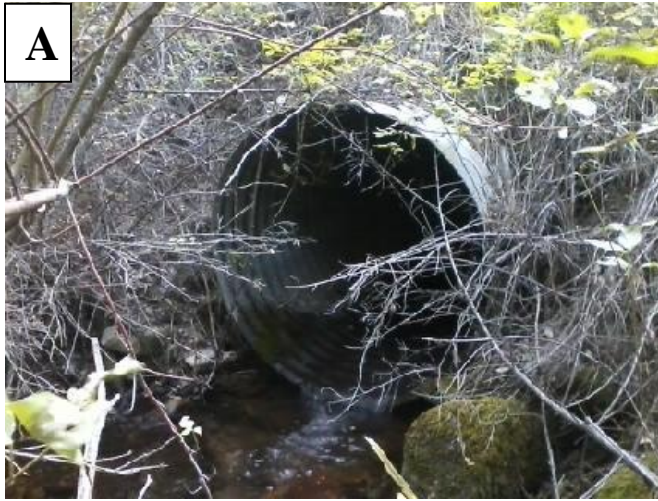
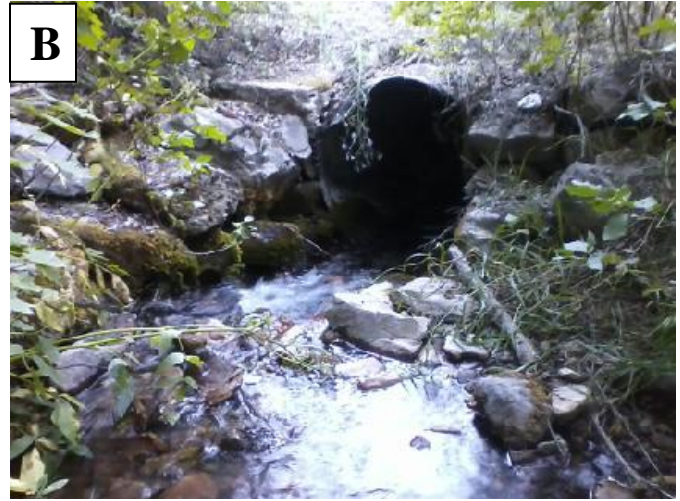
Two undersized stream crossings have been identified in the burned area both of which are road stream crossings along Pardee Creek. The first culvert is located on Pardee Creek Road #97. The existing 30” culvert is constricting the channel and as a result the outlet is perched. The second culvert is located on non-system Road #37220 where it crosses Pardee Creek. The existing culvert is constricting the channel and the outlet is perched. Any increases in post fire runoff, especially coupled with debris or wood transport, create a high probability of increased velocities through the culverts. Increased velocities are likely to lead to additional scour at the outlet, or in the event of plugging would lead to road crossing failure. Furthermore, these culverts do not meet the USFS stream simulation criteria for accommodating bankfull channel widths.

Perched outlet (A) and improper alignment of inlet (B) in undersized culvert located on Pardee Creek Road #97.

Engineering, hydrology, and fisheries findings all indicate high concern should post-fire precipitation and runoff occur. Although runoff risks are low to moderate, the existing condition of the infrastructure leads to high consequence with any increase in runoff, and especially with considerations of wood and debris transport (See Map Appendix B). Prudent options to avoid post-fire impact scenarios are to replace the culvert on Pardee Creek Road #97 at the road stream crossing, remove the culvert from non-system Road #37220 at the road stream crossing, perform major storm proofing on the Lower Club Gulch Road #37185, recontour the Lower Wood Gulch Road #67044, and improving road drainage on the Upper Club Gulch Road #7870.
