Date of Report: September 12th, 2013

**DUGAN FIRE
BURNED-AREA REPORT**
(Reference FSH 2509.13)

PART II - BURNED-AREA DESCRIPTIONA. Fire Name: DuganB. Fire Number: MT- MCD - 171C. State: MontanaD. County: CarterE. Region: Northern (1)F. Forest: CusterG. District: SiouxH. Fire Incident Job Code: PDG8DCI. Date Fire Started: 09/14/2012J. Date Fire Contained: 9/19/2012K. Suppression Cost: TOTAL: \$684,300**L. Fire Suppression Damages Repaired with Suppression Funds**

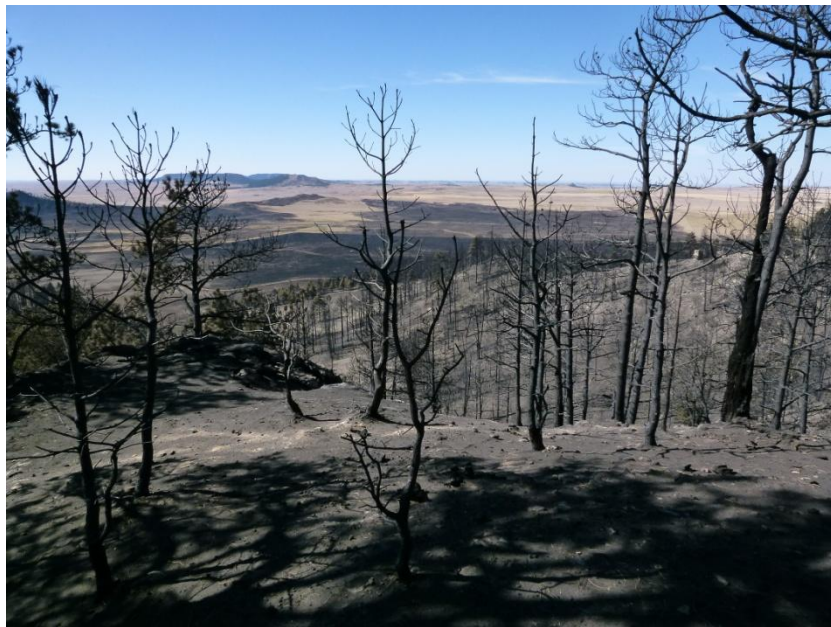
Fire intensity was generally high enough to scorch the entire crown of most trees that burned with high intensity. It is anticipated that high mortality will occur in the ponderosa pine timber stands. In these areas vegetative recovery will be slow and therefore post-fire hydrologic response is expected to last five or more years. Smaller tributary drainages that burned with moderate to high severity will be the most likely produce localized flood discharge levels that may exceed capacities of culverts located down gradient.

Figure 2. Example of high severity burn conditions within the Dugan Fire perimeter.

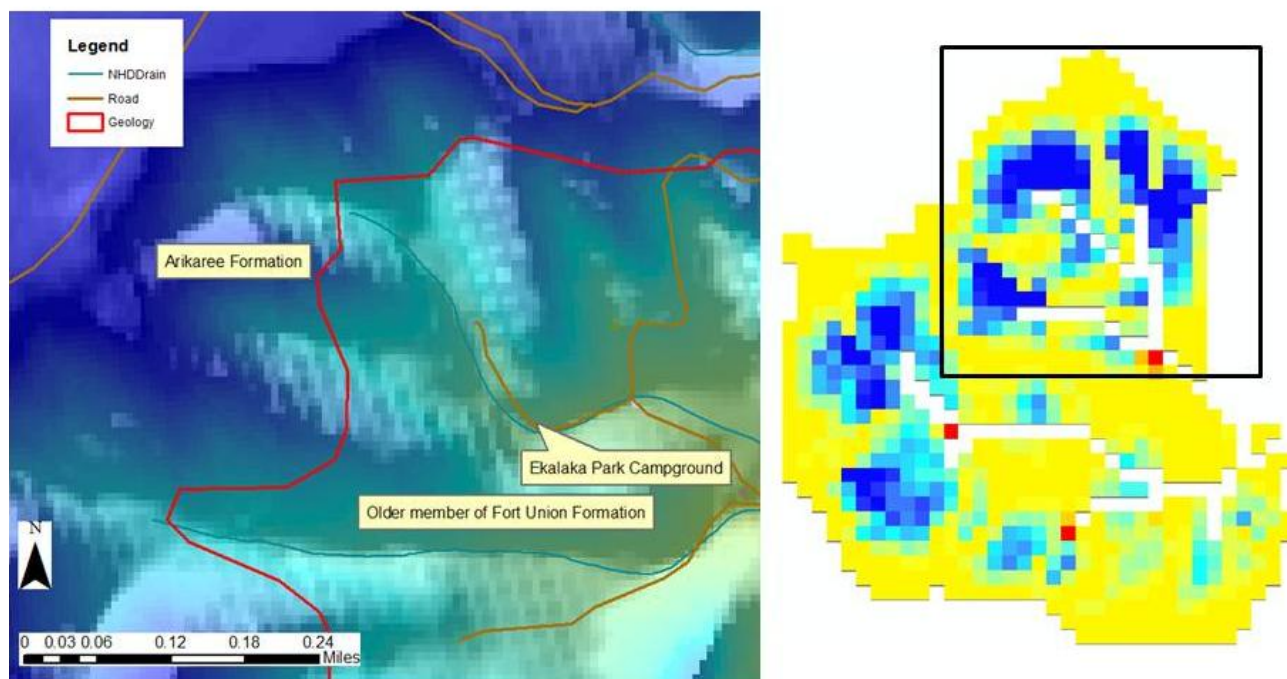
Ekalaka Park Campground Slope Stabilization: Under the standardized NRCS classification scheme for erosion hazard rating, soil series found on hillslopes adjacent to Ekalaka Park Campground fall within the category of “severe” erosion hazard (note that this rating applies under unburned conditions). The Dugan Fire burned under high severity on all slopes adjacent to the campground. Under these conditions, hillslope runoff and erosion modeling predicted an increase in runoff of four times that pre-fire and an increase in erosion of five times that of background rates if left untreated (Efta 2012)². Primary areas of soil loss will be steep slopes near the top of the watershed, with lower slopes likely to experience deposition following shorter entrainment distances. Models show a high likelihood of erosion from above the boundary between the Arikaree formation (where erionite has been found) and deposition in close proximity to the campground if not directly within it (Figure 4).

Figure 4. Map showing location of Ekalaka Park Campground as related to Arikaree formation (left) and WEPP predicted flowpath sediment loss (right). Blue indicates areas of erosion while yellow and red indicate areas of deposition. The black square on the right denotes the watershed area displayed within the left image (from Efta, 2012).

To mitigate this issue, selective tree felling and broadcast seeding with native species is proposed. Tree felling will be conducted such that trees are fallen cross-slope where feasible. Increased slope roughness will shorten runoff flowpath lengths, which in turn will minimize sediment transport distance and prevent seed from leaving the site.

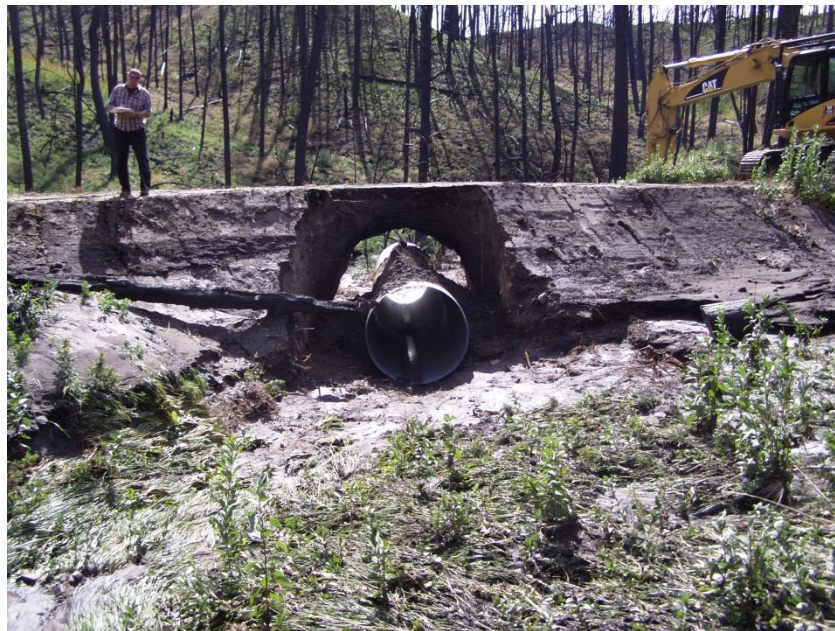
Following this rainfall-runoff event, Sioux District personnel estimate water depths in the Smith Well Draw (through which the JP Smith Road runs, intersecting the draw in 12 locations) was up to 6 feet deep during peak discharge. Assuming conservatively that water continuously inundated the draw to a depth of three feet and using average draw dimensions and slope, discharge would have exceeded 700 cubic feet per second in this ephemeral draw with no defined channel. Some culverts conveyed all runoff and debris without overtopping, while in other locations (primarily where side draws intersected the main draw, conveying high velocity runoff to the main draw), runoff overtopped road fills. Backwater control on the culverts produced turbulence that displaced fill around them via piping. At these locations, culverts were found in place with partial or total fill removal around the culvert and an intact road bed bridging across the top of the culverts. Debris bulking did not appear to be an issue during this event.

Figure 5. Culvert on JP Smith Road following September 7th-8th storm events.

This interim request is to perform maintenance on those road/draw crossings that were impacted by this runoff event. The existing culverts (undamaged) will be re-set and re-compacted in place and armored where appropriate. With a contractor already on site, maintenance costs will be minimized by avoiding further mobilization costs.
