Date of Report: 9/14/09

BURNED-AREA REPORT
(Reference FSH 2509.13)**PART I - TYPE OF REQUEST**

- A. Fire Name: Water Wheel B. Fire Number: AZ-TNF-000100
C. State: Az D. County: Gila
E. Region: 03 F. Forest: Tonto NF
G. District: 04 H. Fire Incident Job Code: P3E55S
I. Date Fire Started: 8-30-2009 J. Date Fire Contained: 9/3/2009
K. Suppression Cost: 1,800,000
L. Fire Suppression Damages Repaired with Suppression Funds
1. Fireline waterbarred (miles): 1
2. Fireline seeded (miles):
3. Other (identify):
M. Watershed Number: 1506020302
N. Total Acres Burned: 773
NFS Acres(773) Other Federal () State () Private ()
O. Vegetation Types: Pinyon-Juniper, Chaparral, Ponderosa Pine
P. Dominant Soils: Typic Haplustepts, Typic Haplustalfs,
Lithic Haplustepts, Udic Haplustalfs

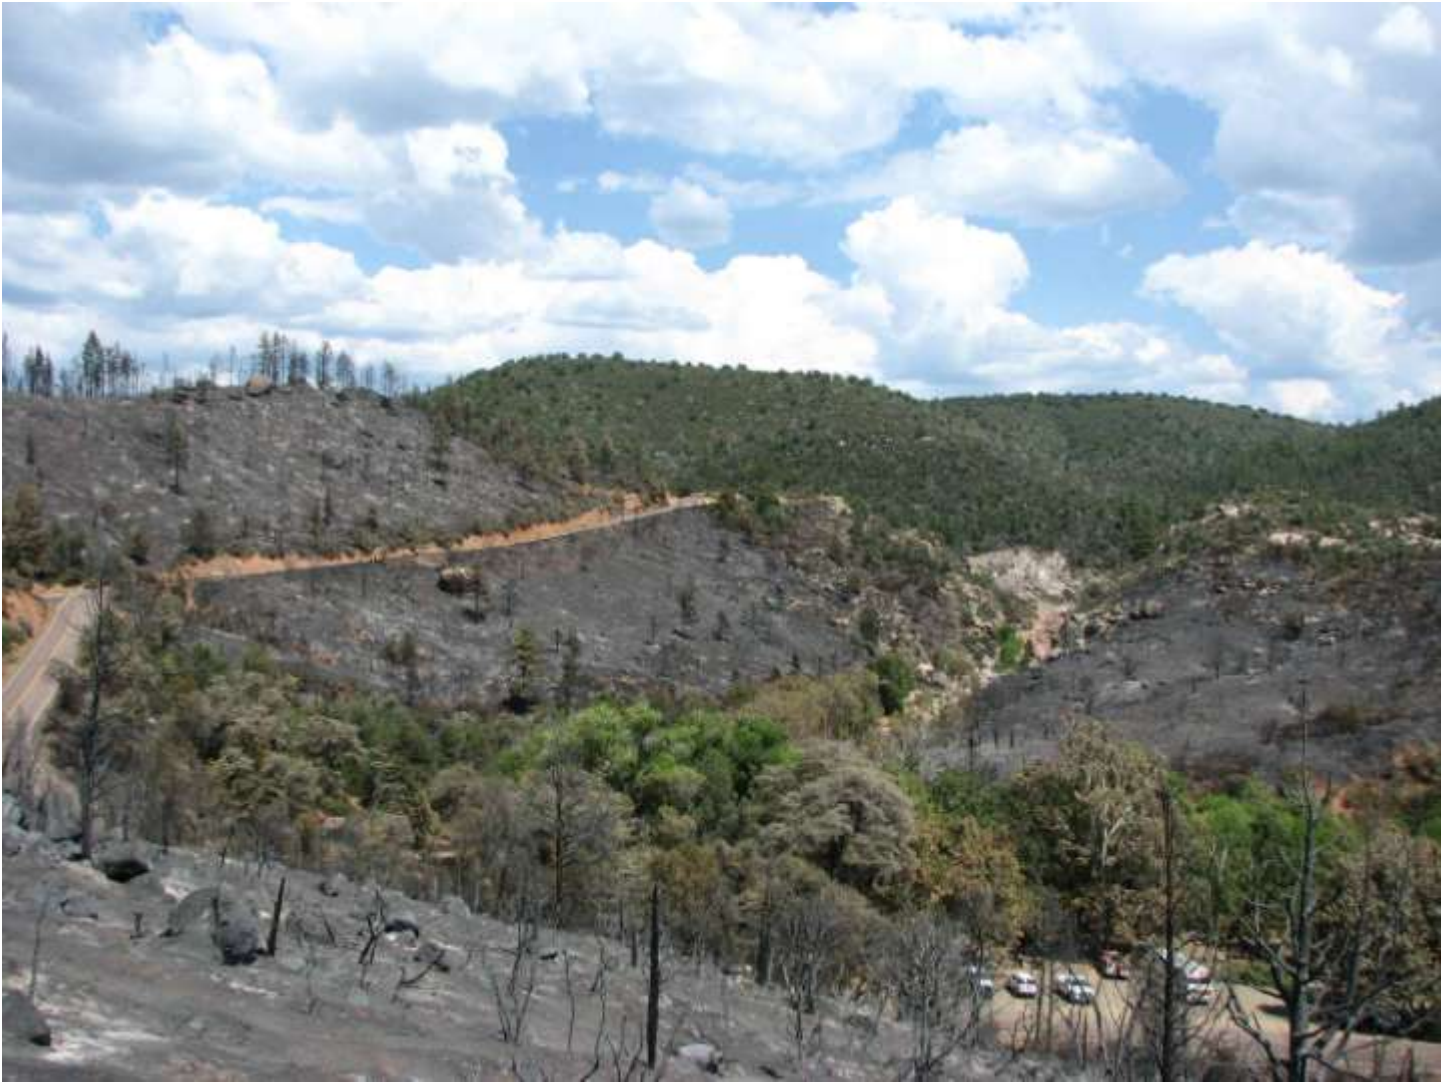
Approximately one mile of the Houston Mesa Road (FR 199) lies within the burned area. This road provides the primary and most direct access to subdivisions located along the East Verde River and Control Road. The Houston Mesa Road also provides access to popular recreation sites that are located within and above the burned area. Many of the slopes above this road burned with high severity (see photo)

The risk of flash floods, rocks, and debris is a hazard to users of this road. Risk of damage to the road itself also exists from plugging and overtopping of culverts and from plugging and overtopping of roadside ditches.

Provide for the safety of users of the Houston Mesa Road (FR 199) by repairing guard rail, removing hazardous boulders and trees, increasing the capacity of roadside ditches, and providing for the capture of some watershed debris and sediment by constructing catch basins at suitable sites along the road.

Reduce the volume of sediment and debris delivered to the Houston Mesa Road by placing wattles in swales draining from severely burned slopes upgradient of the road.

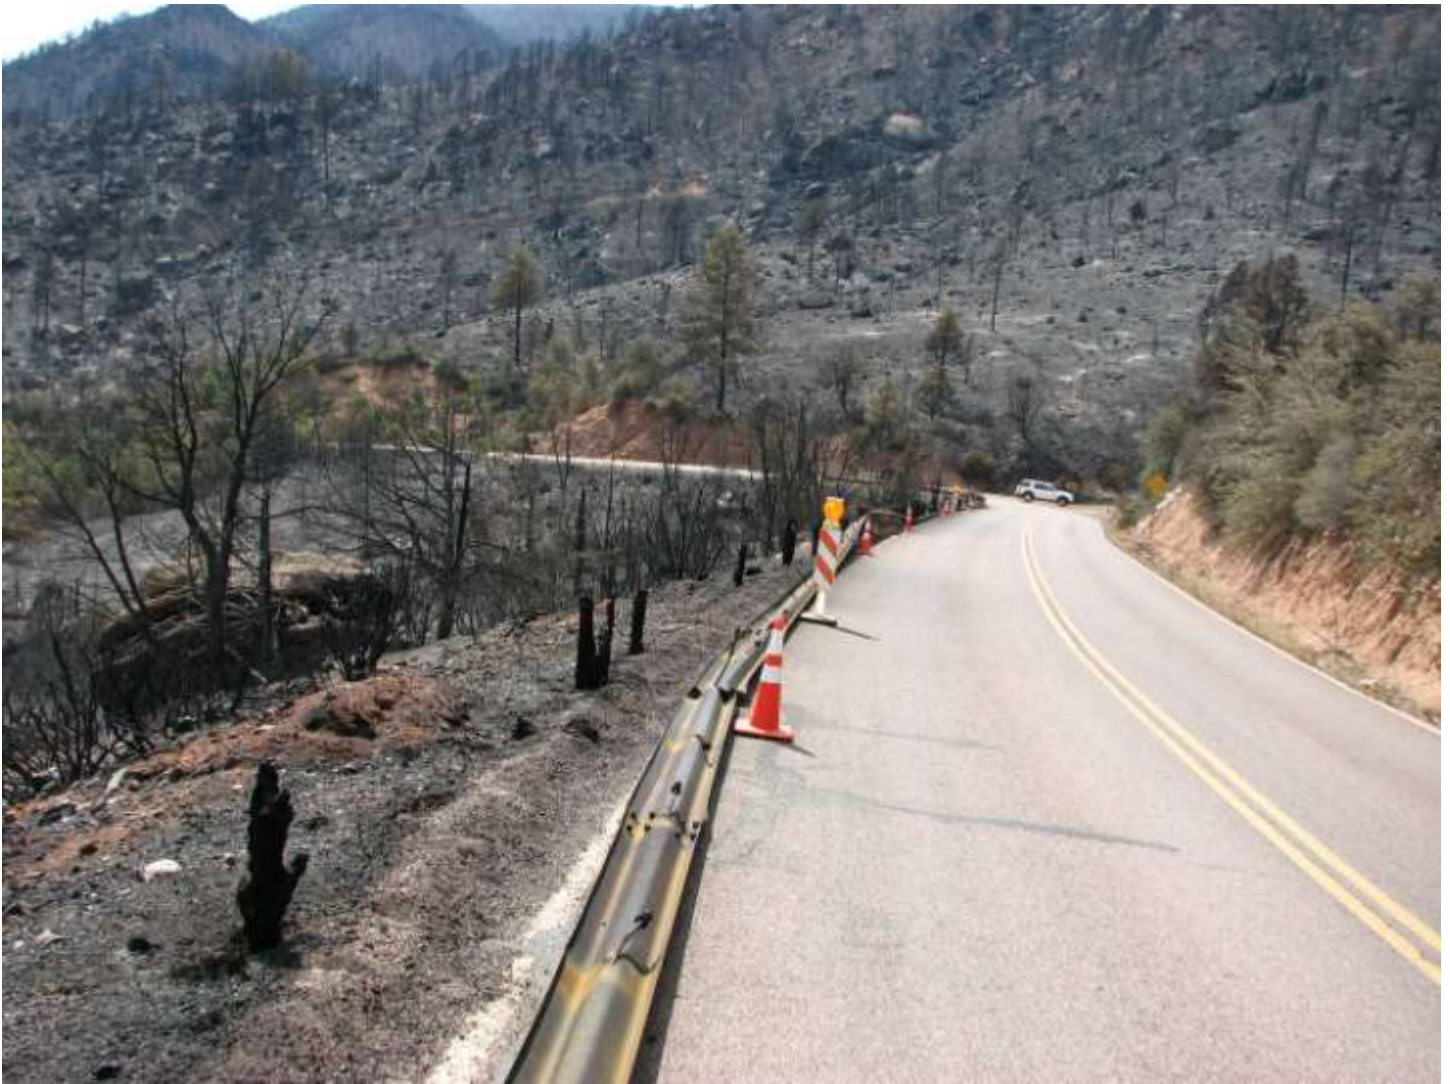
Approximately 1200 feet of guardrail that provides protection for a steep embankment that drops down to the East Verde River was burned in the fire. The guard rail is an essential safety feature for users of the road. The county intends to close the road until the guard rail is replaced because of the safety hazard represented by its absence (see photo below).

1. Replace approximately 1200 feet of damaged guard rail along the Houston Mesa Road. **Previously Approved**
2. Install boulders along the Houston Mesa Road at the Water Wheel Recreation site to provide a temporary barrier for access to the site until watershed conditions have recovered sufficiently to permit users to safely occupy the site.
3. Reduce the risk of hazardous rocks and boulders from the burned slopes above the Houston Mesa Road just below the second crossing of the East Verde River by mulching with bonded fiber matrix.
