HOUGHTON 11 - NARRATIVE SUMMARY

BURNED AREA REPORT

DATE: 1/29/85

1. Fire name: Houghton II
2. Supervisors Fire Number: 745284
3. State: MT
4. County: Lincoln
5. Region: 1
6. Forest: Kootenai
7. Ranger District: Fisher River
8. Date Started: 27 August 1984
9. Date Controlled: Sept. 5, 1984 2000 hrs.
10. Estimated suppression costs: \$4,449,282.28
11. Fire suppression damage repaired with FFF 102 funds:
  - a. 41. . miles of firelines waterbarred
  - b. 12.50.. acres of firelines seeded and fertilized
  - c. . . . other (identify) Stream debris-Appen IV
12. Fire intensity      63% low      32% medium      5% high

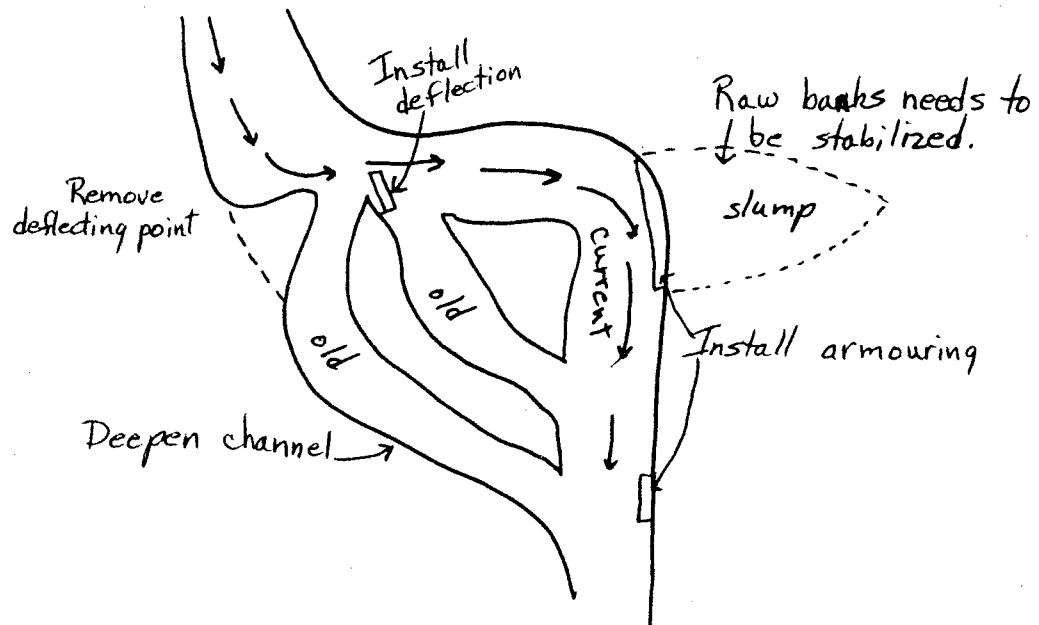
3. The steep burned over bank downstream from Pleasant Valley Campground needs to be seeded quickly before fall growth is not possible. The channel we chose to take the main flow to protect the south bank needs to be opened and deepened. As you indicated, the trees blocking this channel were simply placed on high ground and not used for revetment. The following diagram is my opinion as to what should be done:

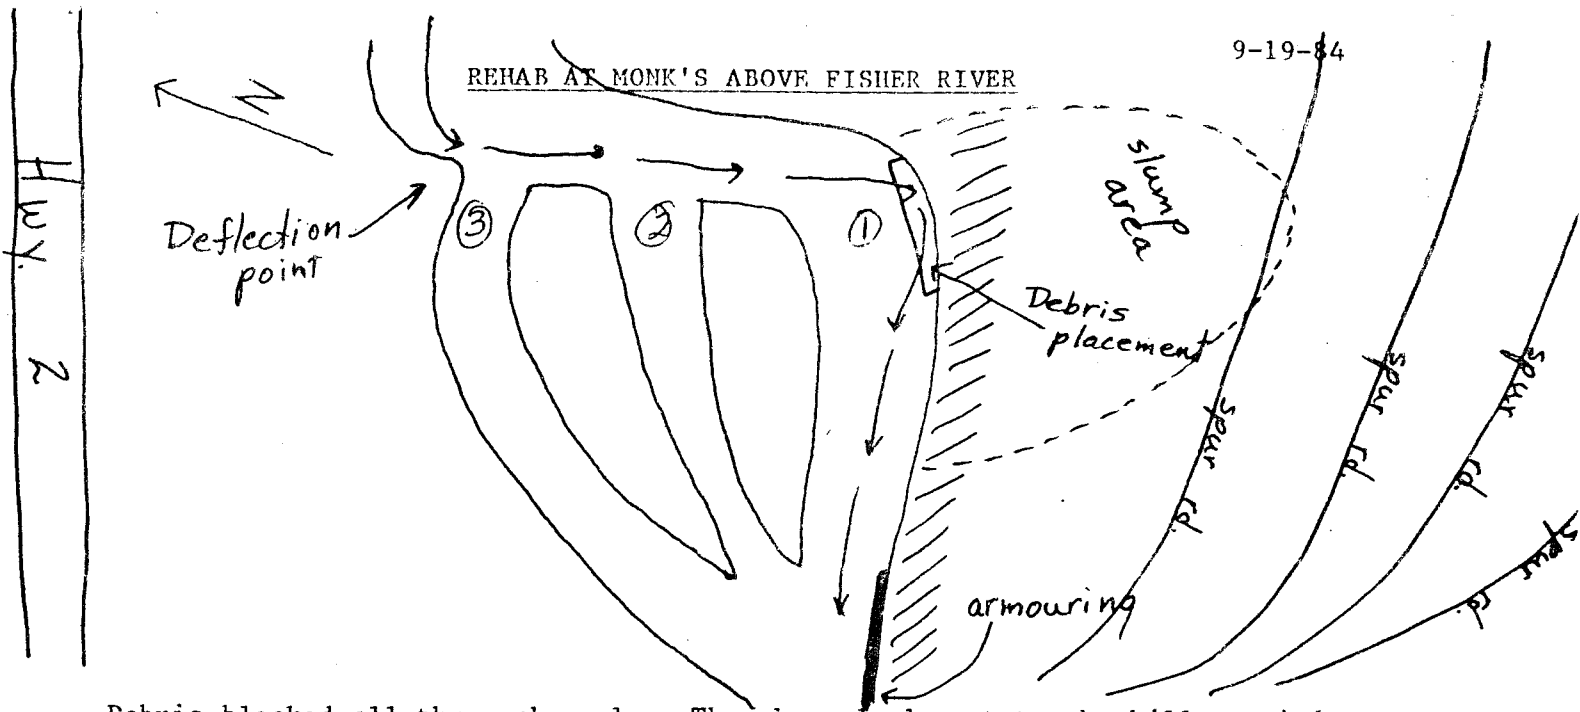
Debris blocked all three channels. The channel closest to the hill carried most of the flow the first week of Sept. In anticipation of increased flows following the fire, the rehab team requested the debris be removed from channels 2 & 3 and placed against the bank/hillslope in the outer part of the bend at channel 1. After several false starts, debris was removed from channels 2 & 3. Unfortunately it was not placed against the toe of the slough. Presently channel 2 carries most of the water, but it is preferable for channel 3 to carry the water.

A slump approx. 100' x 175' occurred where channel 1 made the bend. A lot of sediment was introduced into the Fisher River. Presently the slough is delivering surface erosion material to the Fisher. The organic debris that was to be placed against the bank would have helped to deflect the flow and to also reduce the sediment entry.

After the fire this hillside is a prime candidate to introduce large amounts of sediment to the Fisher River. To reduce the potential of the sediment entry further erosion reduction methods are needed on the hillside. The entire logged area should be seeded immediately with cereal rye. Before snow covers the ground, the dead trees on the hillside should be felled across slope and overlapped to act as check dams. Cuttings should be placed into the slough to help stabilize the soil material. The four roads should be checked for water bars or lack of them and where water is deflected. Some type of armorings needs to be placed at the toe of the slough. Bales of straw could be also used to retain sediment. (Toe of slough and bank of river are one and the same.) More permanent vegetation (orchard grass, timothy, smooth brome and alsike clover) should also be placed with the cereal rye.

Channel 3 needs to be deepened and the deflection paint needs to be removed.

Additional hillsides above and below the above described site should have some cereal rye sown on them. This is especially true where the Fisher River flows adjacent to the hillside.
