Date of Report: 9/17/12

**BURNED-AREA REPORT**  
(Reference FSH 2509.13)**PART I - TYPE OF REQUEST**

**PART II - BURNED-AREA DESCRIPTION**A. Fire Name: MillieB. Fire Number: MT-GNF-000164C. State: MTD. County: GallatinE. Region: 01F. Forest: GallatinG. District: 06H. Fire Incident Job Code: P1G67RI. Date Fire Started: 08/28/2012J. Date Fire Contained: estimated 11/1/12K. Suppression Cost: \$7,800,000 as of 09/14/2012

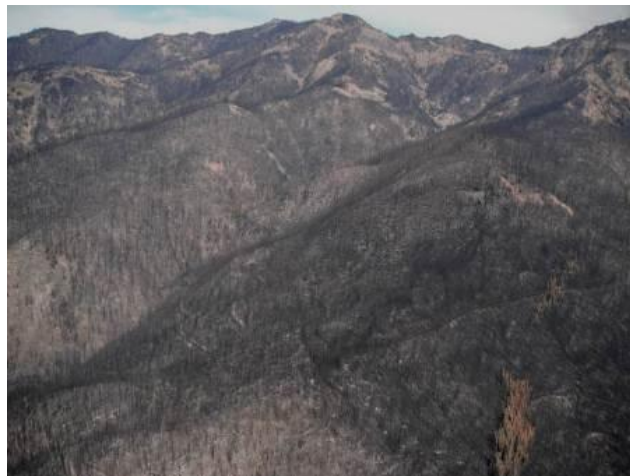
North Central part of the Millie Creek Fire above the Storm Castle Creek Road 132, this watershed has a high runoff, erosion, and debris flow potential.

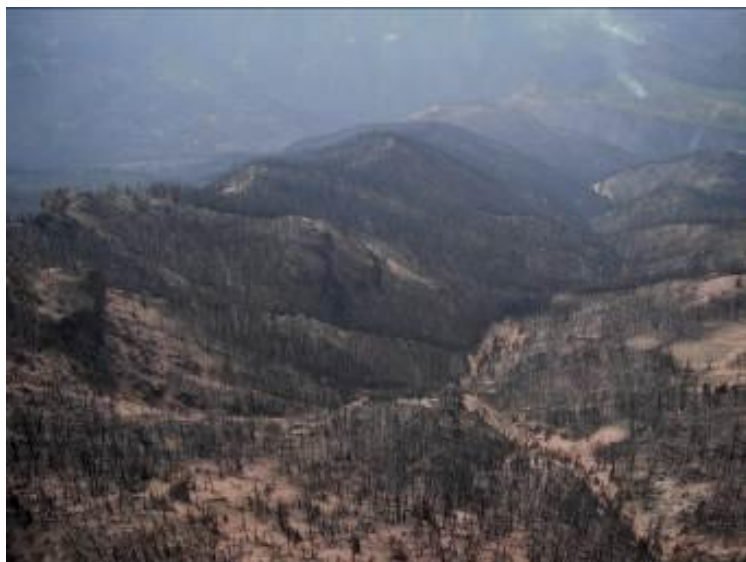
Road 132 culvert crossings in French Creek, Spring Creek, Butte Creek and 2 unnamed tributaries to Storm Castle Creek are very undersized and extremely vulnerable to failure and road damage. The Storm Castle Road 132 is a heavily used major recreation road on the Bozeman Ranger District and provides access to much of the upper Storm Castle Creek drainage including the Trail 185 connection to the Hyalite Creek drainage. The photo at the left shows the upper part of Butte Creek in the Storm Castle Creek drainage above road 132. This part of the fire was mapped at 85% high severity burn with virtually 100% ground cover combustion. This part of the burn is extremely vulnerable to accelerated stormflows, erosion, and debris flows based on debris flow research by Gartner and others (2008), Cannon and others (2009), and Parrott (2003).

The most critical road treatment is to upgrade 4 culverts on the Storm Castle Road 132 (Spring and Butte Creeks, 2 unnamed drainages) and upgrade the undersized French Creek culvert to a bridge where private land access is in jeopardy and to provide AOP capability. The 4 culverts are considerably undersized and a high potential of being blown out and/or overtopped with stormflow runoff and debris. The 4 stream crossings (culverts) on Rd 132 with deep fills will be removed to eliminate the substantial risk of culvert plugging, over topping, breaching, and channel scour. The work will consist of fill removal, removing existing culverts, and re-creating an approximately 15' wide stream bottom area. The 4 culverts are anticipated to be removed in October 2012 and larger culverts installed in June 2013 after the highest risk for snowmelt. This will require closing the 132 road from auto and truck access until the new culverts are installed. Storm Castle Road 132 is a major corridor for public and Forest Service administration. Closing this system road for extended periods is not a realistic option considering the multiple management activities and recreational access.
