USDA-FOREST SERVICE

SADDLE FIRE BURNED-AREA REPORT
(Reference FSH 2509.13)

- A. Fire Name: Saddle Fire
- B. Fire Number: CA-SHF-001371
- C. State: CA
- D. County: Trinity
- E. Region: 5
- F. Forest: Shasta-Trinity
- G. Districts: South Fork Management Unit

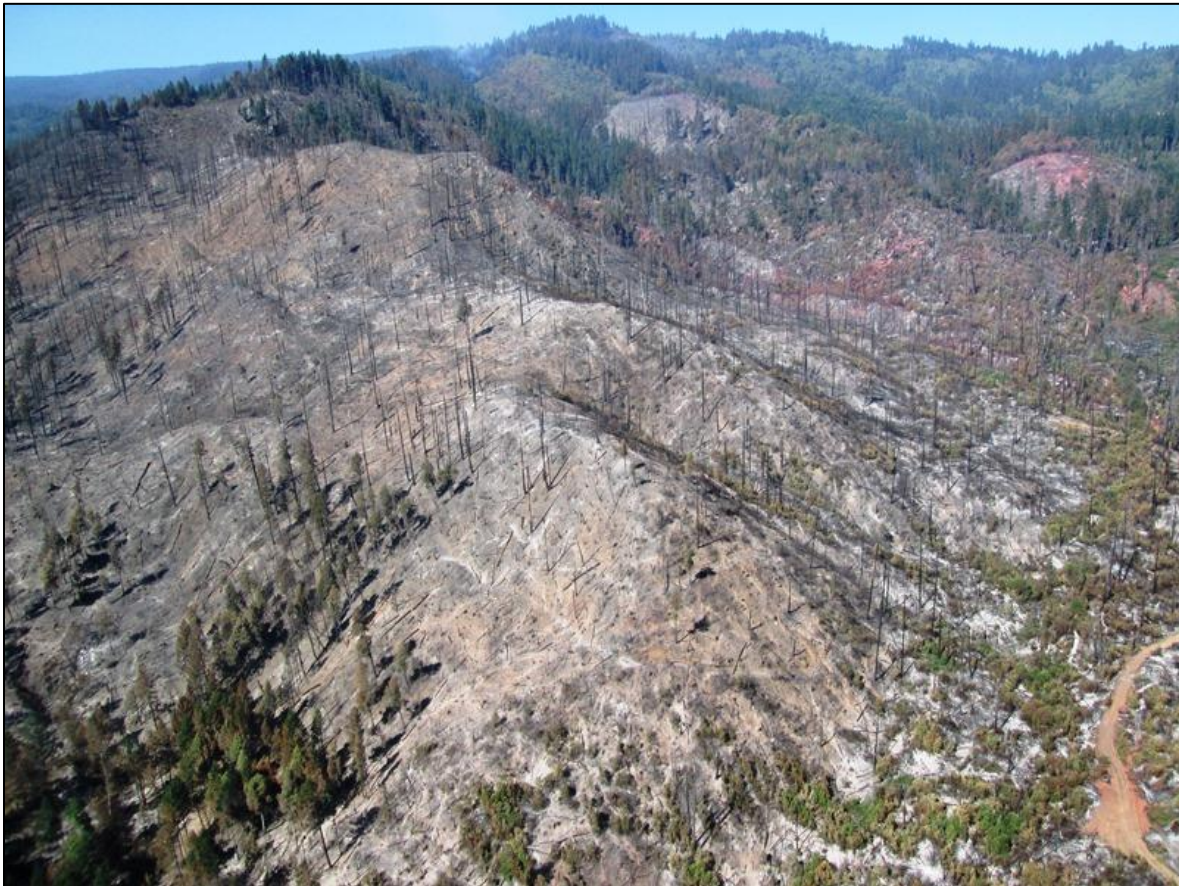
The Saddle Fire of 2015 looking into Saddle Gulch area (to the left) reburned since the Sims Fire of 2004.

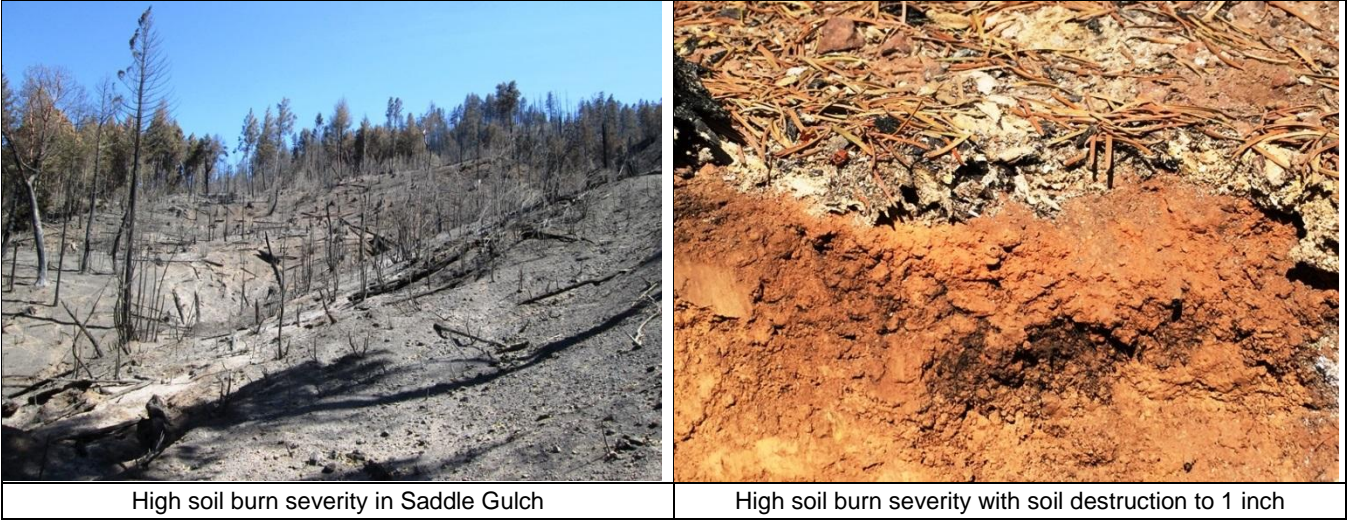
Figure 1 – Saddle Gulch high soil burn severity in red loamy Dunsmuir soil

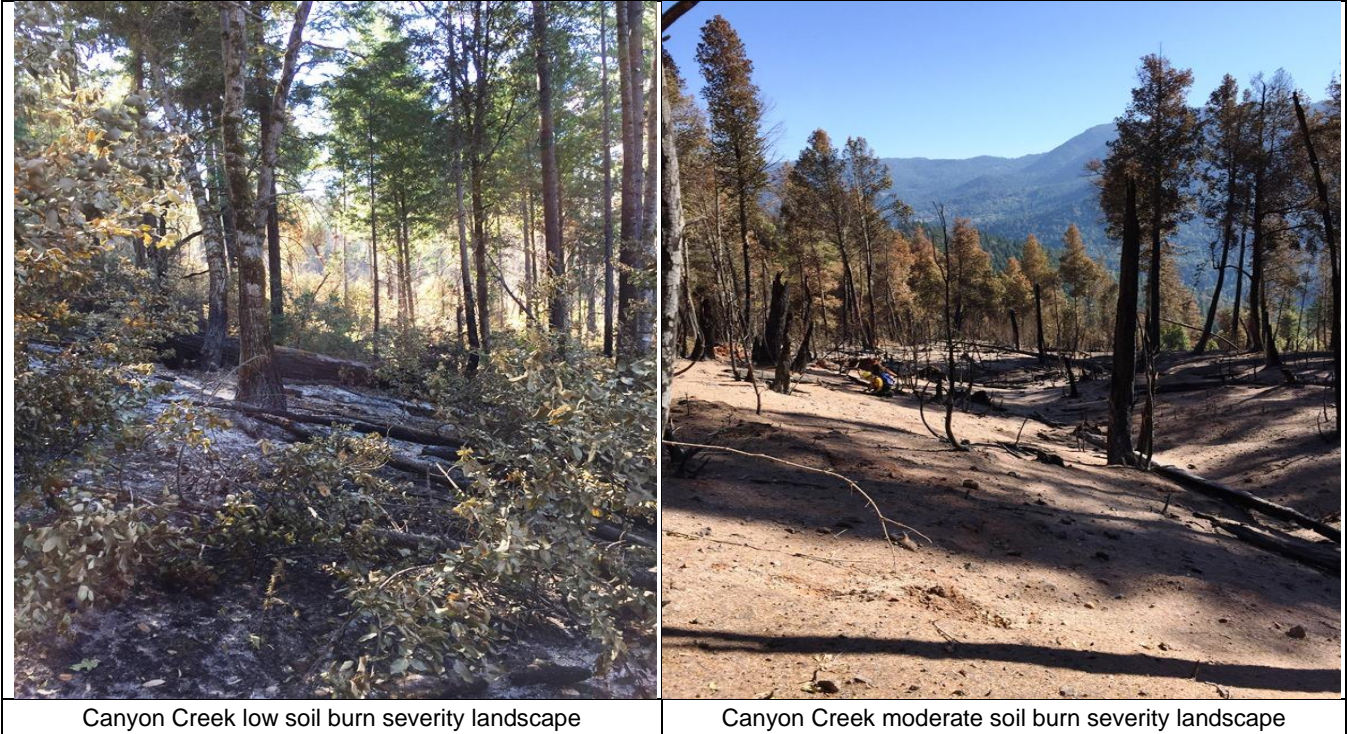
Approximately 55% burned at high and moderate soil burn severity. The rest of the fire was either low or very low soil burn severity (see below soil burn severity map). It is very important to understand the difference between *fire intensity* or *burn severity* as discussed by fire behavior, fuels, or vegetation specialists, and *soil burn severity* as defined for watershed condition evaluation in BAER analyses. Fire intensity or burn severity as defined by fire, fuels, or vegetation specialists may consider such parameters as flame height, rate of spread, fuel loading, thermal potential, canopy consumption, tree mortality, etc. For BAER analysis, we are not mapping simply vegetation mortality or above-ground effects of the fire. Soil burn severity considers additional surface and below-ground factors that relate to soil hydrologic function, runoff and erosion potential, and vegetative recovery. Pictures below show Canyon Creek mixed mortality due to the fire suppression efforts on the south side of the Saddle Fire.

Figure 2 – Saddle Fire southside soil burn severities

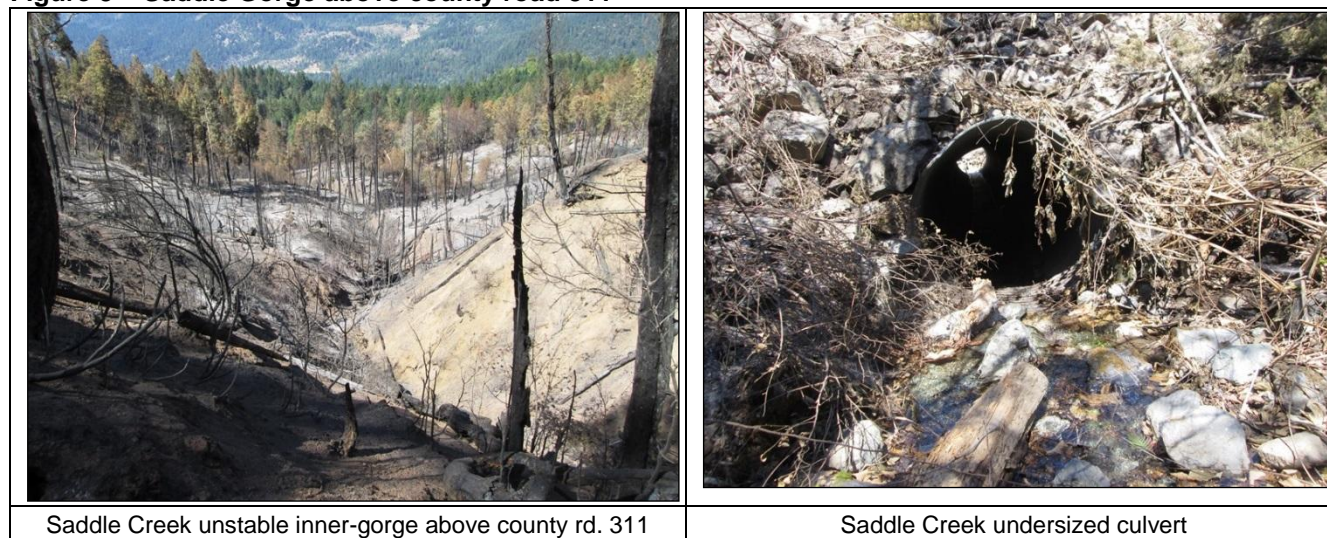
Particular area of concern is Saddle Gulch which was entirely burned at moderate to high soil burn severities. This area is a Dunsmuir soils (moderately deep gravelly loams) in the headwaters of Saddle Gulch draining directly into the south fork of the Trinity River (see cover picture). This area in the past suffered moderate to high soil burning due to the 2004 Sims Fire. Several small landslides exist in the drainage system along with an active deeply incised inner-gorge. All vegetation including an existing conifer stand was 100 percent killed along with in-channel vegetation with an undersized culvert that could plug and cause county road 311 to fail (Figure 3 below). Also Noname Creek just north of Saddle Gulch experienced extensive burning with moderate and high soil burn severity occupying 50% of the drainage.

Figure 3 – Saddle Gorge above county road 311

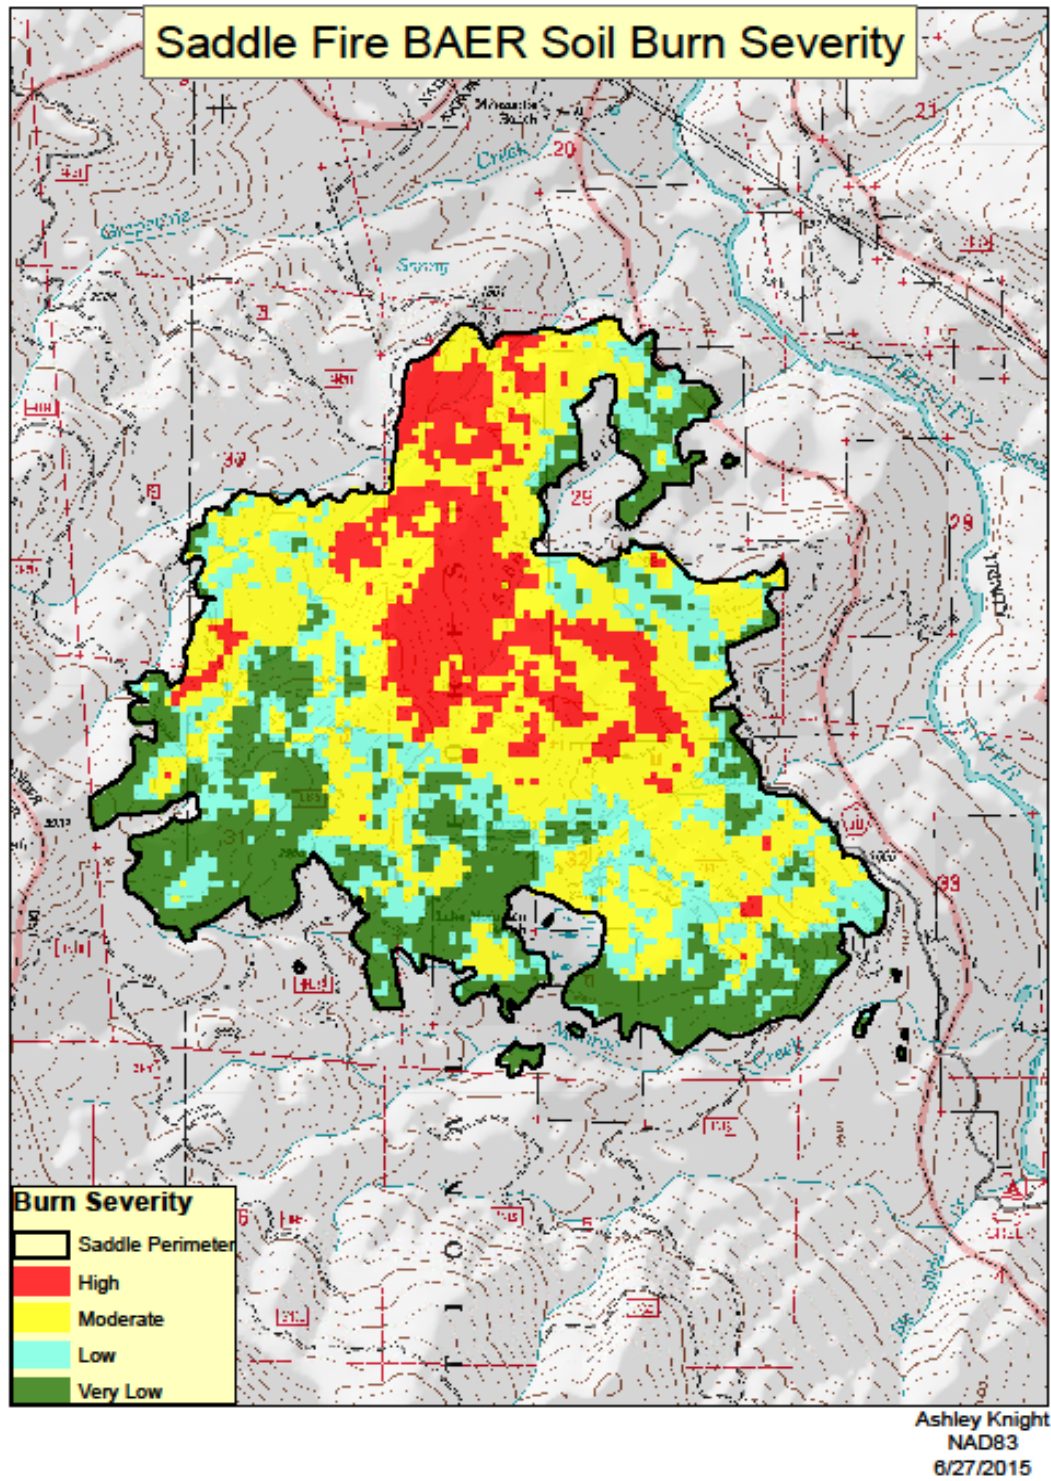
Saddle Fire Soil Burn Severity Map:

Eighteen soil burn samples were taken in the field to confirm the soil burn severity mapping (see Appendix D). Results show that most of the fire area suffered low to moderate soil burn severity with only Noname and Saddle Gulches had high soil burn severity, with Saddle Gulch having the highest proportion of severe burning. Looking at the soil burn severity maps below shows the majority of soil burn severity was moderate to low south of Canyon Creek. Areas that burned the hottest were the west portion of the fire in Noname Creek and Saddle Gulch. This was due to heavy accumulations of dead and down timber left from the Sims fire of 2004.
