BURNED-AREA REPORT
(Reference FSH 2509.13)**PART I - TYPE OF REQUEST**

PART II - BURNED-AREA DESCRIPTIONA. Fire Name: TroughB. Fire Number: P53744C. State: CAD. County: Colusa, GlennE. Region: 05F. Forest: 08G. District: 53H. Date Fire Started: 8/8/2001I. Date Fire Controlled: 9/11/01J. Suppression Cost: \$14 million

Photographs of Trough Fire BAER Treatments

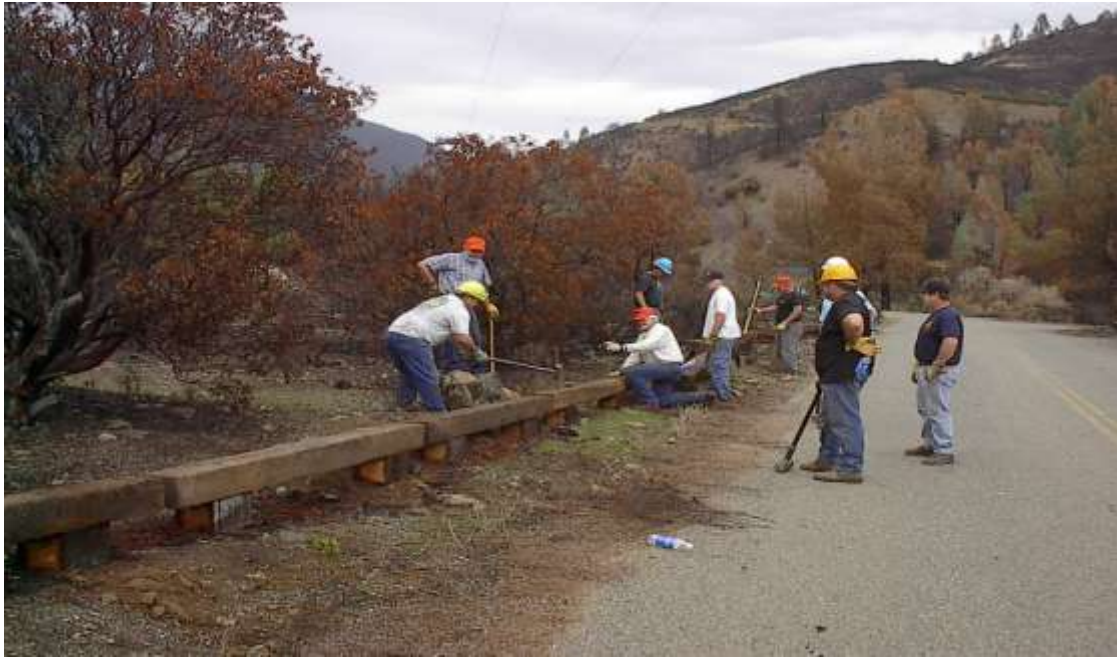
Photograph 2. Members from the Oakland and Valley Climber motorcycle clubs volunteered to install railroad tie barriers. Footings are dug into the ground. The horizontal railroad tie is secured to the footings with reinforcement bar that needs pounded in by hand.

Wood barriers confining OHV riders to staging areas were burned when the fire went through the area. These barriers, plus others, were installed prior to re-opening the area to use. Roughly 20,300 feet of barriers were installed by inmate crews, C&M crews, OHV specialists and motorcycle club volunteers.

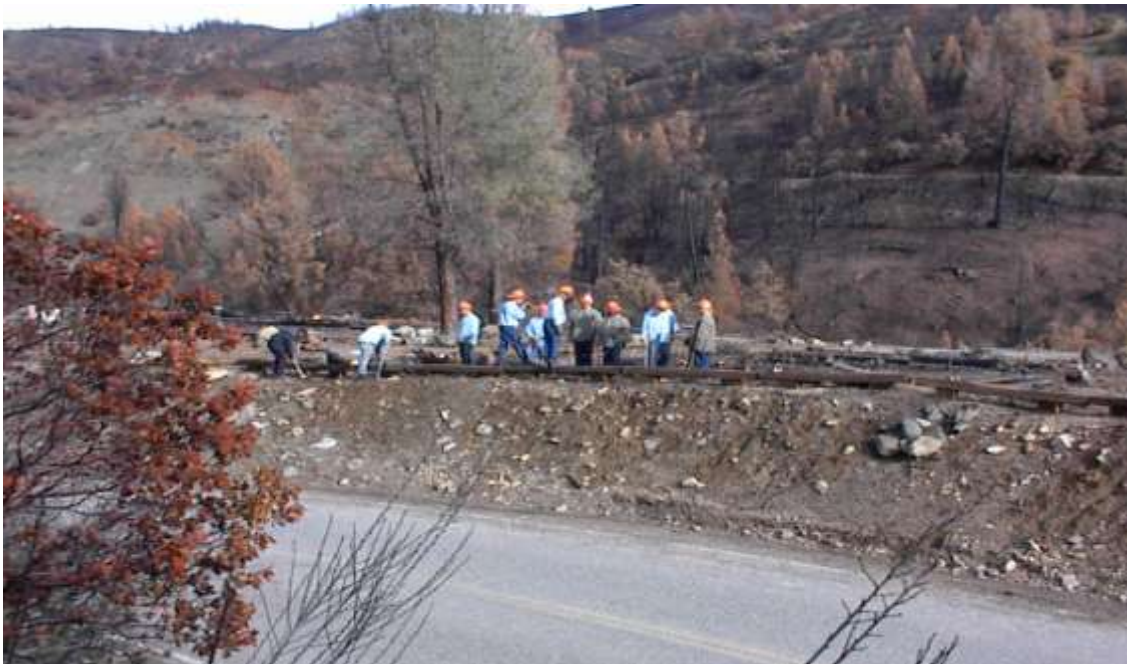
Photograph 3. Inmates were used to install railroad tie barriers in the campground areas and adjacent staging areas.

OHV barriers burned in the fire were replaced using inmates, OHV club volunteers and Forest personnel. There was pressure from the OHV community to open the staging areas for Thanksgiving weekend. District personnel worked very hard to get the barriers installed to meet this timeline.

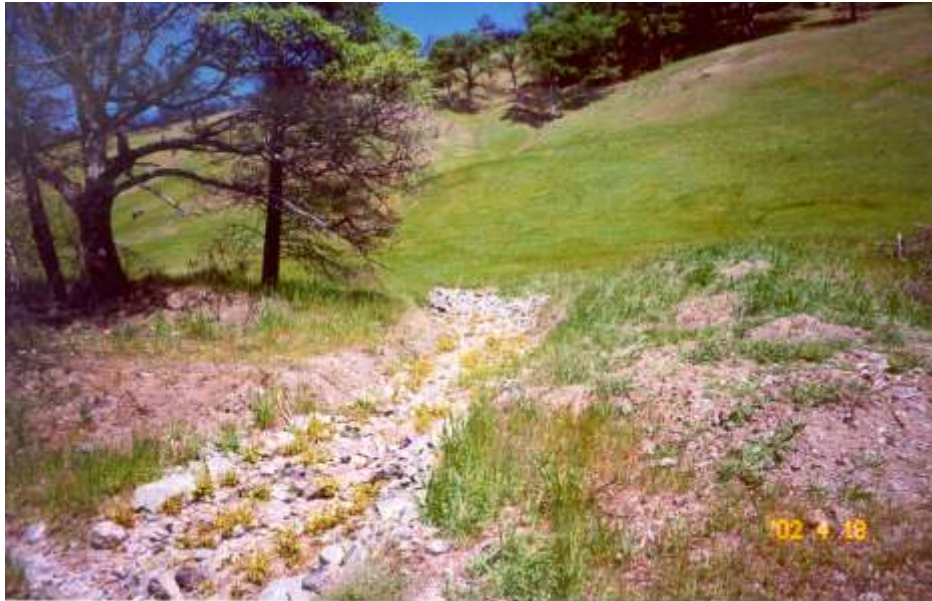
Photograph 4. When settlers built a road into Brittan Ranch, they diverted the stream to the right. This created a new an erosive channel. With previously burned slopes contributing increased water in an erosive channel, the BAER team prescribed a stream diversion . The old channel was re-established and lined with filter cloth and rock.

Channel diversion – two areas in the Brittan Ranch area had streams moved from an unnatural location to the original channel. In the distant past and prior to a Forest Service land exchange, private landowners diverted one stream to flow along an access road and the other to a very small channel. The BAER team estimated that increased runoff from the former diversions would cause severe bank cutting and deposition of soil into a main channel.

Two people walked into the Brittan Ranch and observed the stream diversions. One diversion that required rocking the channel for sixty feet was functioning perfect. The other diversion of moving the stream back into the natural channel also was working well. Some hand work was done to remove branches blocking the diversion.

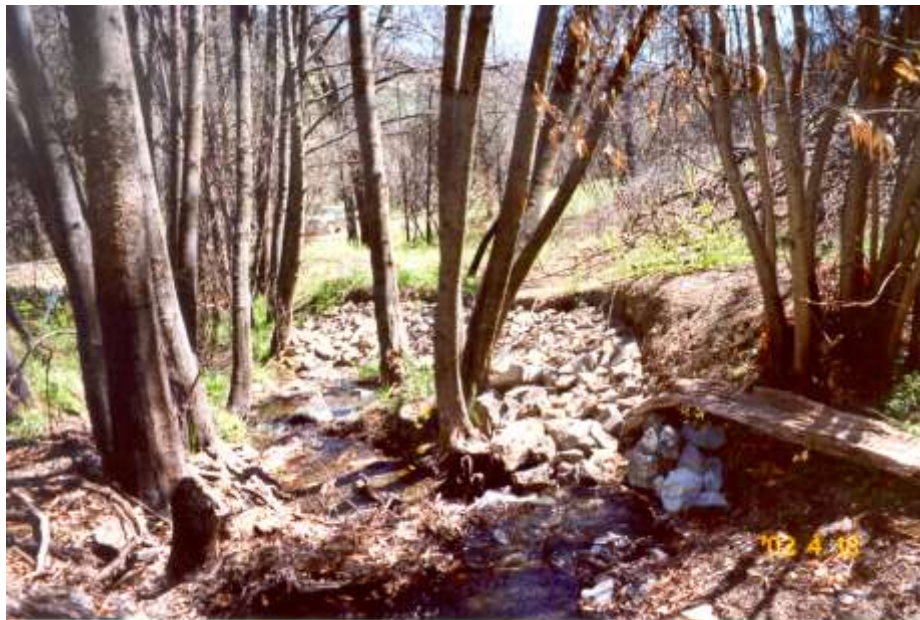
Photograph 5. An eroding streambank on the edge of archeological site was rocked to protect the streambank and arch site from predicted increased peak water flows.

Archeological site protection – a perennial stream was eroding a streambank adjacent to an archeological site. Most of the watershed above the site was burned at high intensity. The BAER team estimated that increased peak flows would cause more bank erosion and some loss of the site. About 30 feet of streambank was rocked to prevent further bank undercutting and loss of the arch site.

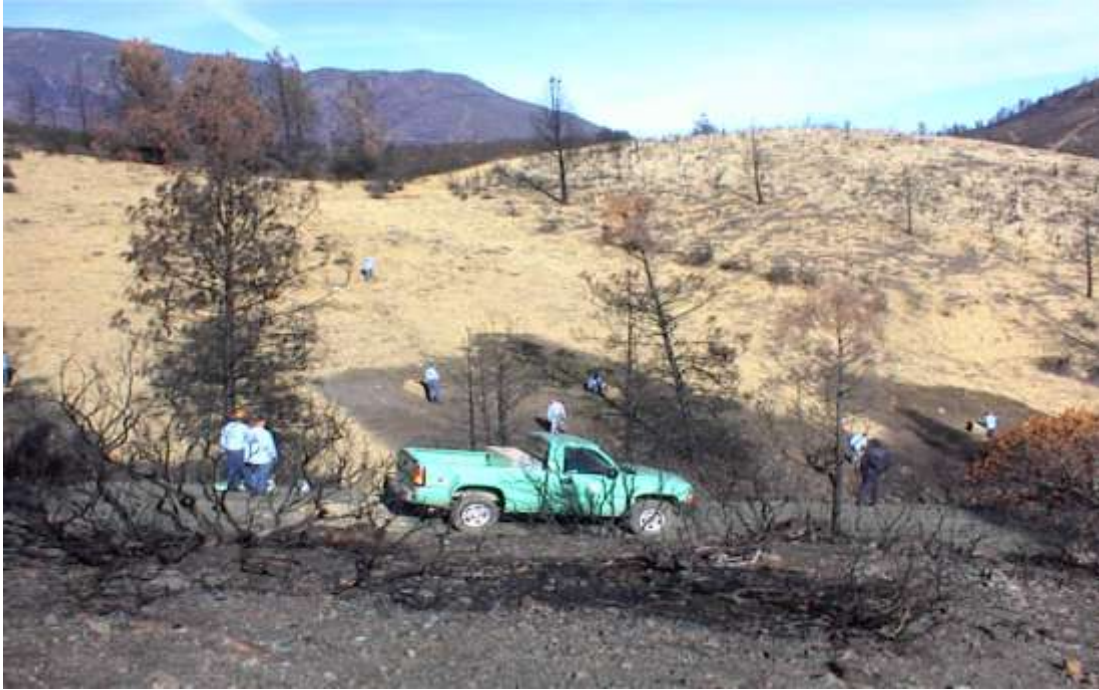
Photograph 6. Inmates were used to hand mulch a hillside that drains into the Davis Flat OHV staging area.

Straw mulch was applied by hand to areas around the Davis Flat OHV area. Hillsides were mulched to reduce runoff into the camping area. Streambanks located near the camping and OHV staging areas were mulched to prevent erosion into streams and to keep people off the denuded slopes.

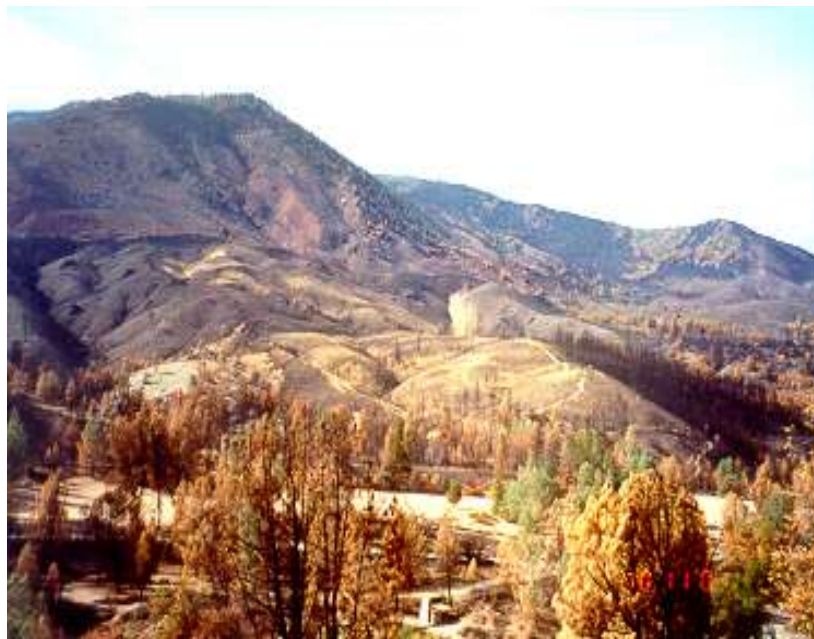
Photograph 8. Helicopter dispersing straw on a watershed that drains to a road culvert. Application rate was one ton per acre.

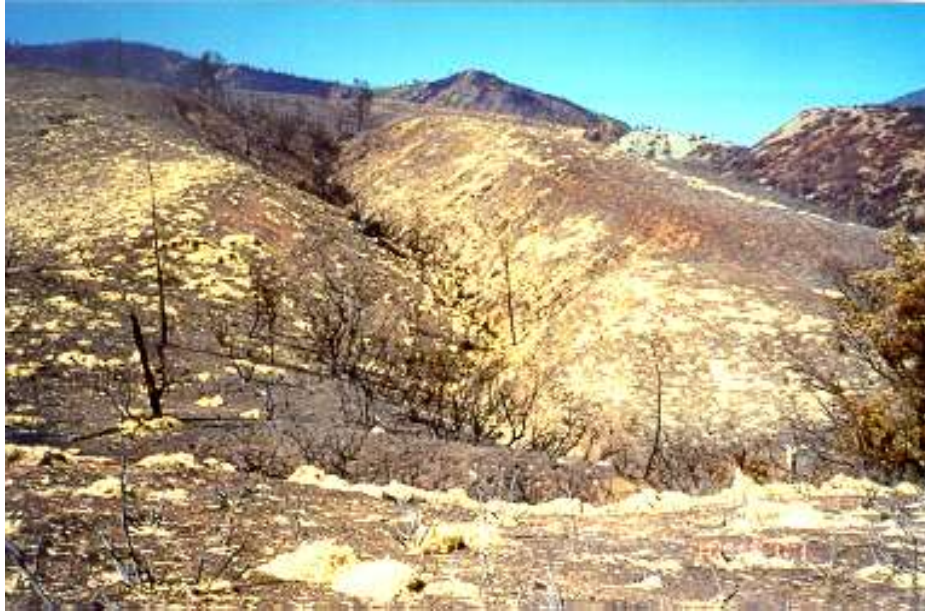
Photograph 9. Initial straw preparation techniques produced straw which was clumpy. Ground cover is about 40%.

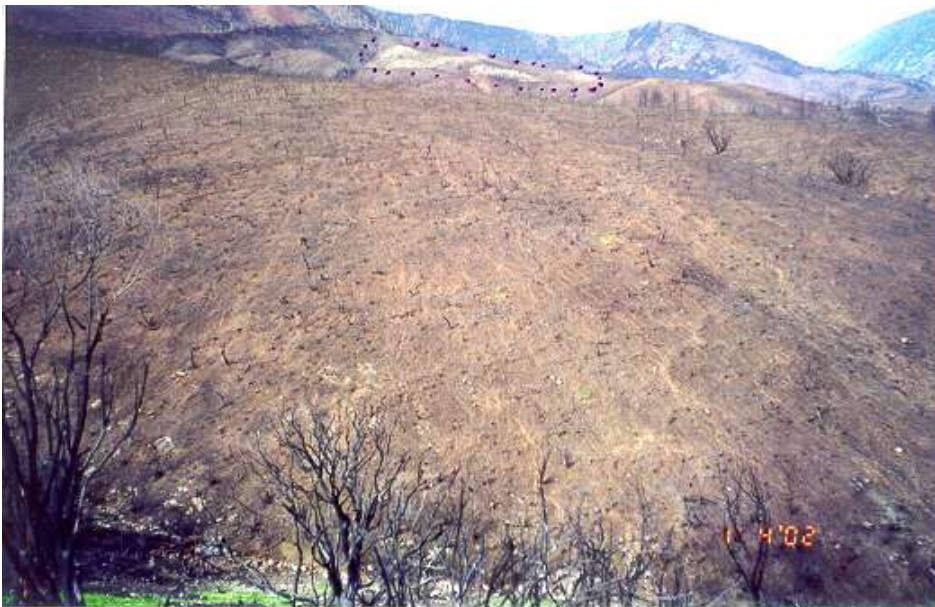
Photograph 10. Adjacent hillside on private land has many rills running down-slope to a stream.

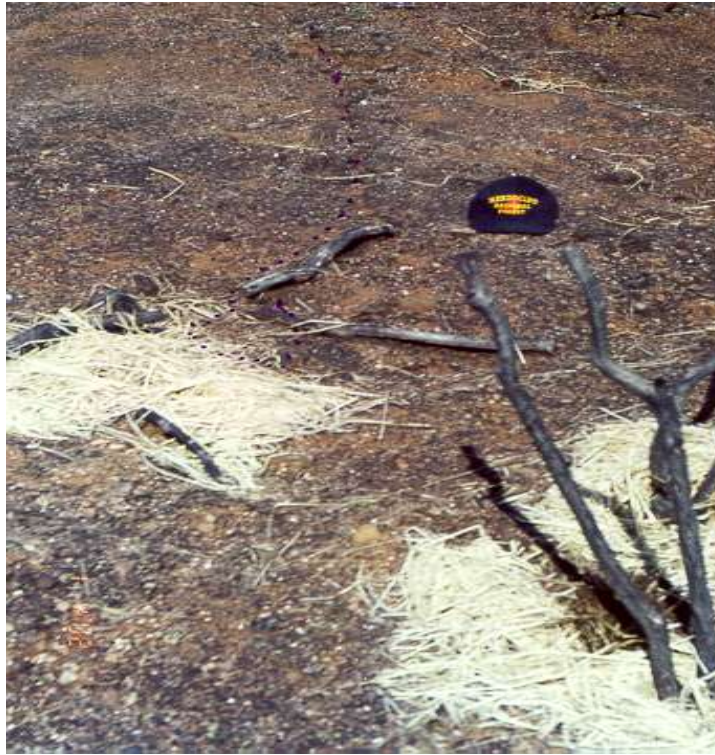
Photograph 11. Clump of straw stopping a rill (dotted line).

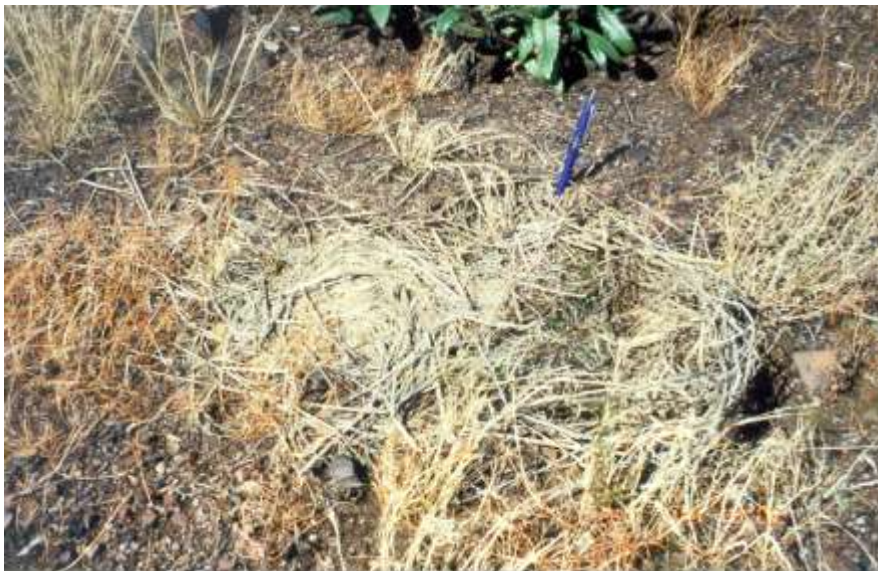
Photograph 12. Sheet erosion caught by clump of straw.

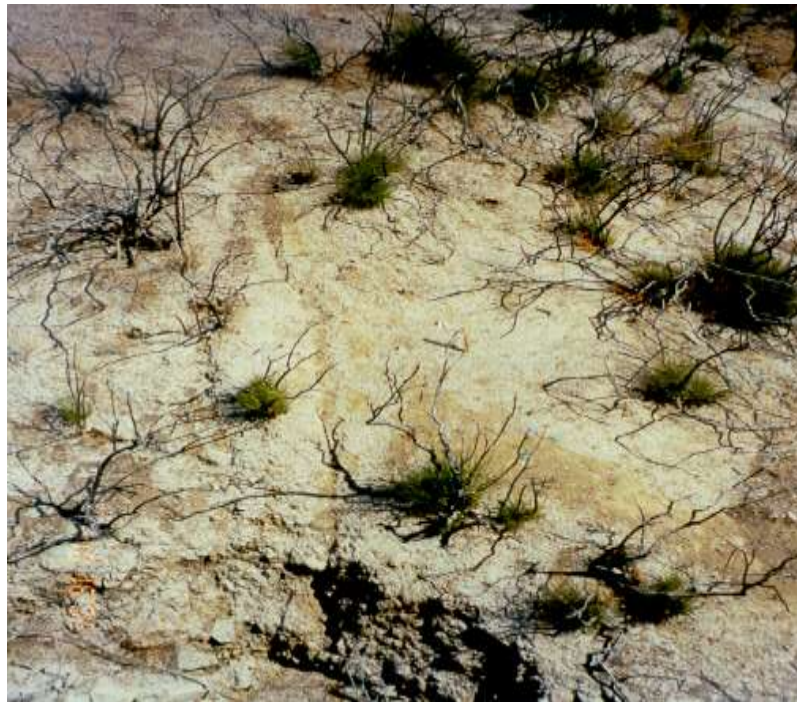
Photograph 14. Hydromulch (gray color) adhering to a steep stream bank after a hot summer.

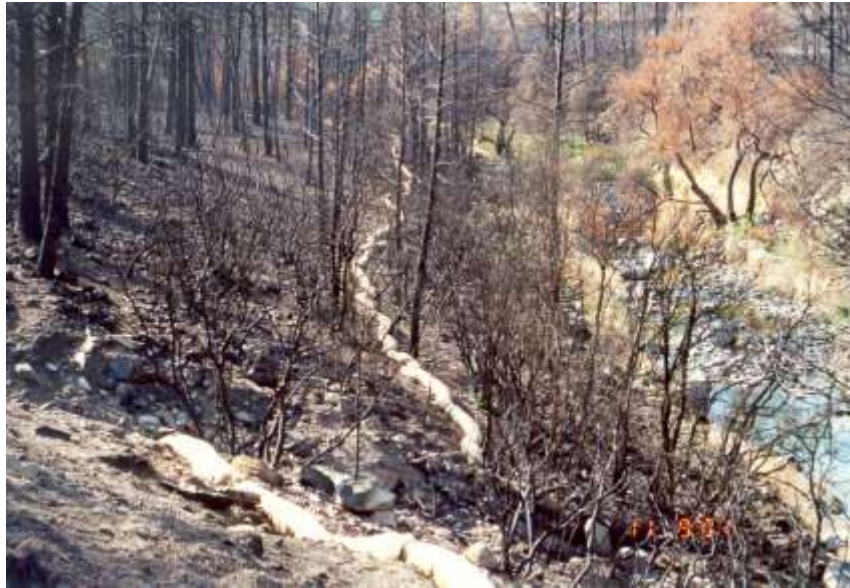
Photograph 15. Youth from the nearby Fouts Springs California Youth Authority Detention Camp were used to place wattles along a streambank. Without the wattles, soil would have moved into the trout stream.

Straw wattles were installed on one section of streambank and on slopes above two archeology sites. Even though soil erosion was not great on these slopes, the wattles stopped surface runoff and trapped sediment.

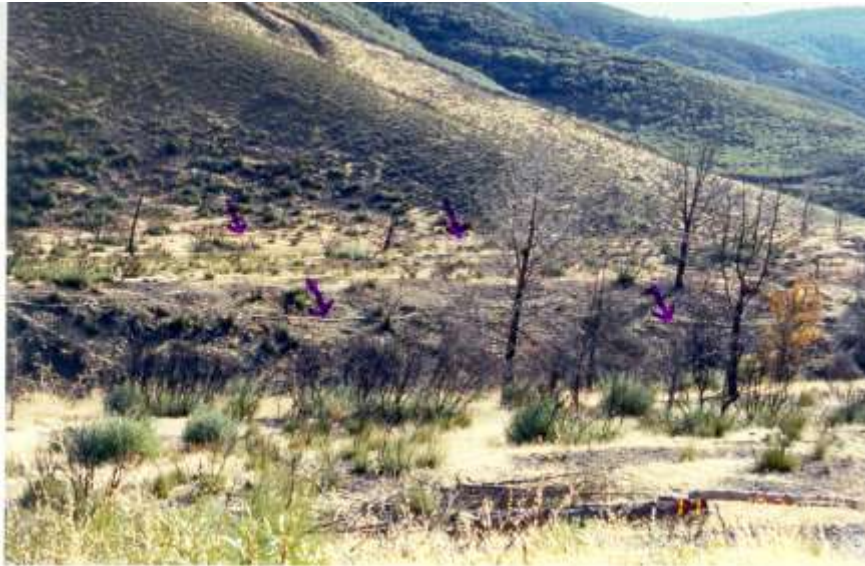
Photograph 16. The upper line of wattles (marked in purple) were installed to protect an archeological site on the flat. The wattles stopped rills from eroding the site.

Two other archeological sites were protected from surface erosion by the use of straw wattles.

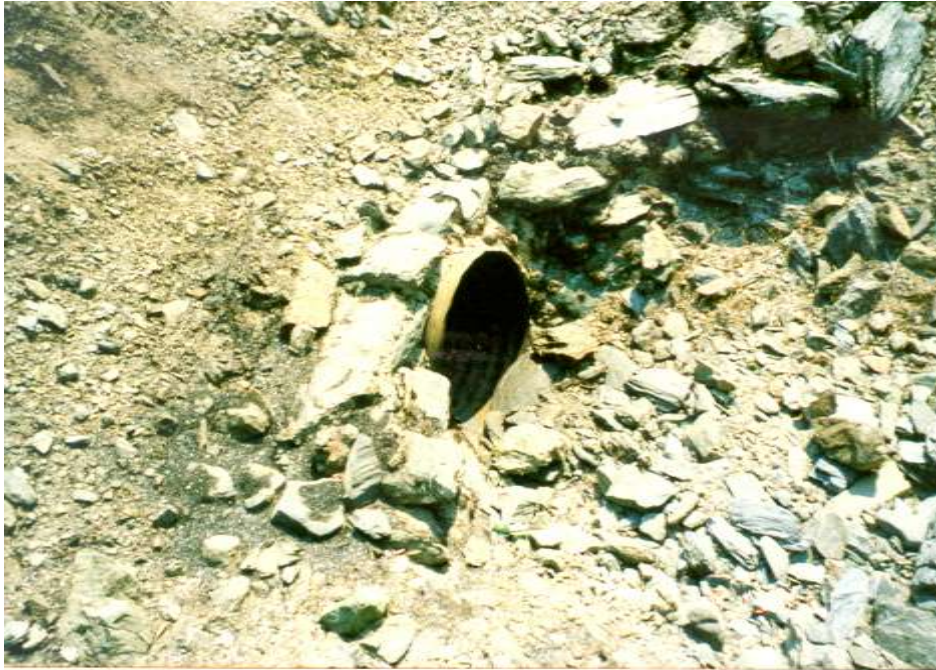
Photograph 17. Culvert in jeopardy! Watershed above this culvert was totally burned at high intensity.

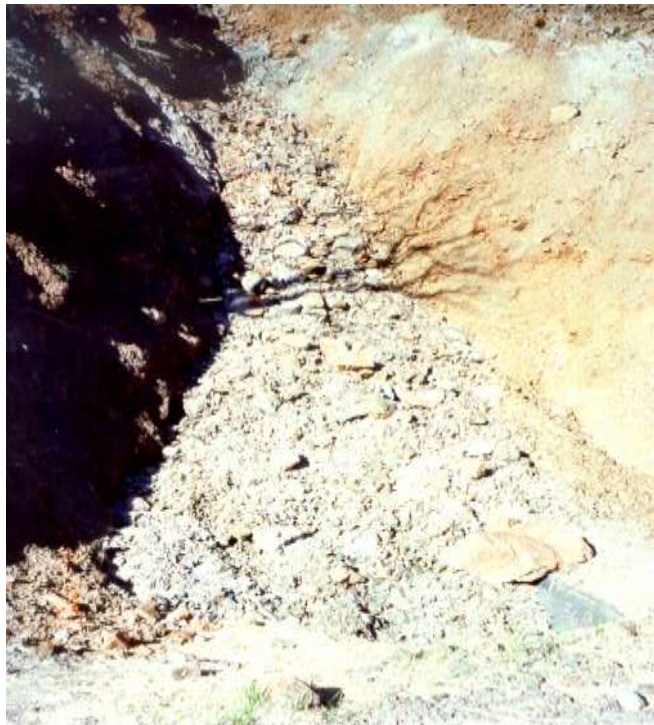
Photograph 18. Value of a culvert end section passing rocks and muck.

End sections on culvert inlets worked very well as only one end section became plugged and caused a minor road washout. C&M foreman Gaddini conducted storm patrols and said "culvert end sections are very worth the money". One can only speculate how many culverts were not plugged due to the installed end sections.

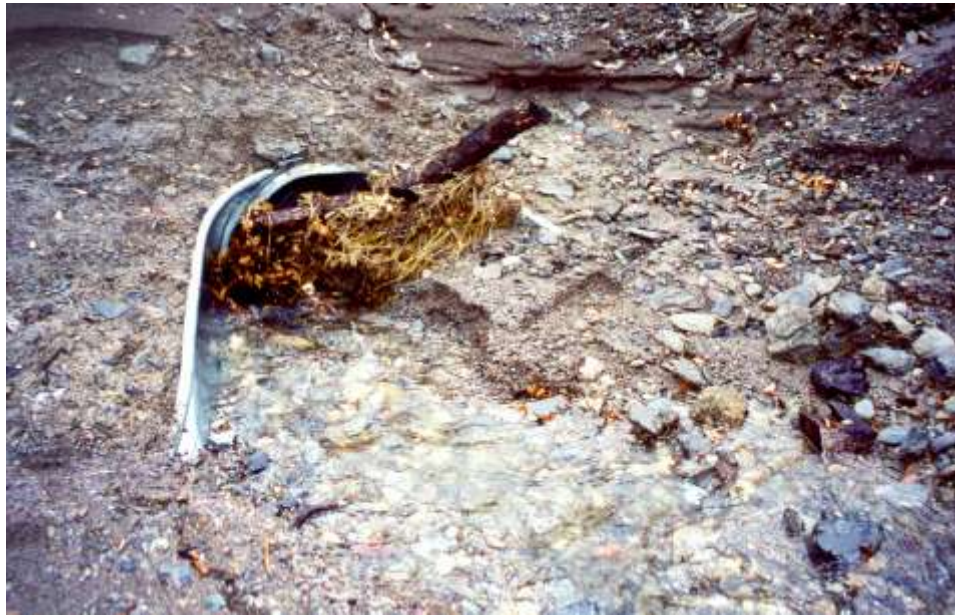
Photograph 19. Culvert end section blocked by unburned woody debris in the channel. The plugged culvert caused water to overflow the stream banks and washout some of the road.

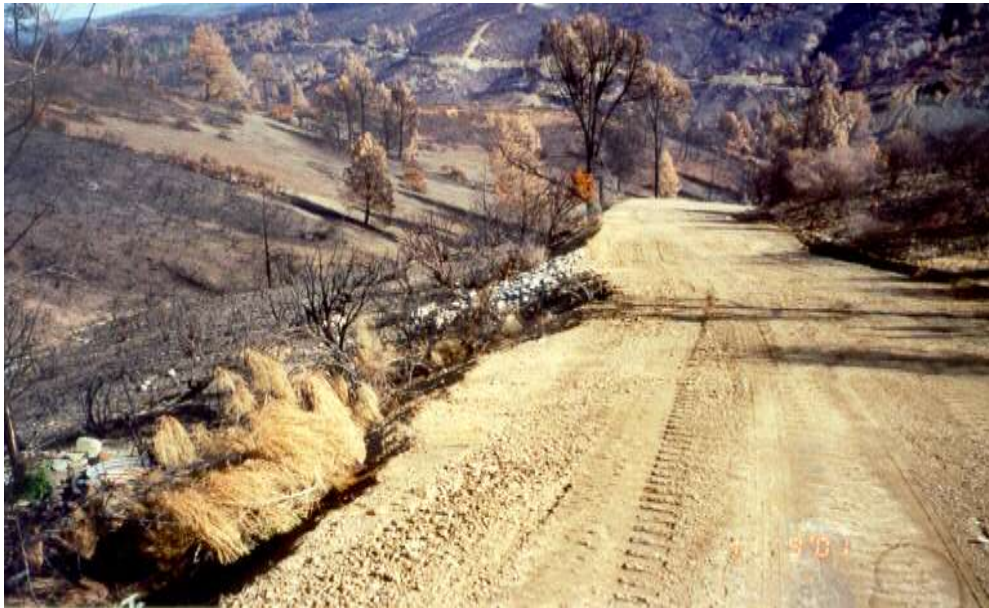
Photograph 20. Rolling dips with rock rip rap were used to drain water from the road surface. This road was originally insloped with a ditch, but is now outsloped.

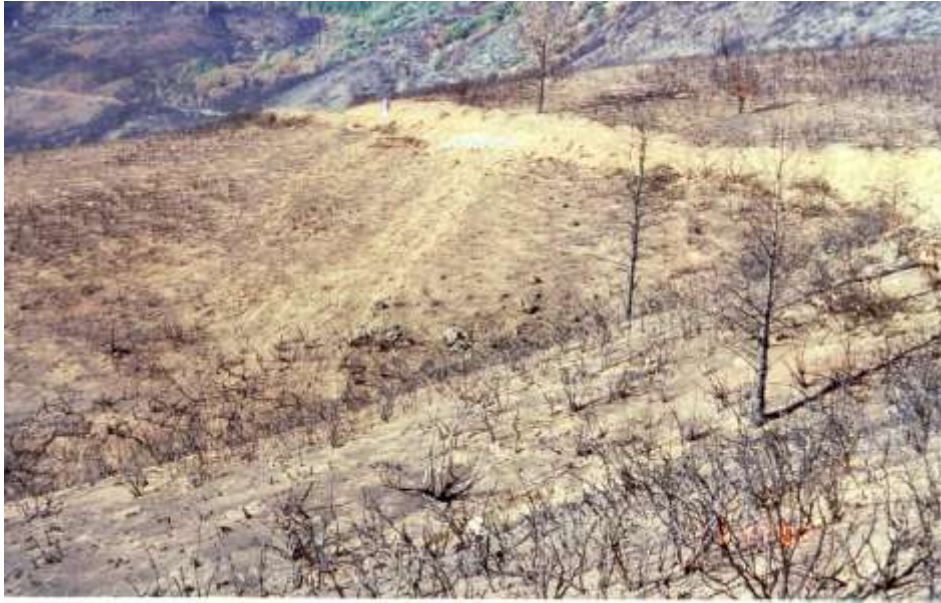
After initial reconstruction, Fall storms generated road runoff that caused rills on the hillside. Contract changes were made to add additional drainage structures. Even with closer spaced (50-70 feet apart) rolling dips there was enough surface runoff from the brushfield soils to cause rill erosion on the hillside below the road.

Photograph 21. This photograph shows the erosiveness of the burned area. Road water runoff from a rolling dip is creating rills that flow into an intermittent channel. Distance of road collecting water is less than 75 feet. Change orders to the road contract were made to add more rolling dips, where feasible, to correct these situations.

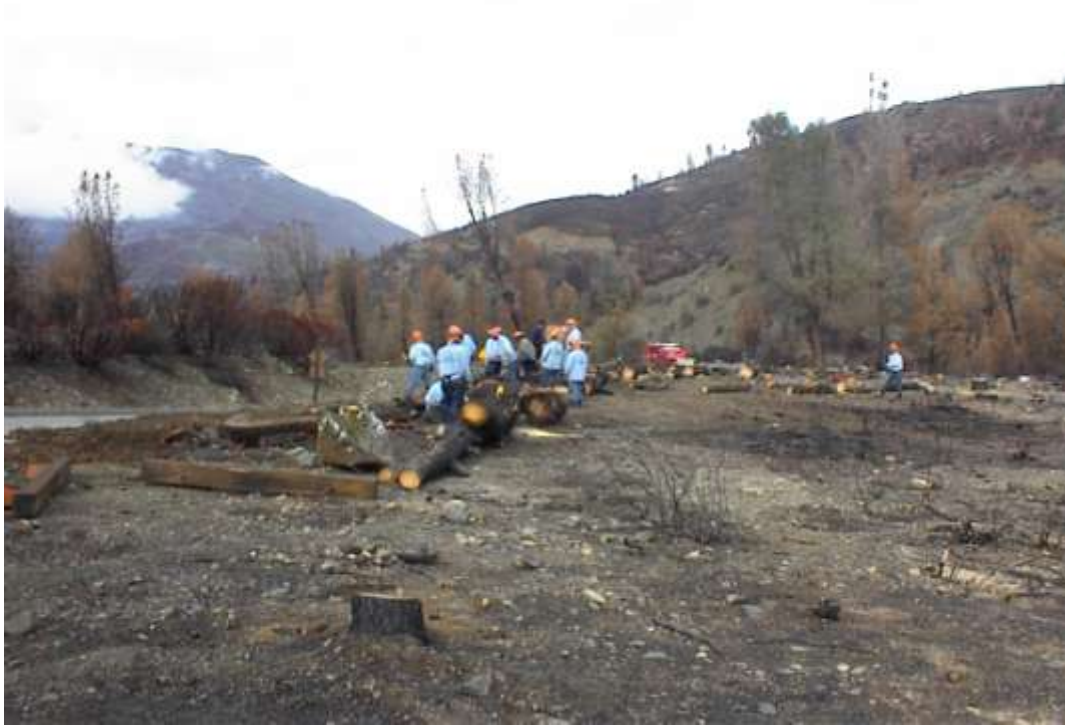
Photograph 22. Inmates were used to fall hazard trees in the campgrounds and along roads and trails of Davis Flat OHV recreation area.

Burned conifer trees were removed along the county road to Fouts Springs, in three Forest Service campgrounds and along one OHV trail. Unfortunately the fire killed many trees and the campground areas now look like clearcuts.
