BURNED-AREA REPORT
(Reference FSH 2509.13)**PART I - TYPE OF REQUEST**

- A. Fire Name: Johnson Bar B. Fire Number: ID-NCF-000390
C. State: ID D. County: Idaho
E. Region: 01 F. Forest: Nez Perce-Clearwater
G. District: Moose Creek Ranger District H. Fire Incident Job Code: P1JA8G
I. Date Fire Started: 08/03/2014 J. Date Fire Contained: estimated 10/30/2014
K. Suppression Cost: \$10,300,000 as of 09/02/2014

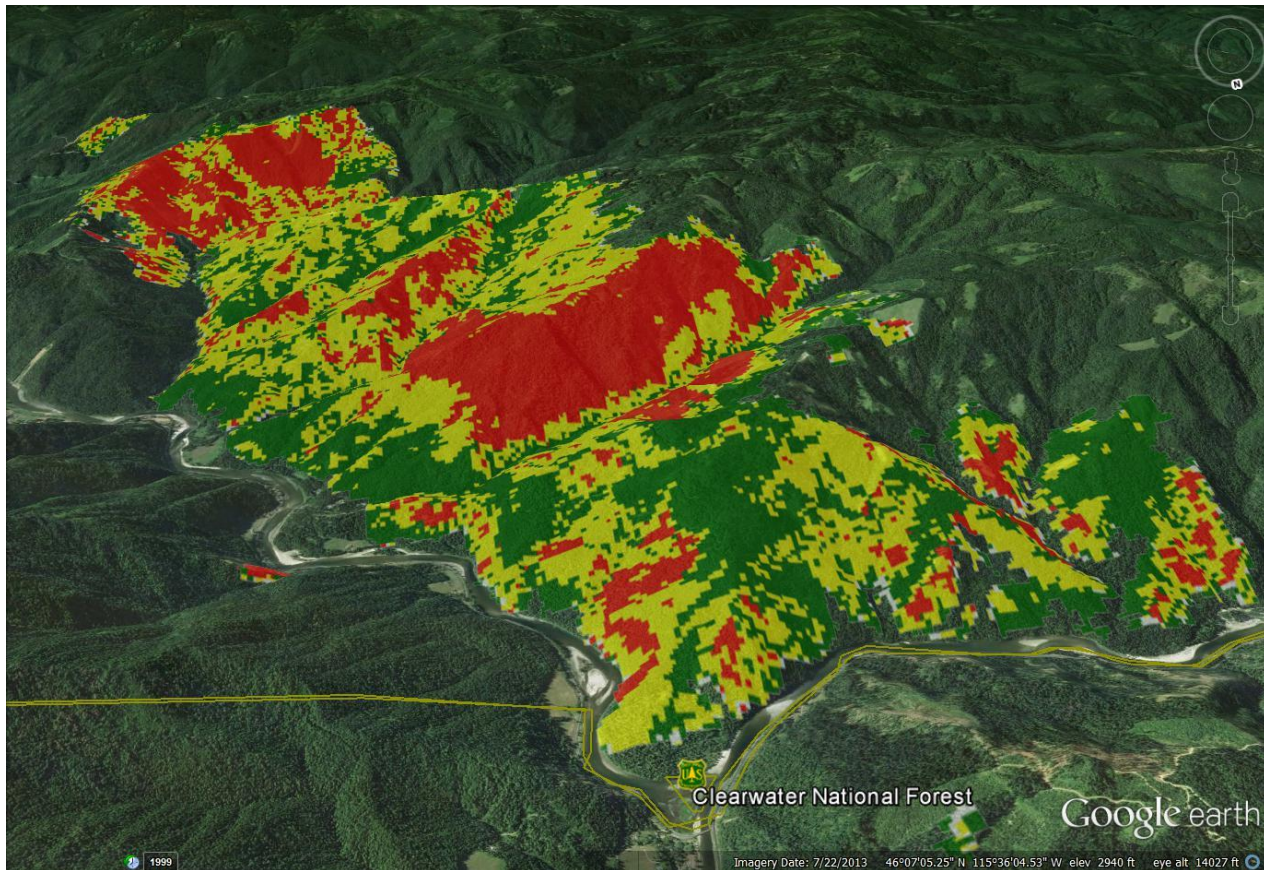
Soils in the Johnson Bar burn area consist primarily of a 6-10 inch volcanic ash mantle over soils derived from metasedimentary geology. The predominant rock type in the fire area was quartzite with inclusions of gneiss and schist. The ash mantle on this sites is the primary source of the ecosystem productivity. An analysis was completed showing the post-fire erosion risk for the fire. The following map shows the post-fire erosion risk created from looking at the burn severity and erosion hazards of the area.

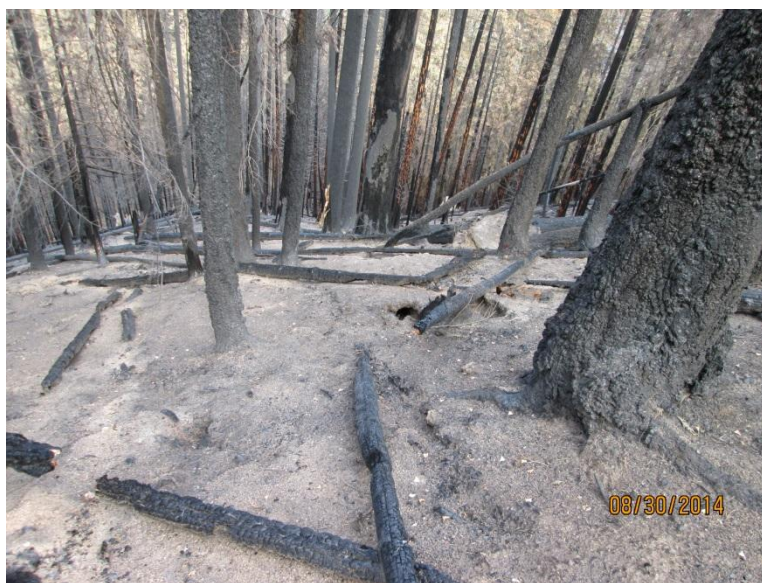
Moderate severity burn on ridge along the Burned Creek watershed.
