Date of Report: 09/04/2013

BURNED-AREA REPORT
(Reference FSH 2509.13)**PART I - TYPE OF REQUEST****A. Type of Report**

- A. Fire Name:** Salmon River Complex **B. Fire Number:** CA-KNF-005561
C. State: CA **D. County:** Siskiyou County
E. Region: R5 **F. Forest:** Klamath
G. District: Salmon River Ranger District **H. Fire Incident Job Code:** P5HS98
I. Date Fire Started: July 31, 2013 **J. Date Fire Contained:** 8/30/2013
K. Suppression Cost: \$23 million
L. Fire Suppression Damages Repaired with Suppression Funds

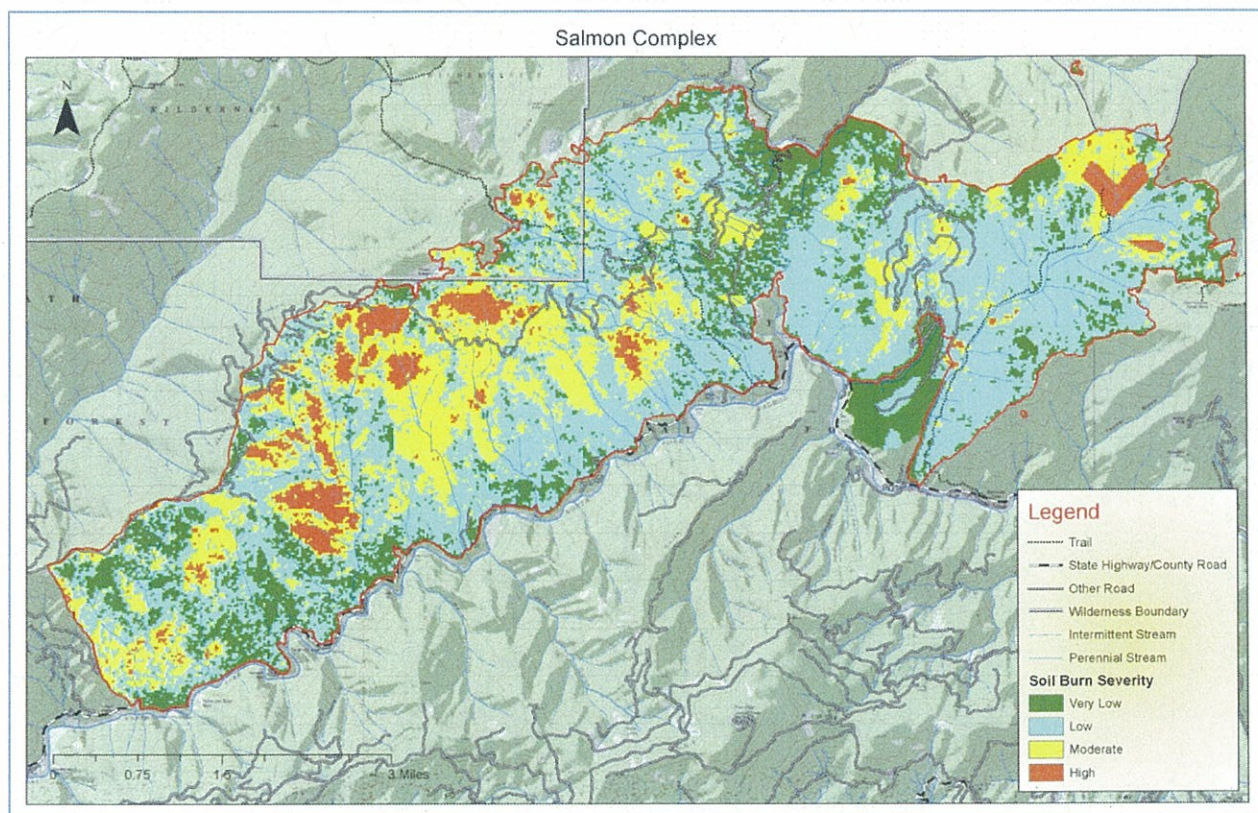
Figure 1 – Pictures of soil burn severity in upper Boulder Creek
