Date of Report: 10/07/2015

BURNED-AREA REPORT
(Reference FSH 2509.13)**PART I - TYPE OF REQUEST**

A. Fire Name: Trail Creek

F. Forest: Flathead

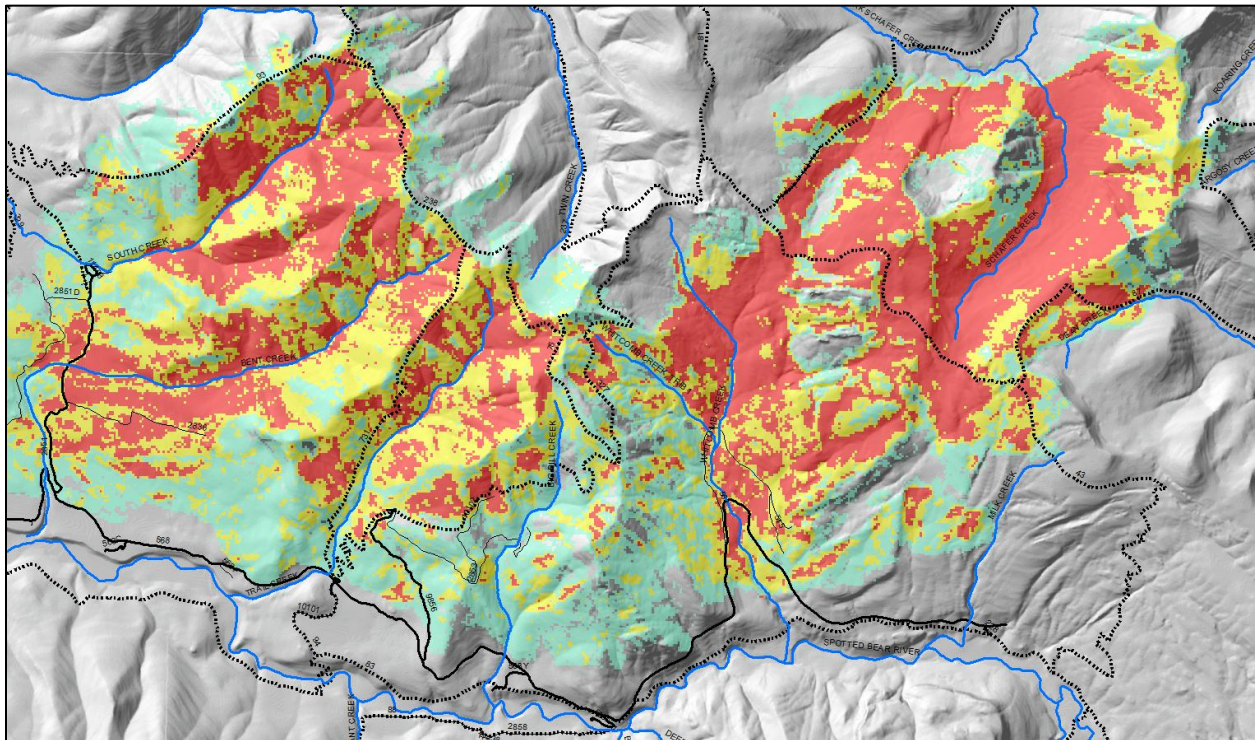
Figure 1. Trail Creek BARC map.

The initial BARC imagery over-estimated burn severity, which is common. Adjustments to the imagery were made, based on field observations of all three categories. The Forest Soil Scientist and Forest Hydrologist determined that areas classified as high severity are definitely on the low end of this category. Organic matter is still present over much of the areas classified as high severity. Soils were determined to be strongly water repellent, based on drip tests and infiltrometer data.
