USDA-FOREST SERVICE

FS-2500-8 (7/08)
Date of Report: 7/15/16

ERSKINE FIRE BURNED-AREA REPORT
(Reference FSH 2509.13)

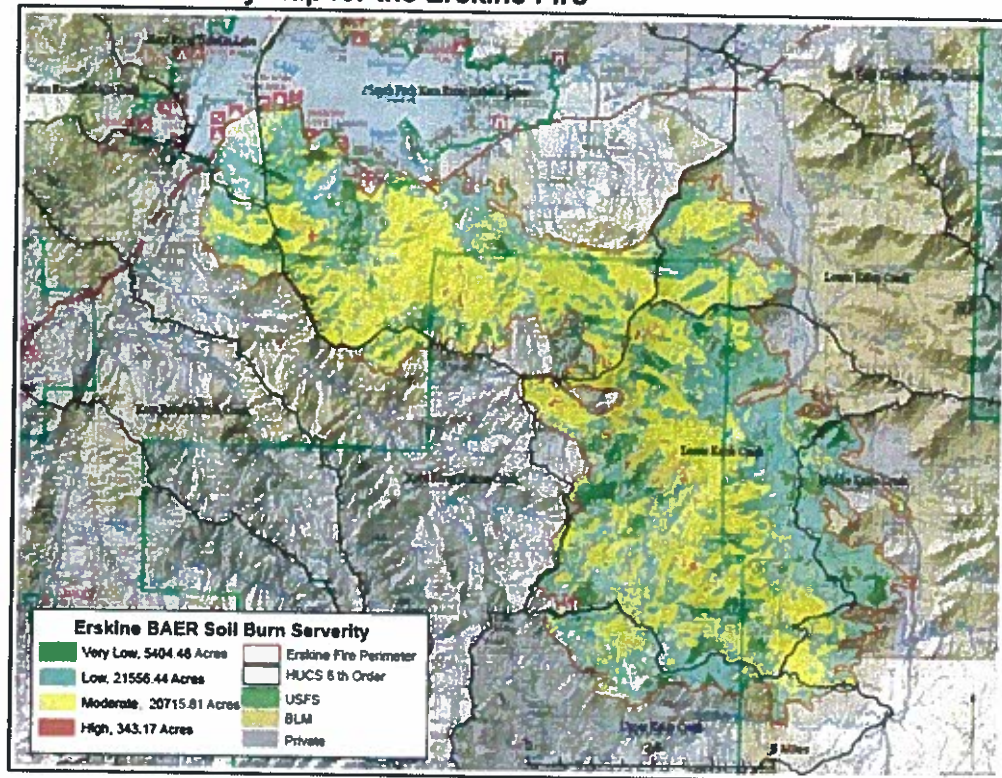
Figure 1 – Soil Burn Severity Map for the Erskine Fire

The following soil burn severity map (Figure 1) illustrates the general soil burn severity pattern on the landscape. The soil burn severity is overwhelmingly moderate (43%) and low (44.9%). In most of the moderate burn severity, and some of the low severity (particularly on south-facing slopes), there is very little vegetation or ground cover remaining except surface rock. There is only 1% high soil burn severity because of the low pre-fire ground cover, and partly because the fire was heavily wind-driven and had short residence times. Very low soil burn severity was 11% of the fire area.

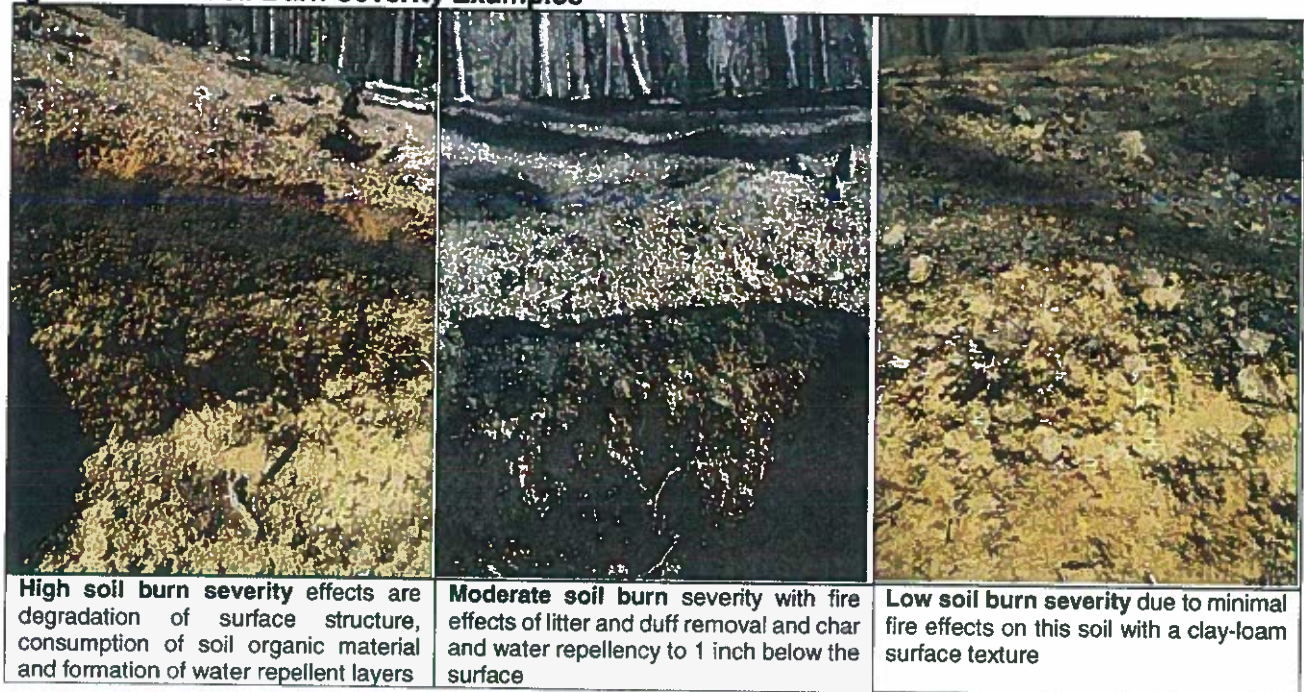
Figure 3 – Fire Soil Burn Severity Examples

The following pictures (Figures 3 & 4) are companion pictures to show typical soil burn severity and landscapes with mixed mortality due to differing vegetation types, slopes, aspect, and location.

Soil type also influenced soil burn severity patterns. Fire effects on soils such as degradation of structure, changes in soil color, consumption of fine roots and depth of water repellent layers were strongly influenced by soil surface texture. In soils with clay loam surface textures, fire effects on soil were commonly minimal and water repellency generally occurred at the surface. In soils with sandy loam and fine-gravelly loam surface textures, fire effects on soil were common to depths of up to an inch and water repellency was observed at depths of up to 8 inches.

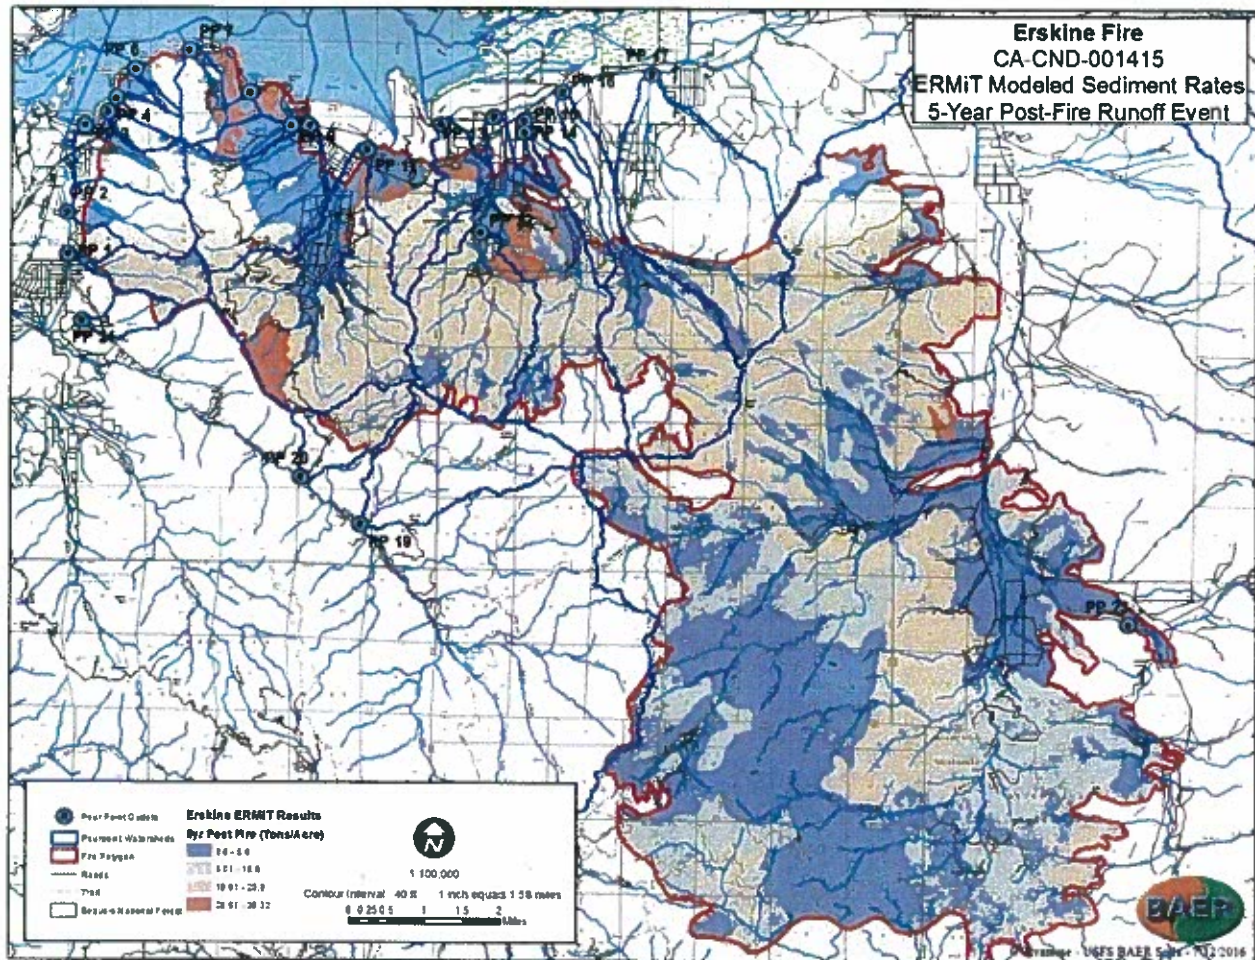
Figure 5 – Predicted 5-year ERMiT Erosion Rates for the Erskine Fire

Erosion Response: In some, but not all pour-point watersheds, significant erosion and sedimentation is expected. Most of the moderate burn severity, and even some of the low burn severity areas contain extremely low ground cover levels, which could contribute to high erosion levels. 57% of the fire area has either a high or very high erosion hazard rating (Table 3).

In pour-point watersheds, sedimentation rate increases range from 2.8 X to 62 X above background in a 2-year runoff event, and range from 14.9 X to over 200 X increase in a 10-year runoff event. Sediment increases are the most pronounced on the steep slopes to the west of Cook peak (Pour-points 1-6), and in the upper portions of Goat Ranch Canyon (Pour-point 16) and Lynch Canyon (Pour-point 11). However, fire-wide the erosion rates are much lower, averaging only 1.1 tons/acre in a 2-year runoff event, and 4.5 tons/acre in a 5 year runoff event (Figure 5).

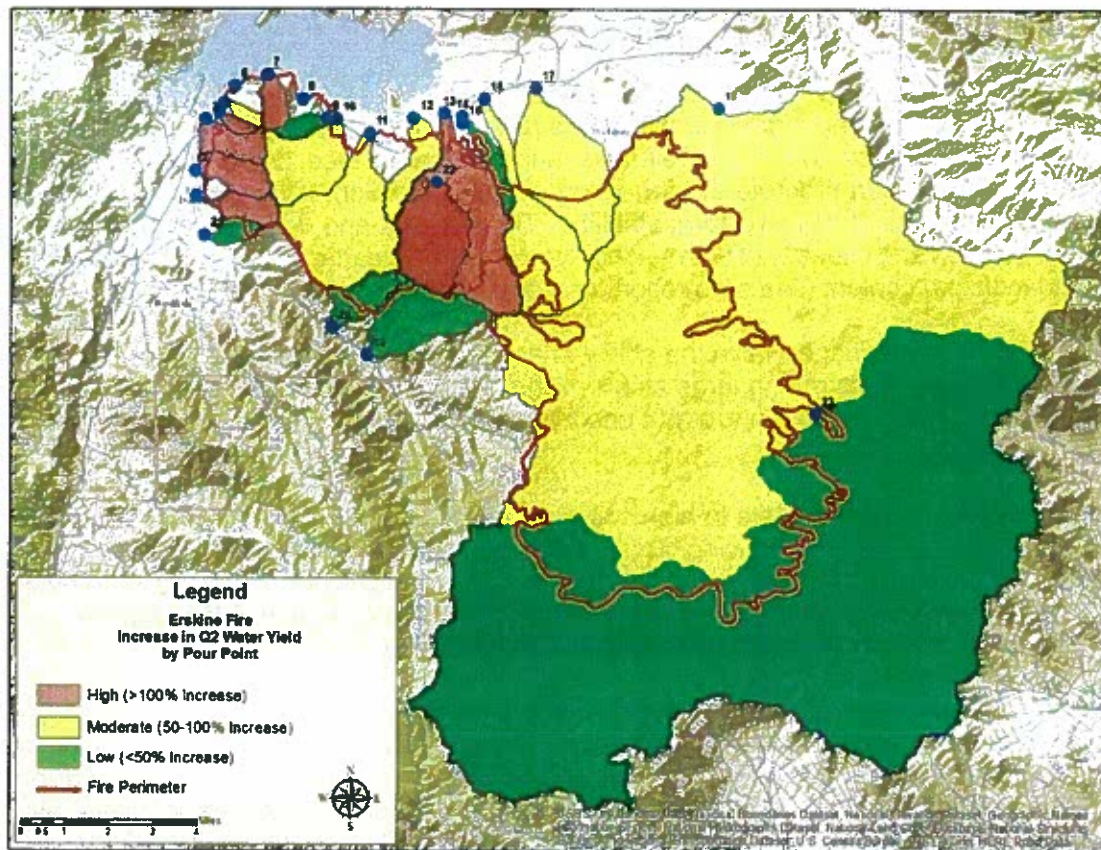
Figure 3a. Map showing the location of pour points used to model post fire runoff. Color coding denotes increase in runoff due to soil burn severity: Red (High) is greater than a 100% increase in runoff; Yellow (Moderate) is between 50-100% increased runoff; and Green (Low), which is less than 50% increased runoff.

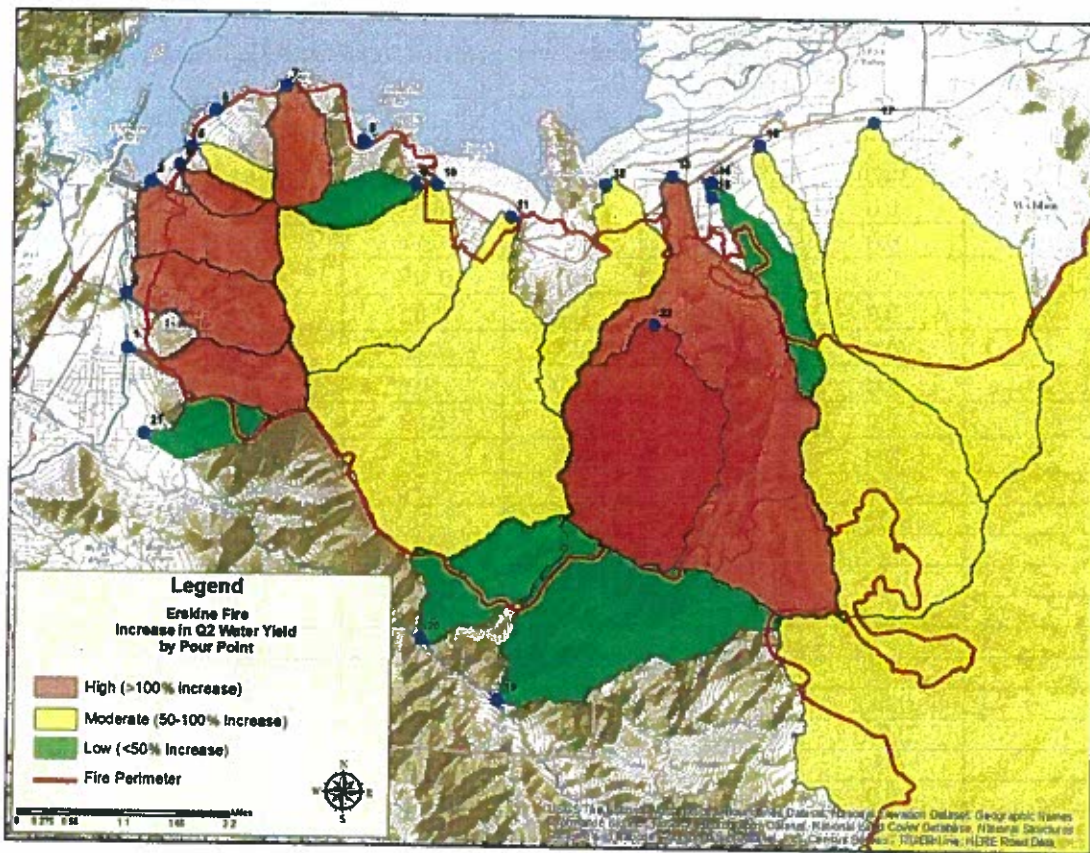
Figure 3b. Map showing the location of pour points in areas with the highest relative runoff. Color coding denotes increase in runoff due to soil burn severity: Red (High) is greater than a 100% increase in runoff; Yellow (Moderate) is between 50-100% increased runoff; and Green (Low), which is less than 50% increased runoff.

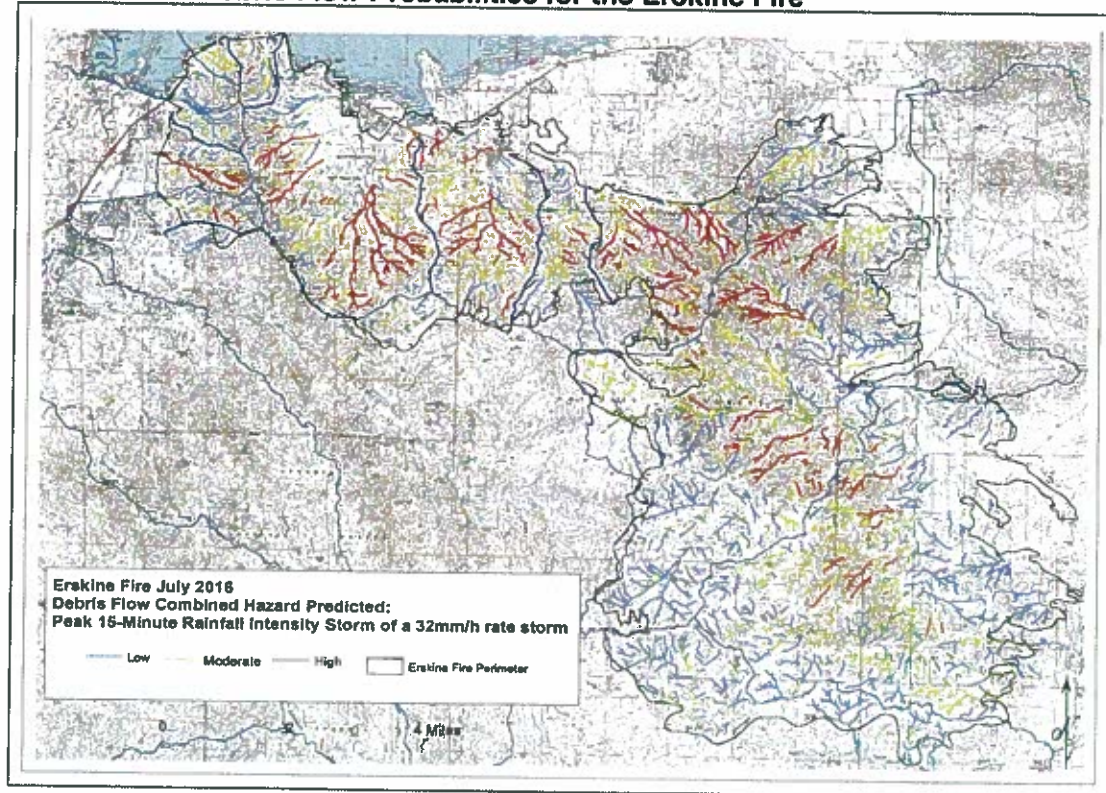
Figure 6 – Predicted Debris Flow Probabilities for the Erskine Fire

Based on USGS debris flow modeling, basins / creeks in the Erskine Fire burned area have a wide range of probability (0-100%) of producing debris flows. Similarly, predicted volumes of debris flows throughout the burned area range from 1k – 100k cubic meters. From analyzing the combined hazard maps, it is clear that even though high hazard debris flows drainages exists through-out the burned areas, the concern areas are focused on the creeks and drainages flowing down from the Cook Peak range, as well as other burned slopes and drainages located directly above existing communities and private residences. Beyond these high concern areas, other drainages that have a moderate-high probability of producing debris flows, are not expected to impact directly any Values At Risks (VAR's).

Treatments for debris flow and flooding hazards include notification of the public of these hazards through a warning system and installation of warning signs along roads in the burn area.
