Date of Report: 9/15/2021**BURNED-AREA REPORT****PART I - TYPE OF REQUEST****A. Type of Report**

PART II - BURNED-AREA DESCRIPTION**A. Fire Name: Chaparral****B. Fire Number: CA-CNF-002791****C. State: California****D. County: San Diego****E. Region: 5****F. Forest: Cleveland****G. District: Trabuco****H. Fire Incident Job Code: P5N87R21****I. Date Fire Started: 9/28/2021****J. Date Fire Contained: 9/9/2021****K. Suppression Cost: approx. \$4,500,000****L. Fire Suppression Damages Repaired with Suppression Funds (estimates):**

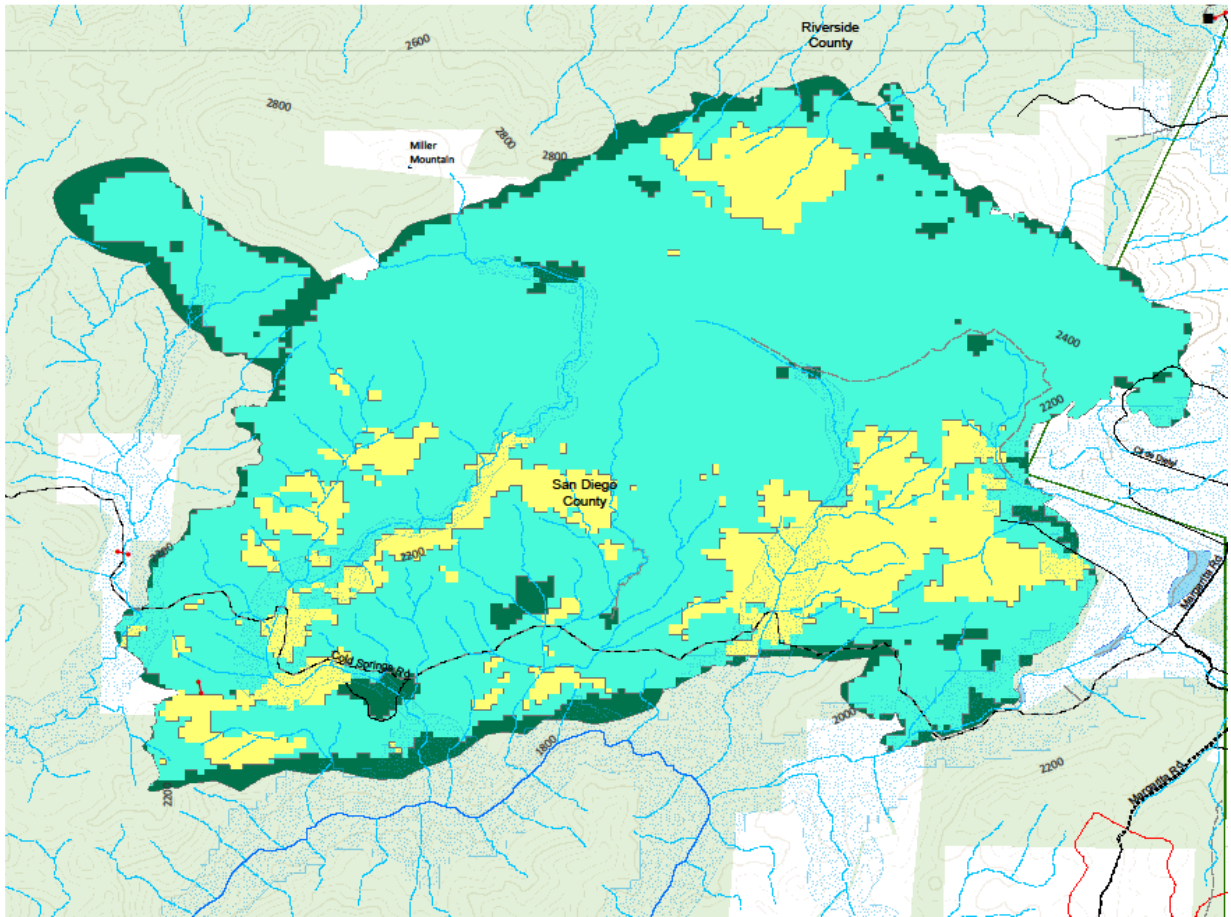
Figure 1 – Soil Burn Severity map

Dark Green - very low/unburned – 9%
Blue - low 74%
Yellow – moderate – 17%

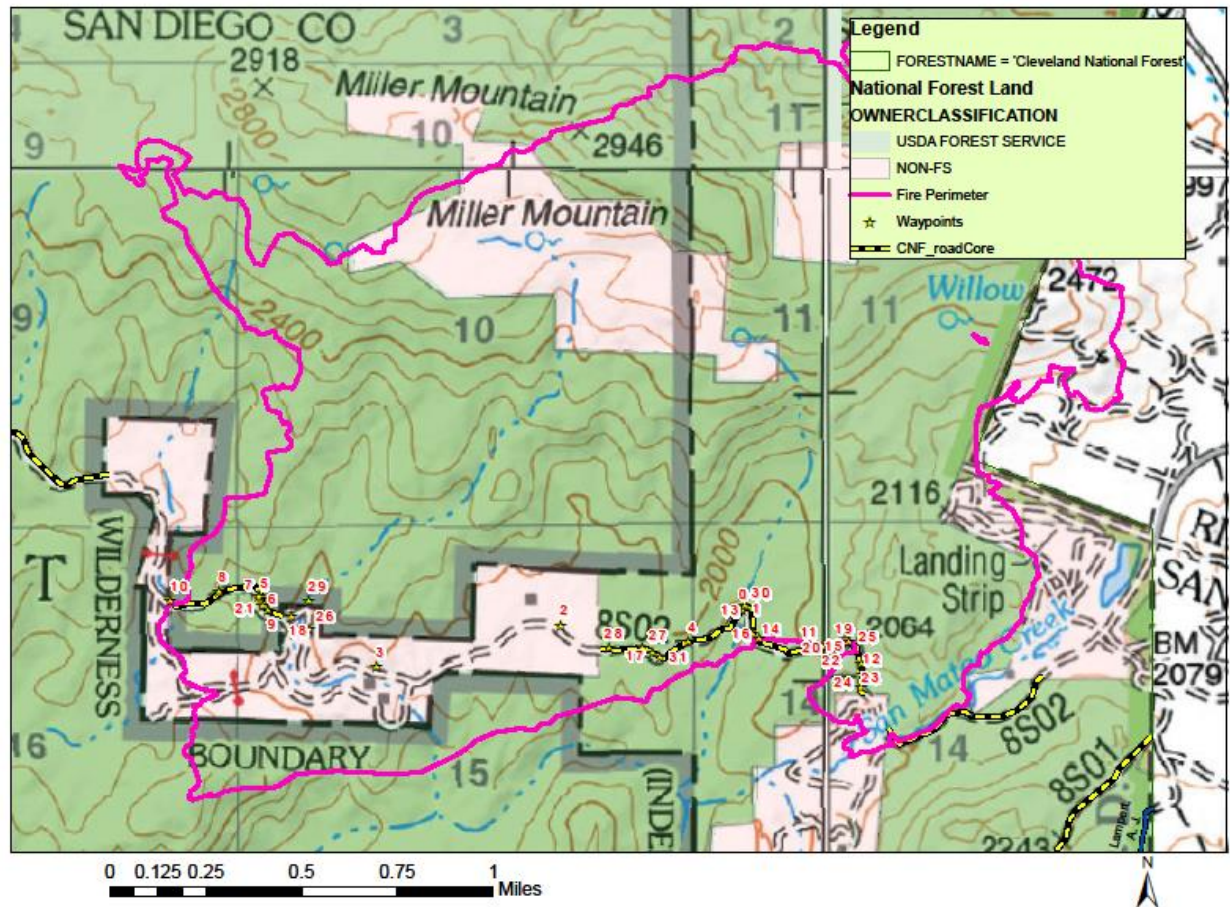
- a. The first crossing is on the Forest with 3 footer culvert and approx. 5 ft. fill. This crossing had under capacity slope stability issues. Probability of Damage or Loss is **Likely** and Magnitude of Consequences **Moderate**. Risk of this crossing is **High**.
- b. The second crossing is on the same channel with the first and is on private property. This crossing functions as a low water crossing. Probability of Damage or Loss is Possible and Magnitude of Consequences Minor. Risk of this crossing is Low.

Drainage features is properly designed and spaced for normal use under normal conditions. Some rolling dips need repair. First major crossing has downstream scour and evidence of fill stability issue.

Figure 2 – treatment map – road stabilization, storm patrols – treatments focus on major culvert only at 0/30 mark, other road features are noted for reference

- Stabilize fill for first large culvert to reduce risk of blowout by scouring from high flow events.
- Storm patrol and post-storm repairs to keep road in place.
- Coordination with local agencies
