LIME COMPLEX BURNED AREA REPORT
(Reference FSH 2509.13)

A. Fire Name: Lime Complex

B. Fire Number: CA-SHF-001041

Lime Complex Interagency BAER TEAM Hydrologist Report Shasta Trinity National Forest

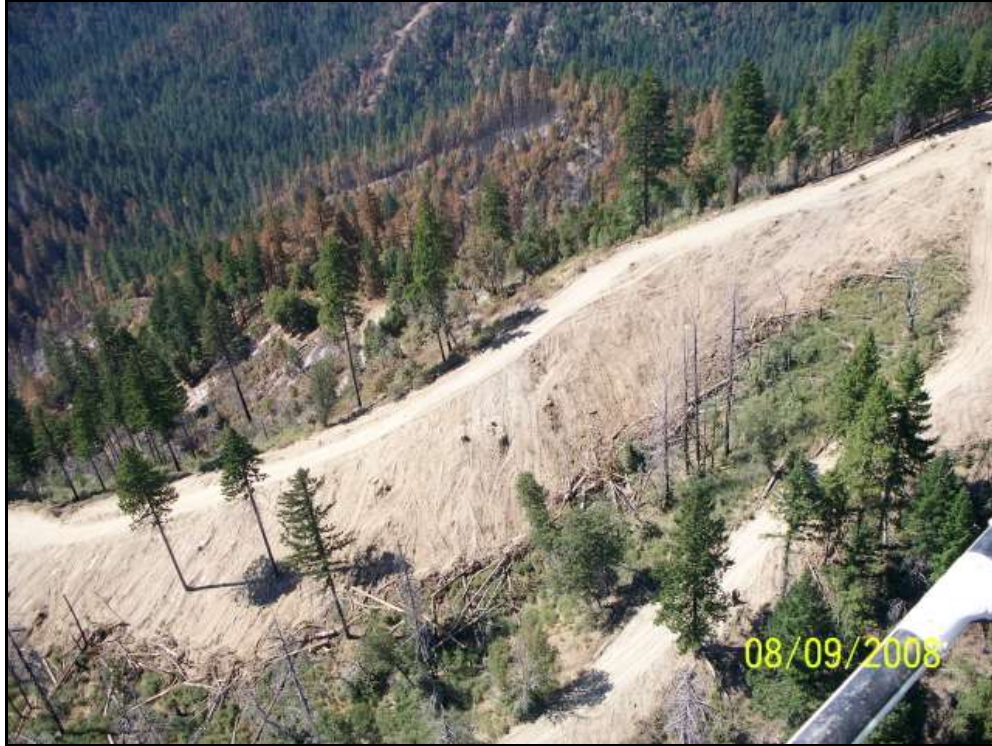
Fireline on Miners Fire portion of the Lime Complex

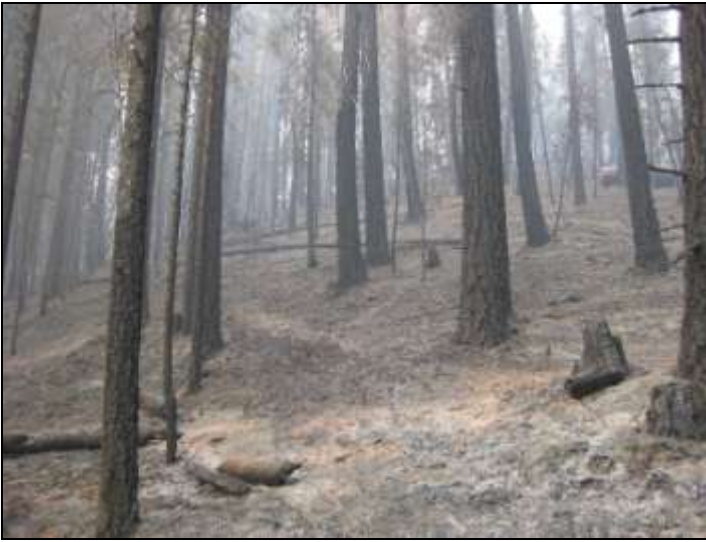
Approximately 21% burned at high and moderate soil burn severity (see soil burn severity map below). The rest of the fires were either low or very low soil burn severity. General trends are forested areas that were north or east-facing slopes were nice under-burns. Forested areas that were south or west-facing slopes burned hotter and had tree mortality of 20-40% with ridges burning hotter (see pictures below).

Telephone Fire under-burn

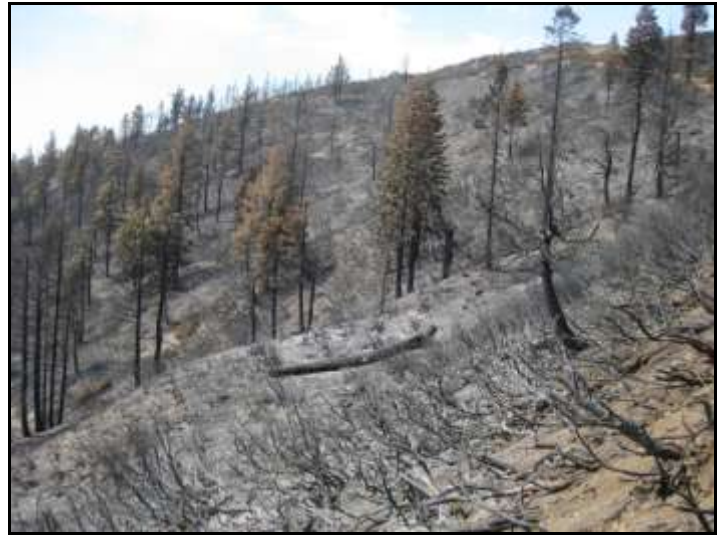
Miners Fire ridgeline

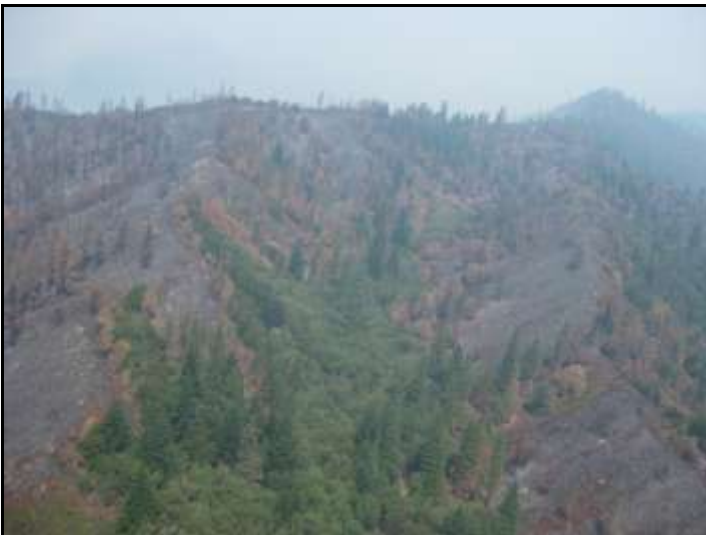
Chaparral areas that were north or east-facing slopes had moderate soil burn severity were patchy. Chaparral areas that were south and west-facing, burned moderately high to high soil burn severity removing almost all vegetation (see pics below).

Miners Fire mixed brush

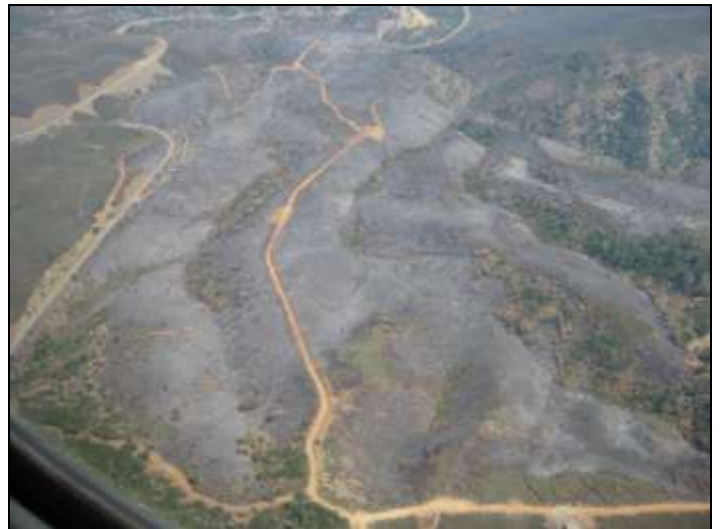
Noble Fire brush fields

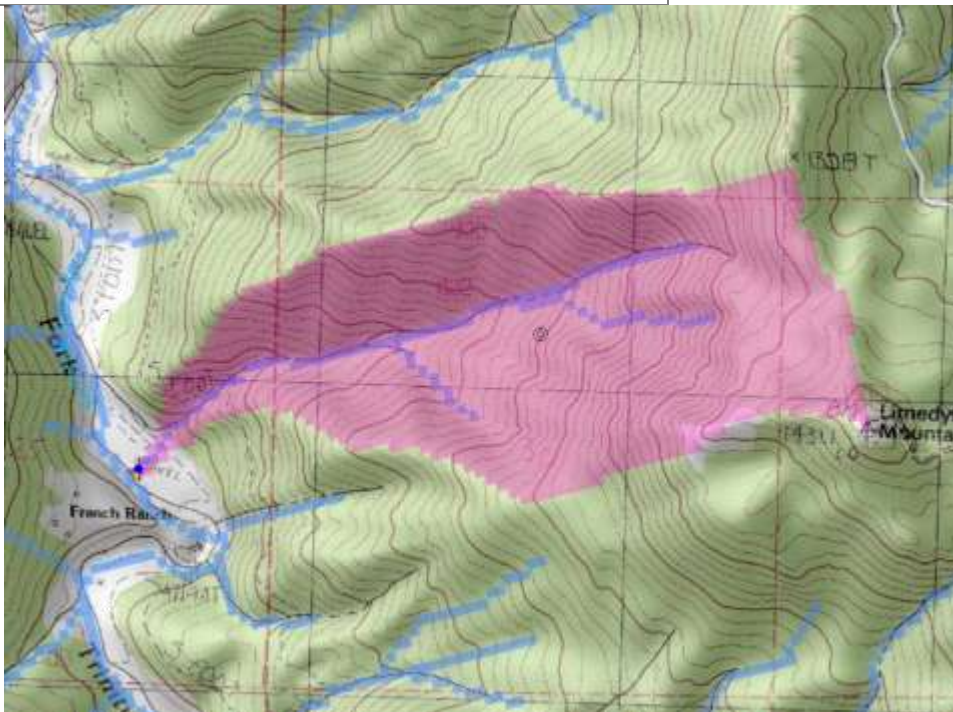
Limedyke Lookout Slide

- i) Limesdyke Lookout Slide – Increased sedimentation to the South Fork Trinity River, with recent activity in the last 2 years. Inner gorge and toe zones positions, if they super saturate could deposit 5 to 10 cubic tons of sediments into the river below.
- ii) Cold Camp Creek – Drains into Indian and then Butter Creek. Butter Creek is spawning grounds for Coho Salmon and MIS Spring Chinook. Transport of sediments to Lower South Fork due to burn severity in creek could also affect salmon spawning habitat. Higher flows are expected and head-cuts are likely if not treated.
