BURNED-AREA REPORT

(A) Fire Name: Taboose

(B) Fire Number: CA-INF-002108

(F) Forest: Inyo

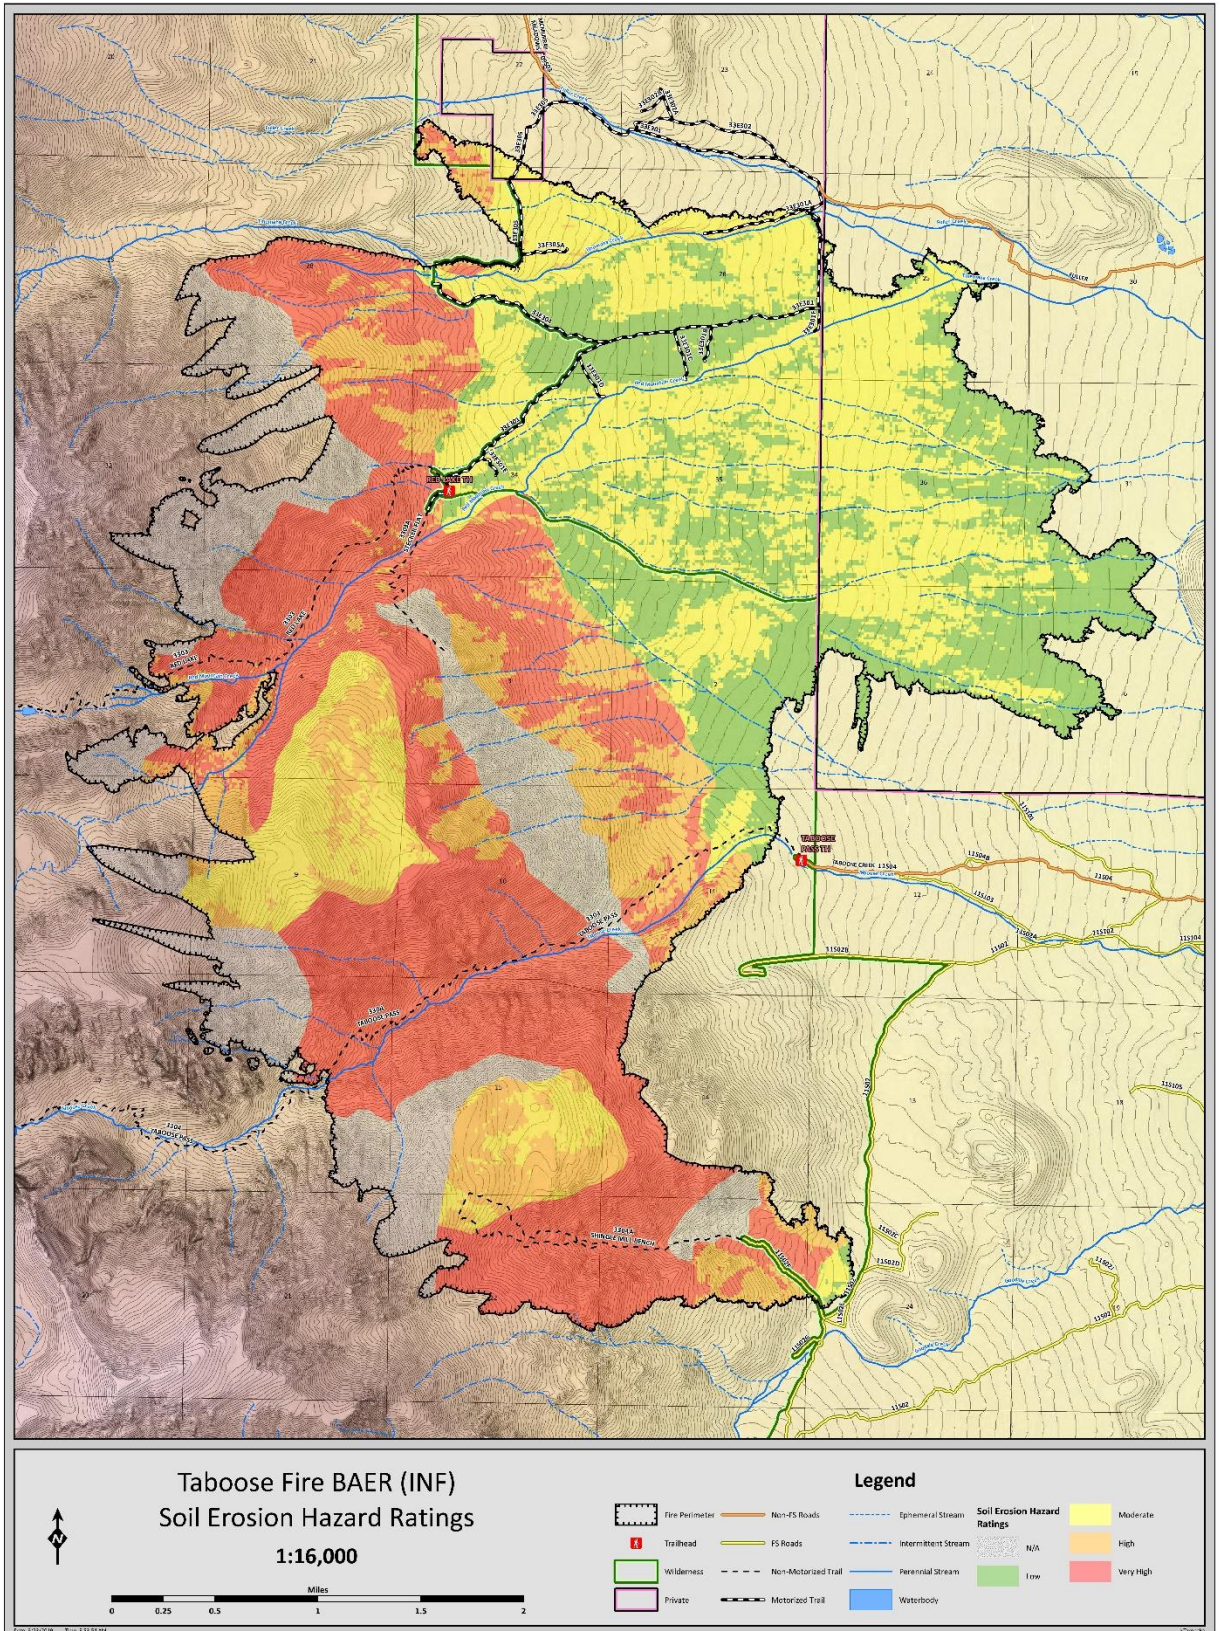
- a. *Sediment production*: the erosion hazard rating map (below) shows areas of high risk of sediment production. The BAER Team observed stored ash and sediments in the main and side channels as this area has not burned in recent history. In addition, the high winds experienced in this area blew ash and loose sediments into the channels, “super charging” them for the first runoff producing storm.
