Date of Report: 11/11/2007

BURNED-AREA REPORT

☒ 1. Initial Request. This is the first complete BAER Assessment associated with the 300,000 acre plus East Zone Complex Fires on the Payette NF. This BAER Assessment addresses threats to life and property along with specific recommendations for land, channel, road, trail, and protection and safety treatments.

- A. Fire Name: East Zone Complex
- B. Fire Number: ID-PAF-007071
- C. State: Idaho
- D. County: Valley and Idaho
- E. Region: R4
- F. Forest: Payette NF
- G. District: Krassel RD and McCall RD
- H. Fire Incident Job Code: P4DP22
- I. Date Fire Started: July 7, 2007
- J. Date Fire Contained: October 26, 2007
- K. Suppression Cost: \$20 million 8/26/07 - \$32 million 9/26/07
- L. Fire Suppression Damages Repaired with Suppression Funds
 - 1. Fireline waterbarred (miles): 4.5
 - 2. Fireline seeded (miles): 0
 - 3. Other (identify): Duff and organic litter pulled back onto fireline.

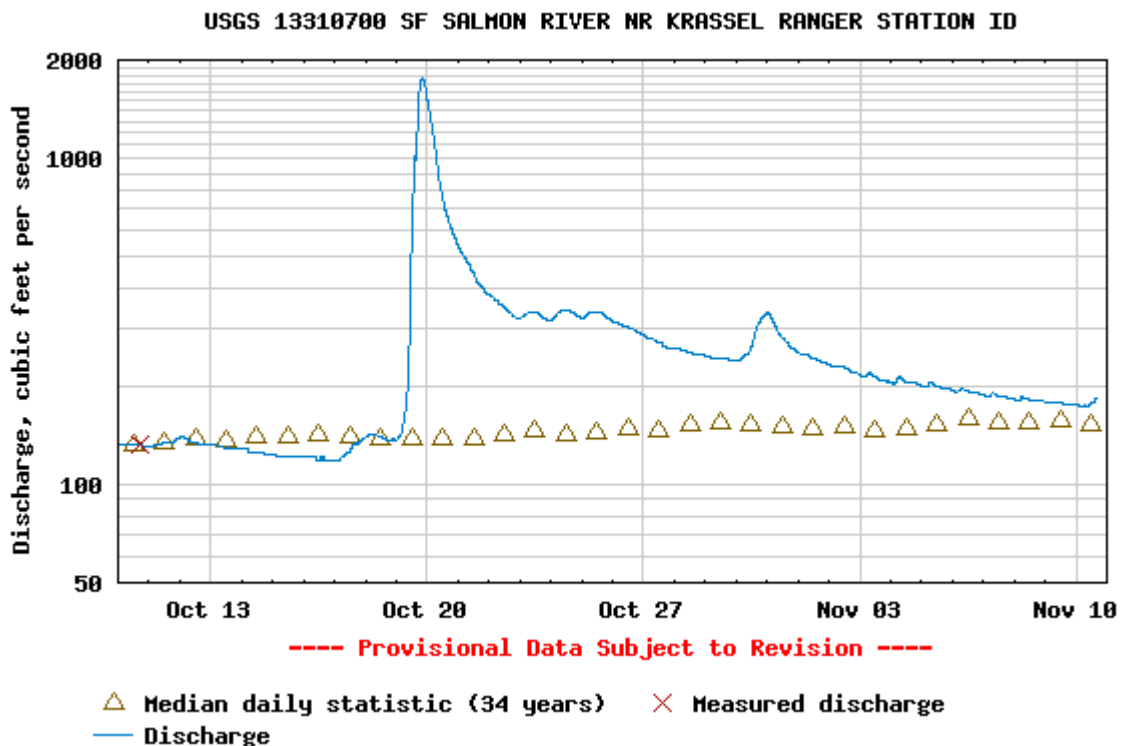
Example Of Post-Fire Increased Peak Flows Following 1-Day Rain Event On Oct. 19, 2007
