Subject: Final Burned Area Emergency Rehabilitation (BAER) Report  
Hondo Fire - Carson National Forest

BURNED-AREA REPORT  
(Reference FSH 2509.13, Report FS-2500-8)PART I - TYPE OF REQUEST

#### Hondo Fire - Storm Damage Assessment

## Assessment of Watershed Conditions - February 3, 1997

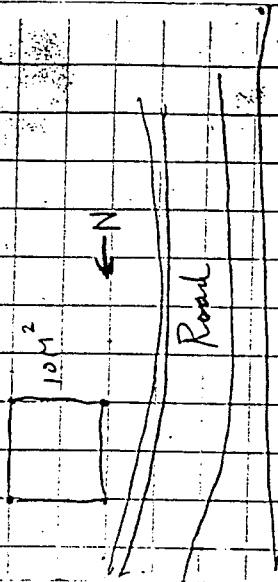
Established Ground Cover  
(grassland + forbs) at the  
Magnet. Pesticide Cellar
