BURNED-AREA REPORT
(Reference FSH 2509.13)**PART I - TYPE OF REQUEST****A. Type of Report**

PART II - BURNED-AREA DESCRIPTION**A. Fire Name: Kelley****B. Fire Number: ID-STF-000423****C. State: Idaho****D. County: Camas & Elmore****E. Region: 04 - Intermountain****F. Forest: 14-Sawtooth****G. District: Fairfield****H. Fire Incident Job Code: P4HXM6****I. Date Fire Started: August 24, 2013****J. Date Fire Contained: October 3, 2013****K. Suppression Cost: \$9,503,314****L. Fire Suppression Damages Repaired with Suppression Funds (NFS lands only)**

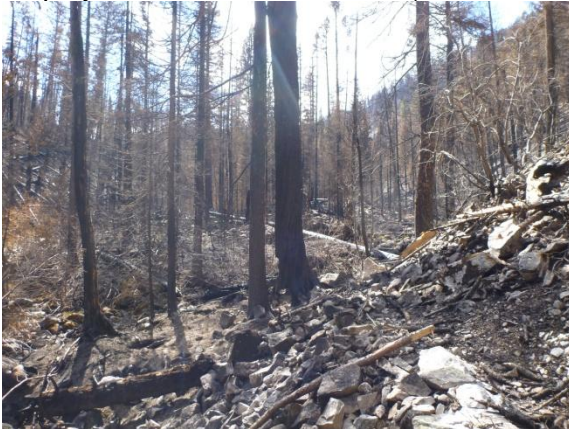
- a. **Very High Risk** to Forest Service employees and recreationists along the Gardner Gulch Trail, West Fork Beaver Creek Trail, East Fork Beaver Creek Trail, Deadwood Creek Trail, Iron Mountain Trail, West Fork Kelley Creek Trail, and Kelley Flats Learners Loop Trail. These trails are motorized use trails and are very popular with the motorized community. Increased threat of falling trees/snags, rocks and other debris within or downslope from hillslopes burned at moderate to high severity pose a serious threat to employees implementing BAER treatments as well as recreationists along 16.6 miles of trail within the burned area. Visible and concealed burned stump holes within the trail tread in low, moderate and high burn severity areas have compromised trail stability posing a very high risk to safety for both Forest employees and trail users. There is a high probability that increased potential for hillslope erosion and sediment in moderate and high burn severity areas, or in areas downslope of hillslopes burned at moderate to high severity could result in loss of egress thereby posing a serious threat to Forest employees and recreationists. (Treatments TR01, TR05, TR06, TR08)

Rock, debris and hazard trees across Deadwood Trail

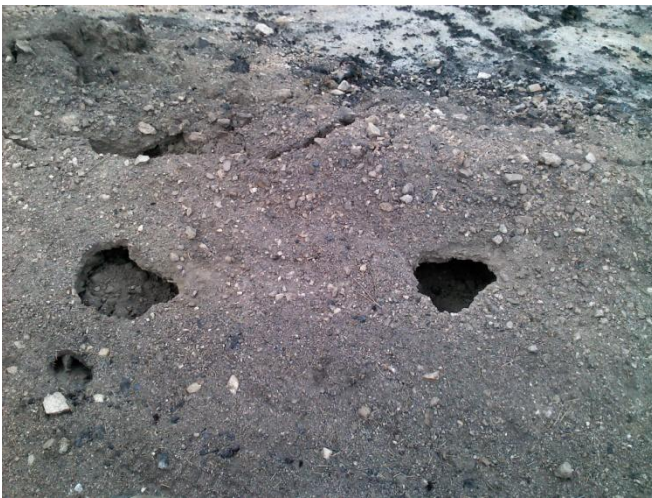
- c. **High Risk** to the Gardner Gulch, West Fork Beaver Creek, East Fork Beaver Creek, Deadwood Creek, Iron Mountain, West Fork Kelley Creek, and Kelley Flats Learners Loop Trails infrastructure due to increased threat for loss of trail tread from rolling rocks, logs and other debris, and hillslope erosion and sediment. There are 25.8 miles of trail located within the burned area perimeter and approximately 16.6 miles of trail located within or downslope from hillslopes burned at low to high severity are at risk. Of particular concern, are areas where tree stumps burned directly adjacent to or under the existing trail, making these areas more susceptible to capture of flows coming off hillslopes, resulting in significant erosion and loss of trail tread. (Treatments TR01, TR05, TR06)

Holes in West Kelley Creek trail tread from burned out stump directly adjacent to the trail.

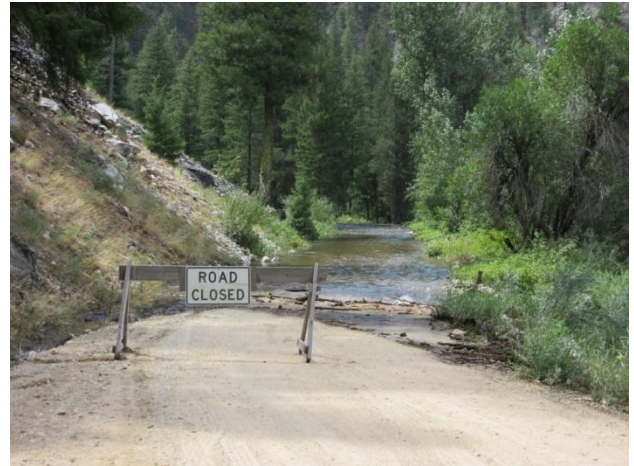
River diverted on to Road 227

While work on the Forest maintained road segment successfully protected the road, significant storm events over the burned area in August resulted in two very large debris flows that completely dammed the S. Fk. Boise River, diverting the river on to the County owned portion of Road 227. A segment of road was completely lost as a result of the upper most debris flow requiring significant reconstruction before access on this road could be restored. Further field review has determined that lower debris flow represents a significant risk for loss of the segment of road adjacent to that debris flow during spring runoff events. Given limited funding from both the Forest and County sources, the Forest is working to take preventative measures in an attempt to reduce the risk to this primary access route. However, it is recognized that these measures will most likely not provide a long term solution for the risk to the road at either debris flow location.

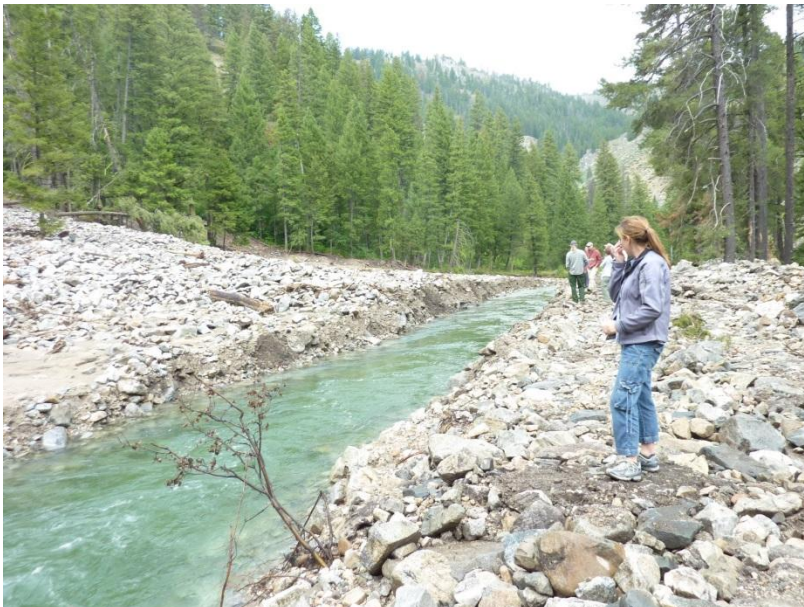
Emergency trench dug to move the river off the road and back to the river channel
