USDA-FOREST SERVICE

RIVER COMPLEX FIRE BURNED-AREA REPORT
(Reference FSH 2509.13)

PART II - BURNED-AREA DESCRIPTIONA. Fire Name: River Complex FireB. Fire Number: CA-SHF-002066C. State: CAD. County: TrinityE. Region: 5F. Forest: Shasta-TrinityG. Districts: Trinity River Management UnitH. Fire Incident Job Code: P5J0HRI. Date Fire Started: July 31, 2015J. Date Fire Contained: September ??, 2015K. Suppression Cost: \$30?? million

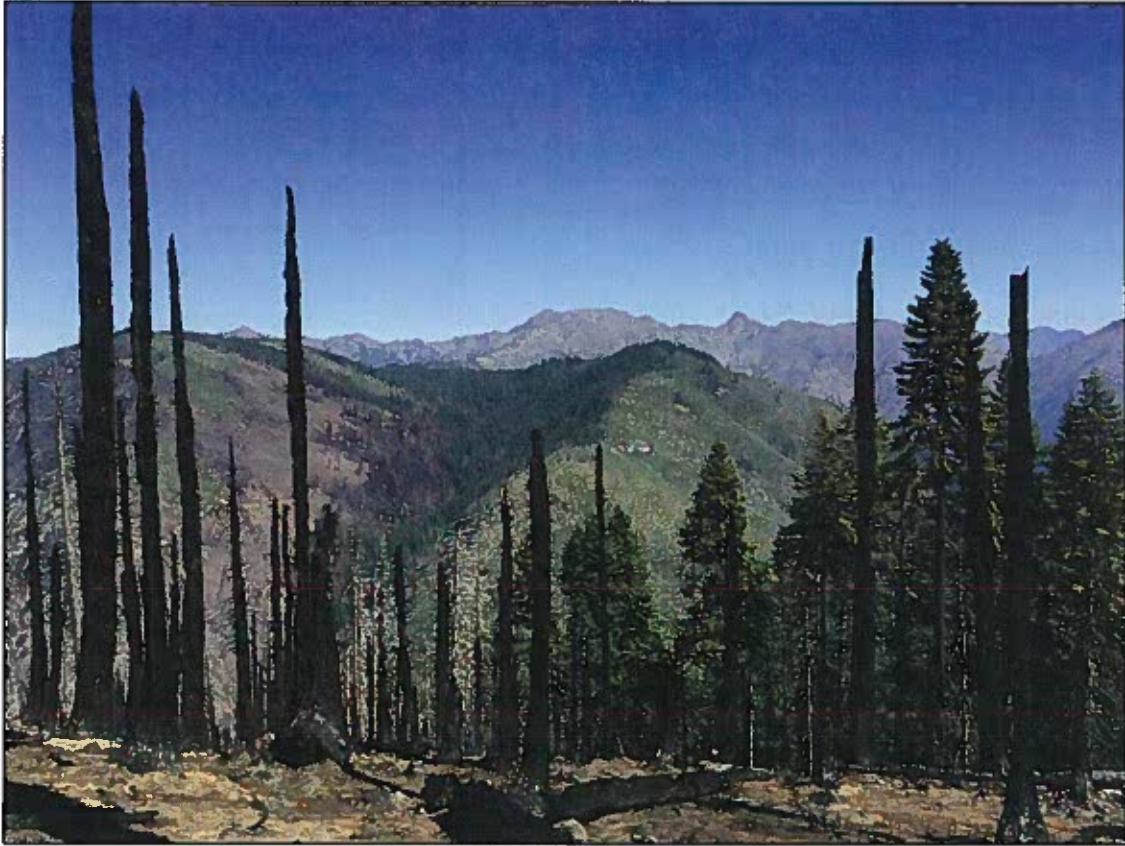
The River Complex Fire of 2015 looking at Thurston Peaks within the Trinity Alps.

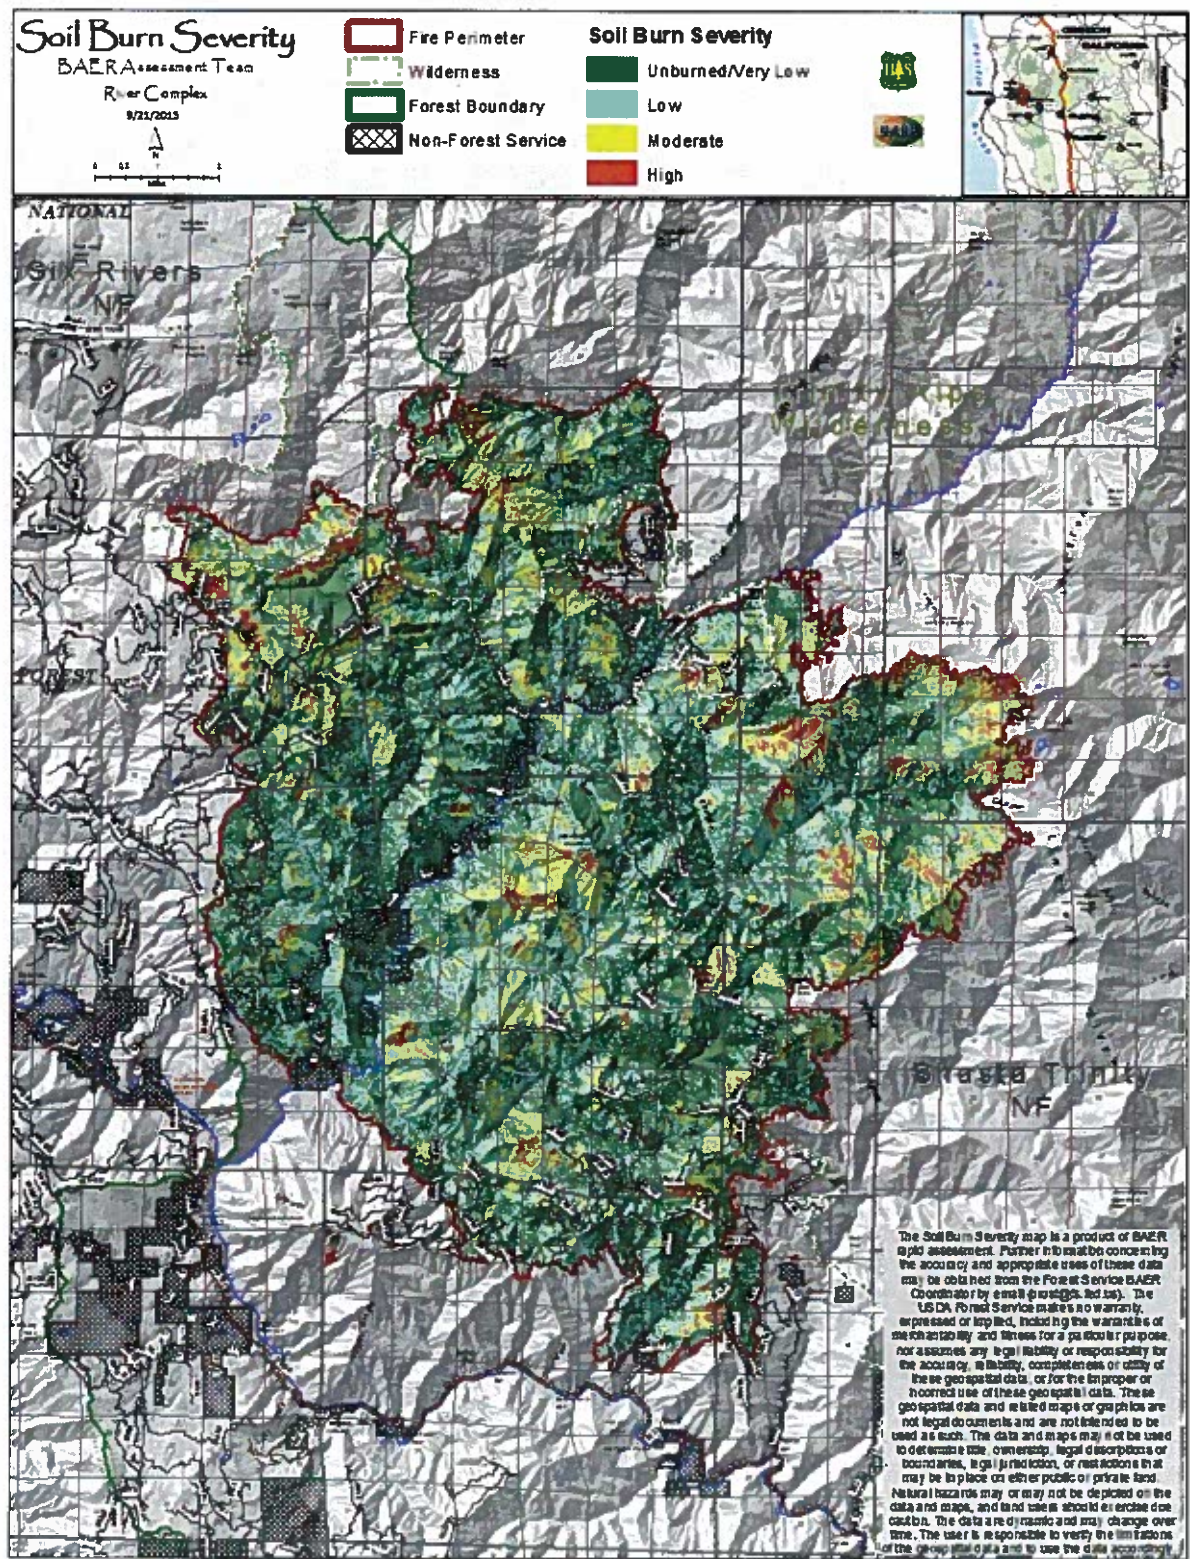
Figure 1 – Soil Burn Severity Map for the River Complex

The following soil burn severity map (Figure 1) illustrates the general soil burn severity pattern on the landscape.

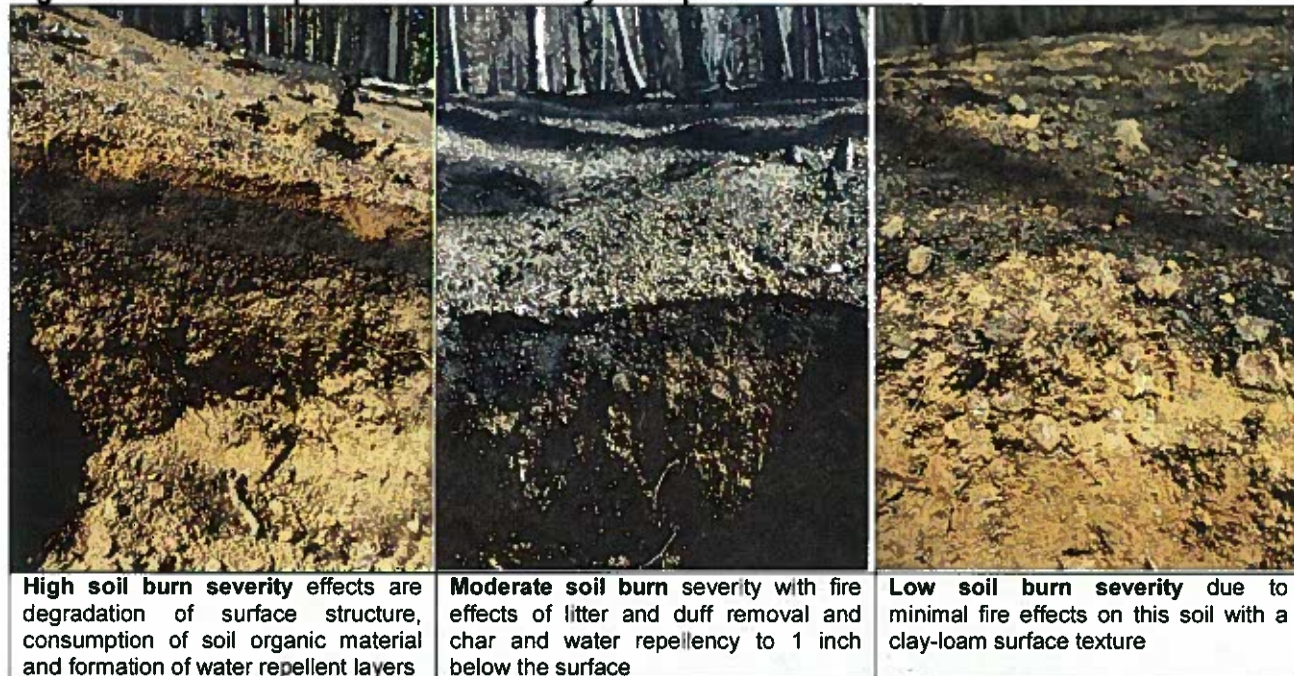
Figure 3 – River Complex Soil Burn Severity Examples

The following pictures (Figures 3 & 4) are companion pictures to show the landscape with mixed mortality due to differing vegetation types, slopes, aspect, and location.

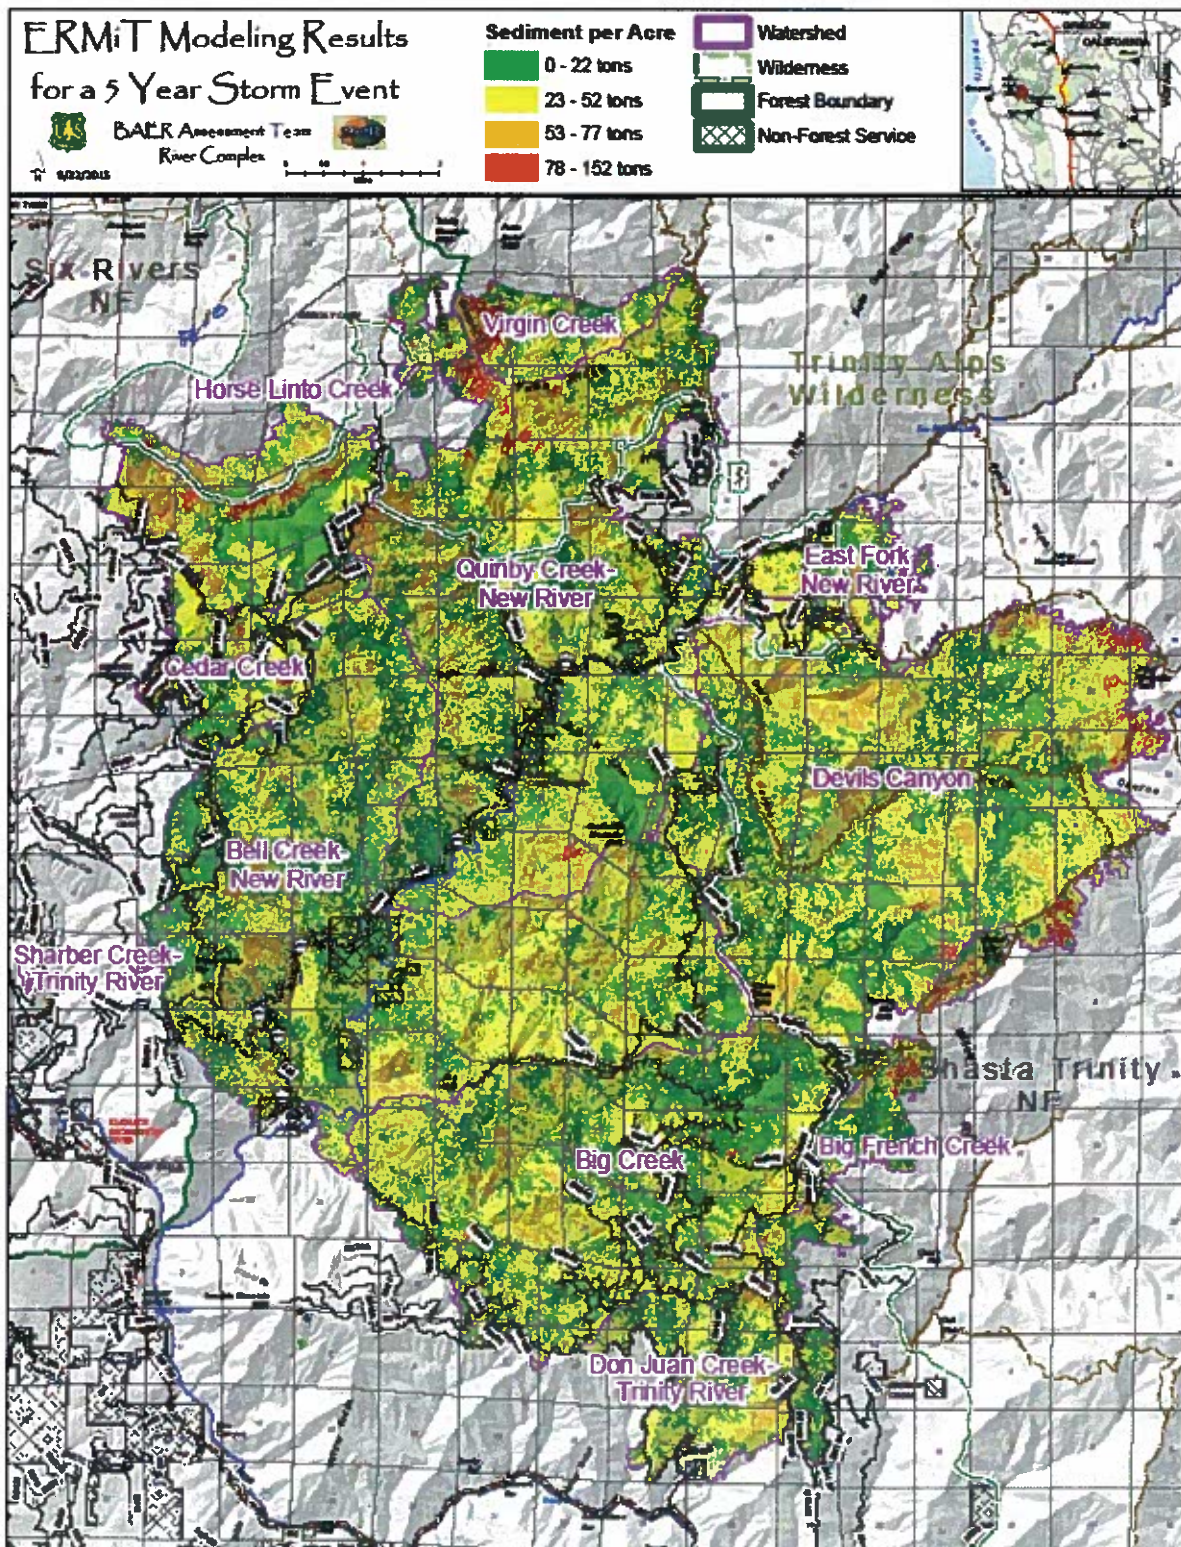
Figure 5 – Predicted ERMiT Erosion Rates for the River Complex

These watersheds were modeled to determine the amount of erosion to a particular value at risk (culvert, bridge, stream, etc.) each with its own watershed size. The following table displays predicted sediment rates for each of the main watersheds within the River Complex; Bell, Quinby, and Devils Canyon are expected to receive the highest quantities of sediment, mostly due to the large amount acres burned within those basins.

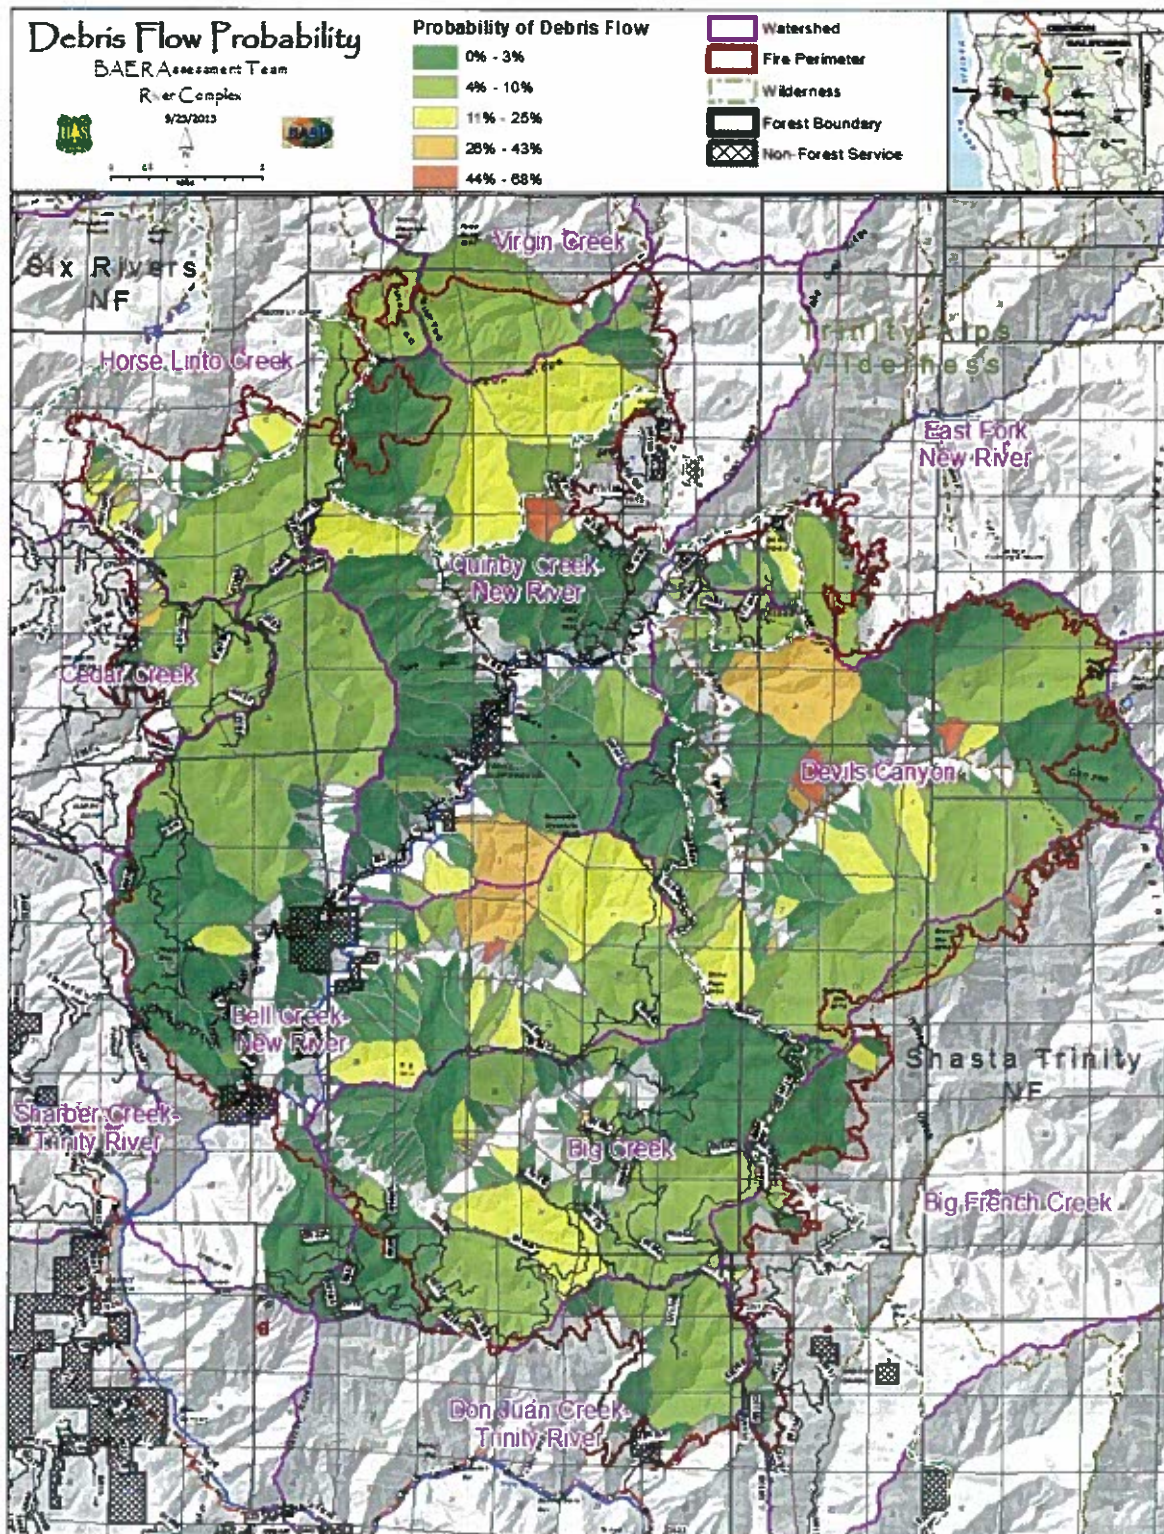
Figure 6 – Predicted Debris Flow Probabilities for the River Complex

It should be noted that the USGS debris flow model is designed to address relatively short duration, high intensity storms, and no longer duration winter storms. Additionally, it is not yet calibrated for the Klamath Mountains. As such, it should be viewed as an indicator of debris flow potential, rather than as an absolute predictor.

Rock fall has already occurred along the road system, particularly on Roads 7N26 and 402, and will continue to occur at an elevated rate at least through the first winter. The probability of damage or loss to people or vehicles traveling the roads from rock fall is estimated to be "possible", and the magnitude of consequences would be "major", and this translates to a risk of "high". Debris flows and landslides are less likely to occur than rock fall, and the potential for damage or loss is "possible", and the magnitude of consequences would be major, yielding a risk rating of "high".

Treatments for debris flow and rock fall hazards include notification of the public of these hazards through warning signs and road closures, notification of other agencies clearing and improvement of catch basins and ditches along roads, maintenance and up-grade of drainage structures, and construction of rolling dips in critical locations along roads.

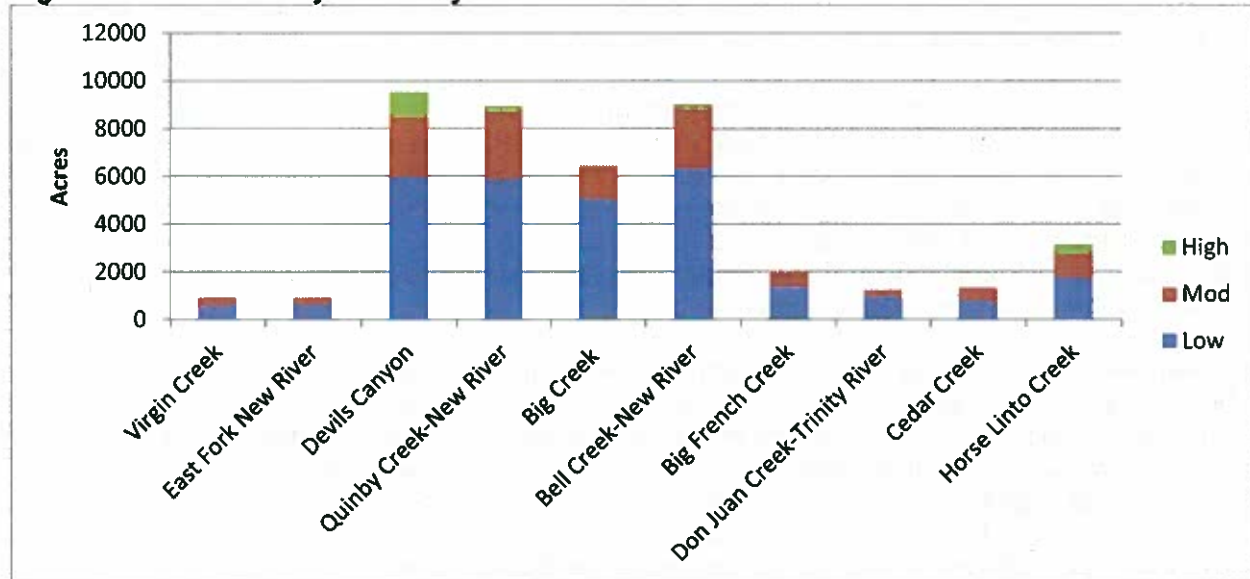
Figure 6 - Burn Severity Summary for HUC 6 Watersheds

HUC 6 and Pour Point Basin Fire Severity Summary: The Devils Canyon, Quinby Creek-New River, Big Creek and Bell Creek-New River watersheds had over 75% of their total area burned in the River Complex Fire (Figure 6). The Devils Canyon Creek Watershed experienced the greatest fire activity (93% of watershed area burned). Devils Canyon Creek Watershed also had the most acres burned at high and moderate severities (6% and 14%, respectively). It is noteworthy that high severity fire was not clustered in any single HUC 6 watershed and was scarce over the rest of the fire area. The Horse Linto Creek Watershed had the second greatest area of high severity acres at 2% and the Quinby Creek-New River, Big Creek, and Bell Creek-New River each had approximately 1% of their watershed areas burned at a high severity. In this overall context only Devils Canyon Creek clearly stands out as being the most affected by high severity fire.

While the HUC 6 numbers suggest limited impacts at the HUC 6 watershed scale, smaller watershed areas that have proportionately more area burned at high and moderate severities may experience locally greater impacts associated with fall and winter runoff events. For example the East Fork Horse Linto Creek drainage had 9% of its area affected by high severity fire. Similarly the Swede Creek drainage above the 05N04 Road had 8% of its area burned at high severity.

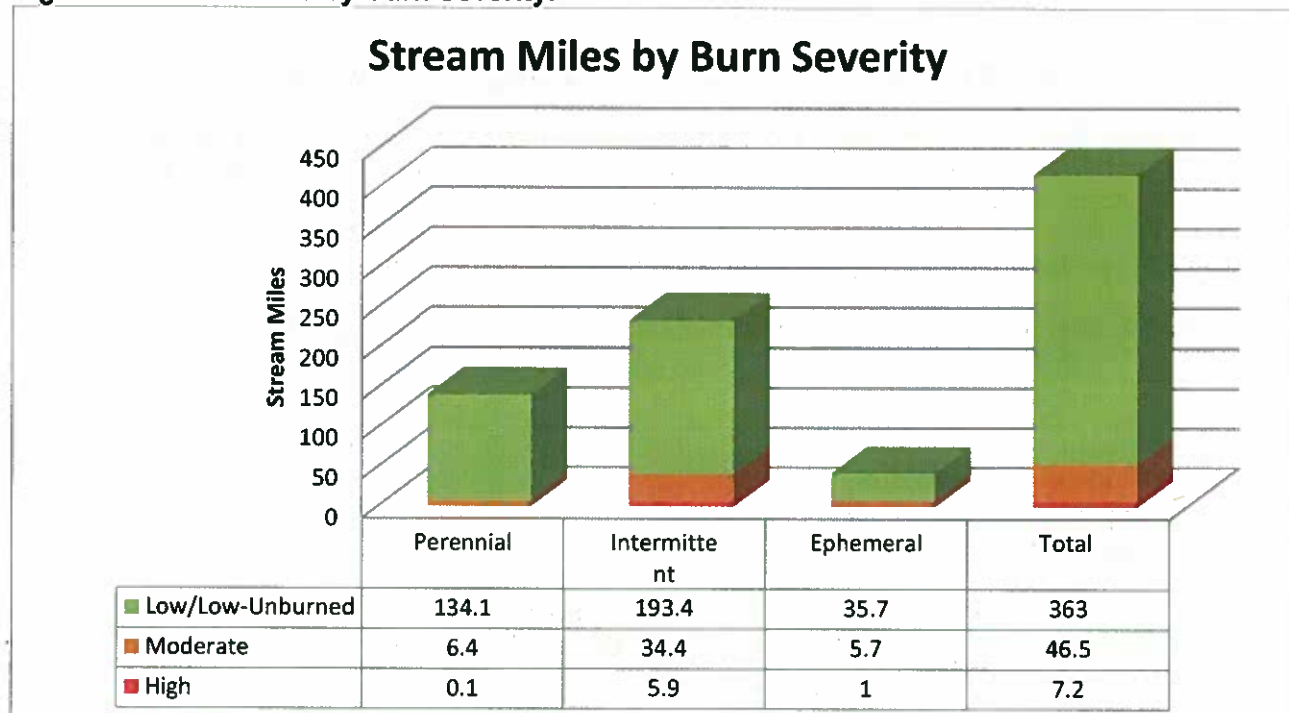
Figure 7: Stream Miles by Burn Severity.

The River Complex burned a total of 417 miles of perennial, intermittent and ephemeral streams in 10 HUC 6 watersheds. There are about 141 miles of perennial streams, 234 miles of intermittent streams and 42 miles of ephemeral streams within the fire perimeter. Figure shows the miles of channel located within each burn severity type. Many of these channels have burned previously in the numerous fires that have occurred over the past 16 years. Field reviews suggest that stream channels that were located in previous burn areas did not burn as hot as those that located in areas that had not burned within the past 30 years (though this was not always the case – e.g. East Fork Horse Linto Creek).

Based on burn severity mapping the River Complex has had similar effects to the previous fires. High and moderate severity burn areas have mostly occurred in headwater drainages burning though ephemeral and dry intermittent draws. Field observations by BAER personnel indicate that perennial channels in the River Complex generally experienced low severity burns that affected understory vegetation but left most overstory vegetation intact. The field observations agree with a GIS analysis that looked at channel types and burn severity within the River Complex. The analysis indicates that the vast majority of the stream miles that were affected by the burn were located within low to low-unburned severity areas and less and only 6.4 and 0.1 miles of channel were burned at moderate or high severities, respectively.
