Hayden Pass Fire July 2016

Date of Report: August 1, 2016

BURNED-AREA REPORT
(Reference FSH 2509.13)**PART I - TYPE OF REQUEST****A. Type of Report**

PART II - BURNED-AREA DESCRIPTION**A. Fire Name:** Hayden Pass**B. Fire Number:** CO-PSF-001022**C. State:** CO**D. County:** Fremont/Custer**E. Region:** 02**F. Forest:** PSICC**G. District:** Salida/San Carlos**H. Fire Incident Job Code:** P2KE7R16-0212**I. Date Fire Started:** July 8, 2016**J. Date Fire Contained:** N/A**K. Suppression Cost:** Est. \$9.5 million as of 07/30/2016). Suppression costs likely to extend to Fall, 2016.**L. Fire Suppression Damages Repaired with Suppression Funds**

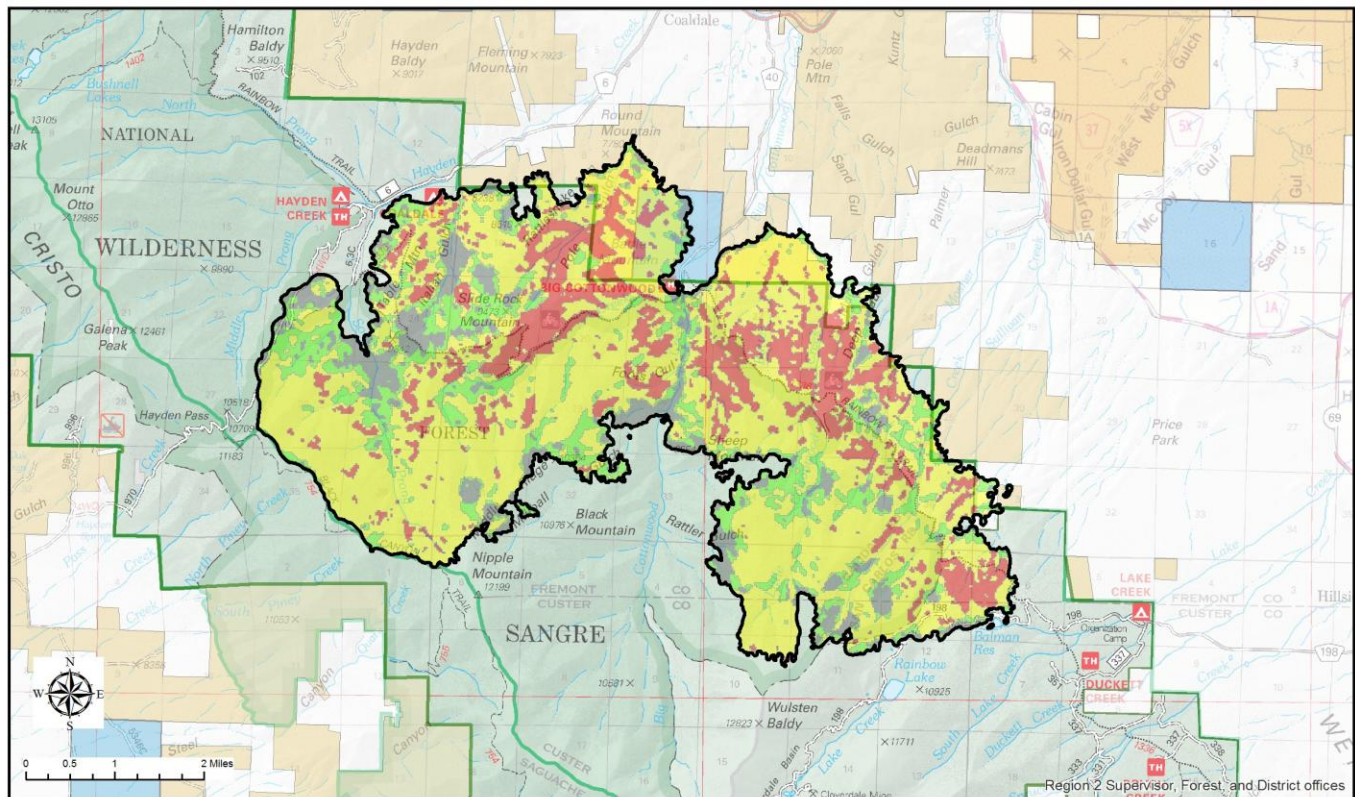
Figure 1: Soil Burn Severity Map.

Severity	Acres Burned	Percent
High	2974	18%
Moderate	9240	56%
Low	2613	16%
Unburned	1693	10%

As of July 20, 2016 the Hayden Pass Fire had burned approximately 16,520 acres and full containment is not expected until October. The soil burn severity (SBS) map shows approximately 74% burned at high and moderate soil burn severity. The rest of the fire was either low soil burn severity or unburned. Large contiguous areas of high and moderate soil burn severity occur throughout the burned area. Increased post fire soil erosion, runoff and debris flows within and downstream from these areas is likely to cause flooding, scouring and/or deposition of materials.

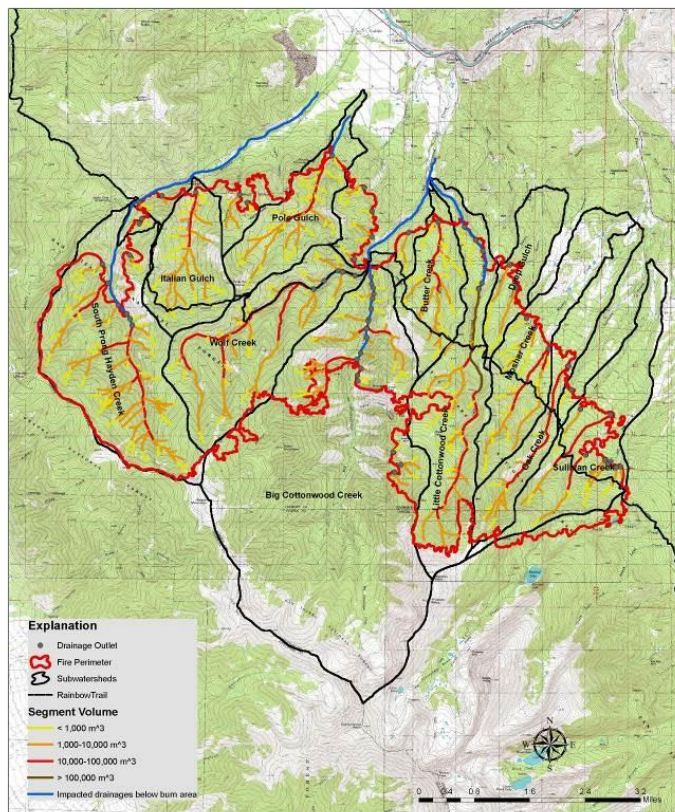
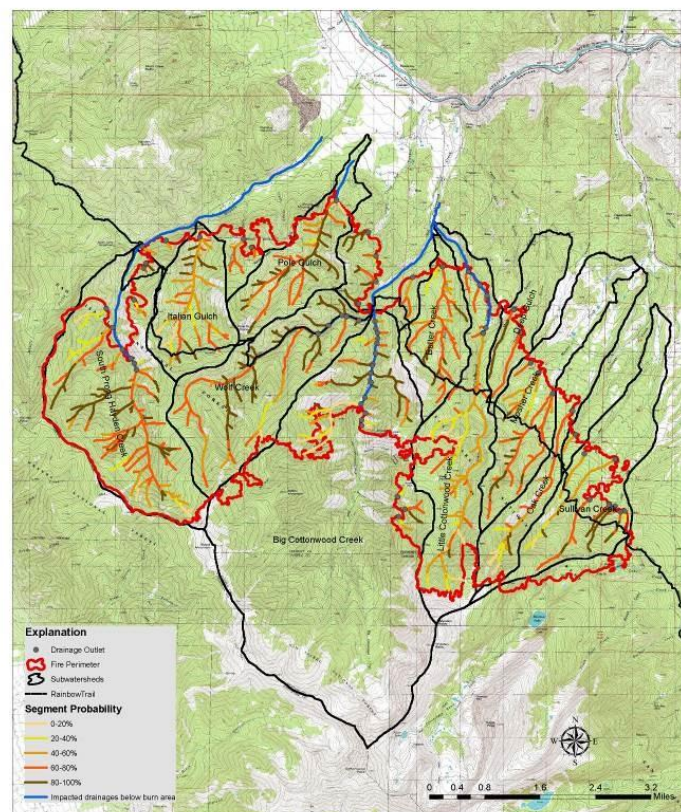
**Preliminary Hazard Assessment (USGS)
BURNED AREA EMERGENCY RESPONSE (BAER)**

Throughout the burned area, the combined hazard ratings for debris-flow in first order tributaries to the main stem stream channels are moderate to high. At the fire perimeter exiting the burned area, the hazard ratings are high for all main stem channels, except the Italian Gulch and Deep Gulch channels which have moderate hazard ratings. At the burned area perimeter, volumes are predicted to be >100,000m³ for Little Cottonwood Creek. Volumes in the range of 10,000 to 100,000m³ are predicted for Oak Creek, Mosher Creek, Sullivan Creek, Butter Creek, Big Cottonwood Creek, Wolf Creek, Pole Gulch, Italian Gulch and South Prong Hayden Creek.

Volume of debris flow by stream channel (m^3), Likelihood of debris flow by stream channel (%). Preliminary debris flow hazard for a design storm with a 15 minute rainfall intensity of 24 millimeters per hour (mm/h).
