Date of Report: 25 AUG 2020**HOG FIRE BURNED-AREA REPORT**

PART II - BURNED-AREA DESCRIPTION**A. Fire Name: Hog Fire****B. Fire Number: CA-LMU-003874****C. State: California****D. County: Lassen****E. Region: 5****F. Forest: Lassen****G. District: Eagle RD****H. Fire Incident Job Code: PNM93Y20 (1502)****I. Date Fire Started: 7/18/2020****J. Date Fire Contained: 8/17/2020**

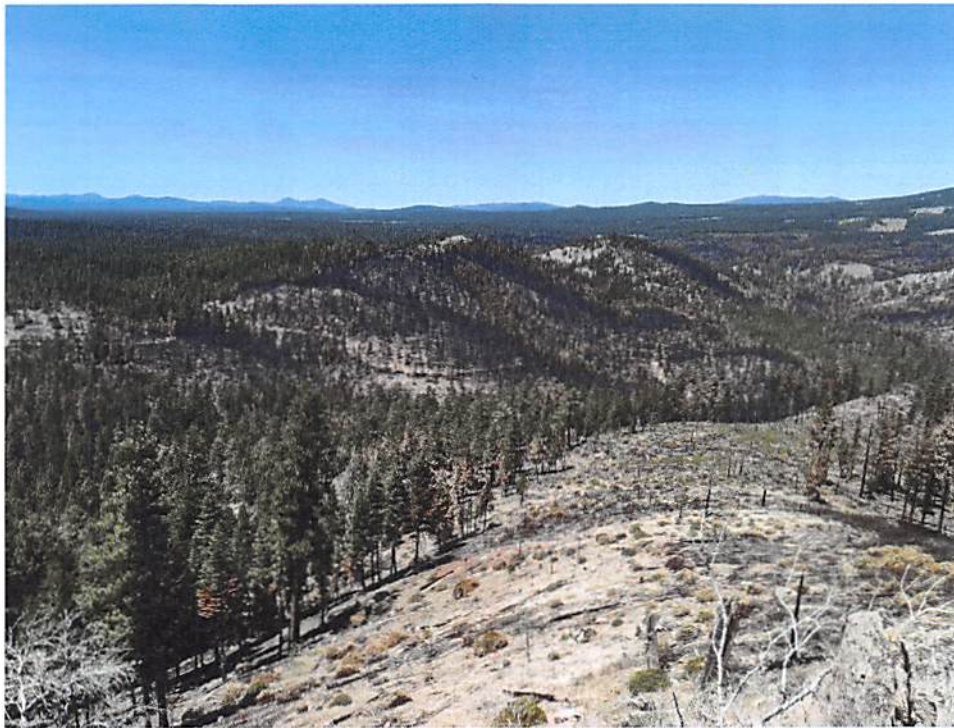
*Figure 1**View from Little Fredonyer**Photo: Jesse Merrifield***PART I - TYPE OF REQUEST****A. Type of Report**
