Date of Report: June 19, 2013

BURNED-AREA REPORT
(Reference FSH 2509.13)

PART II - BURNED-AREA DESCRIPTION**A. Fire Name:** Powerhouse Fire**B. Fire Number:** CA-ANF-002297**C. State:** CA**D. County:** Los Angeles**E. Region:** 05**F. Forest:** Angeles National Forest**G. District:** 53**H. Fire Incident Job Code:** P5HH9J**I. Date Fire Started:** May 30 , 2013**J. Date Fire Contained:** June 10, 2013**K. Suppression Cost:** \$28 million**L. Fire Suppression Damages Repaired with Suppression Funds**

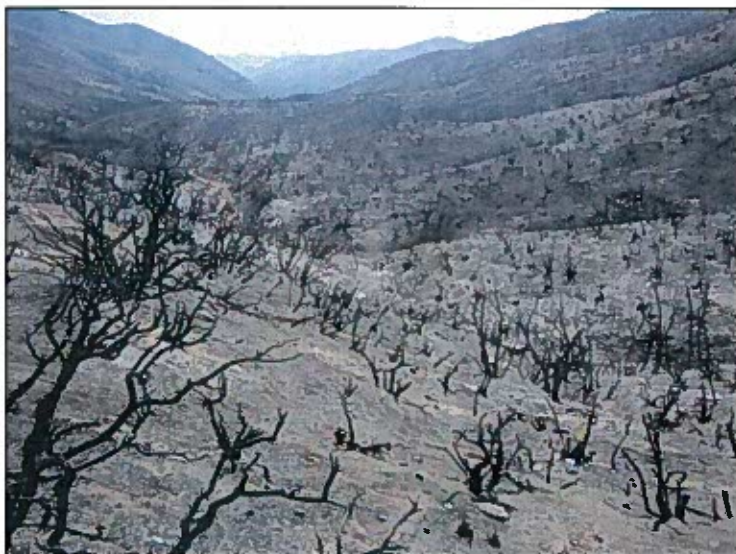
High soil burn severity in mixed oak/brush in upper Tule Crk.

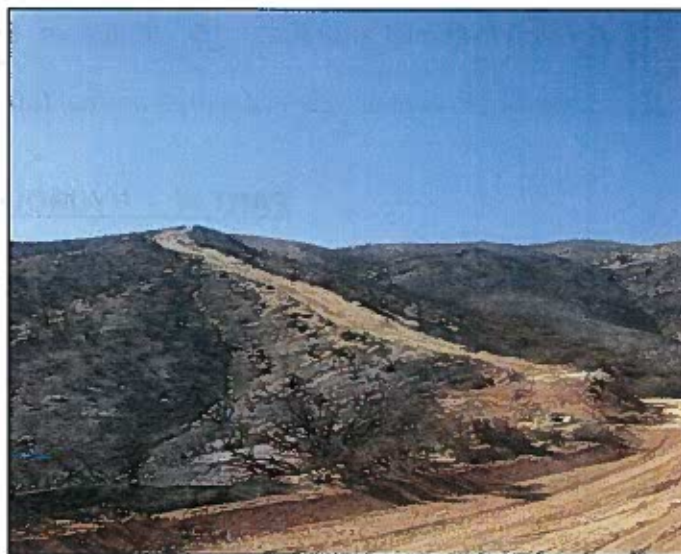
Moderate soil burn severity in upper Tule Creek.

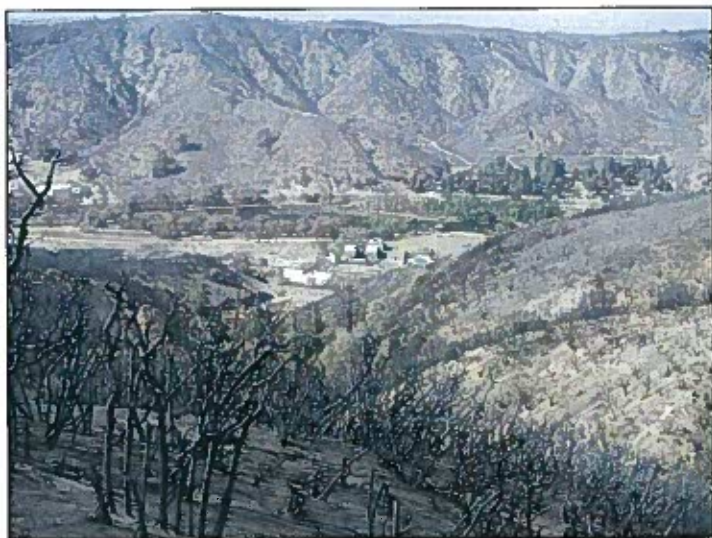
Low soil burn severity in the background of grass and brush

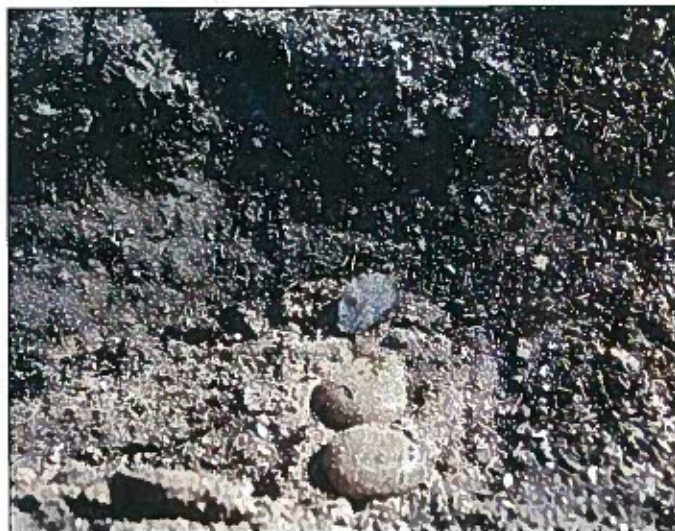
High soil burn severity with char to 2 inches with repellency

Water repellancy is running from 2 to 4 inches deep depending upon soil texture and vegetation that was burned. Steep gravelly scrub oak/manzanita areas that were either south or west-facing burned hot, leaving strong water repellancy down to 4 inches. Deep char and soil organic matter destruction were also present (see pictures above).

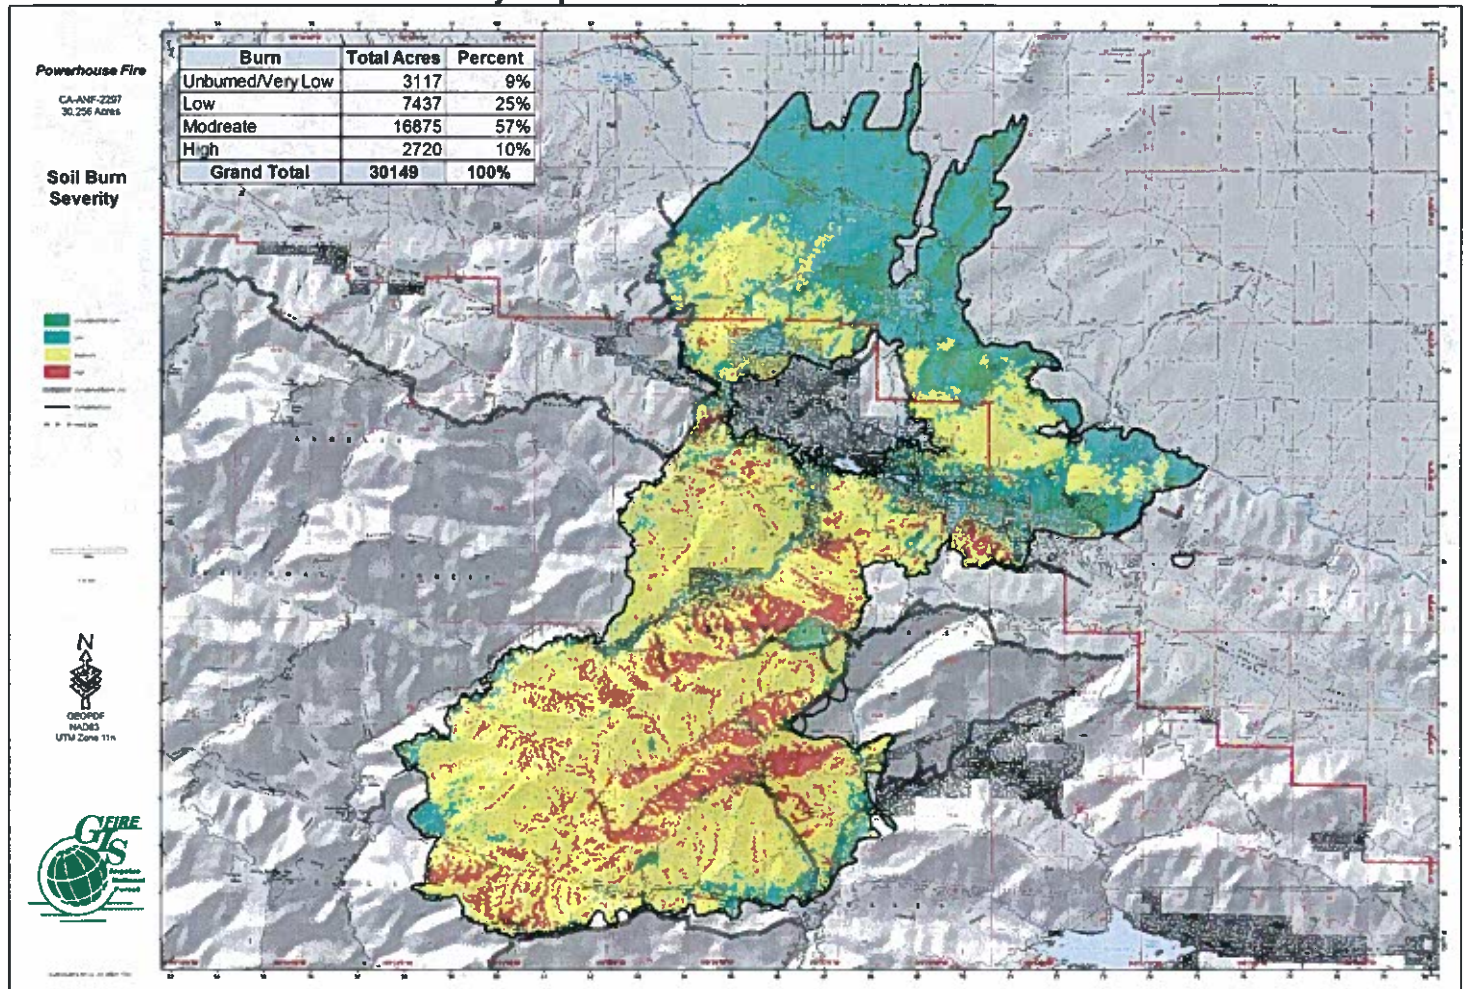
Powerhouse Fire Soil Burn Severity Map:

Approximately 67% of the burn area burned is at a high and moderate soil burn severity (see soil burn severity map below). The rest of the fire was either low or very low soil burn severity. It is very important to understand the difference between *fire intensity* and *burn severity* as discussed by fire behavior, fuels, or vegetation specialists, and *soil burn severity* as defined for watershed condition evaluation in BAER analyses. Fire intensity or burn severity as defined by fire, fuels, or vegetation specialists may consider such parameters as flame height, rate of spread, fuel loading, thermal potential, canopy consumption, tree mortality, etc. For BAER analysis, we are not mapping simply vegetation mortality or above-ground effects of the fire. Soil burn severity considers additional surface and below-ground factors that relate to soil hydrologic function, runoff and erosion potential, and vegetative recovery.
