Subject: Blue Cut Fire BAER Initial 2500-8 Request

Date of Report: 9/6/2016 Initial Request

Blue Cut Fire – San Bernardino National Forest, Front Country Ranger District

BURNED-AREA REPORT
(Reference FSH 2509.13)

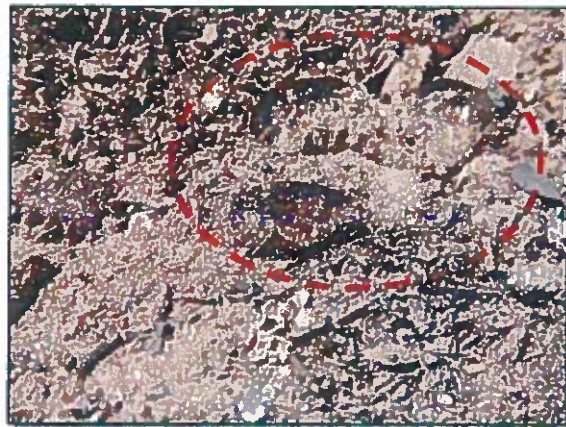
Figure 1: Strong soil water repellency

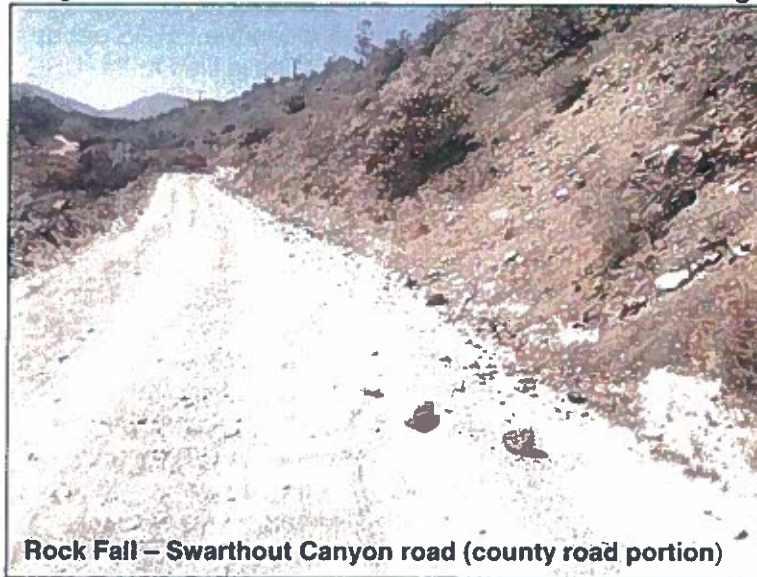
- Roads (Forest Service roads (3N06/3N49) Lytle Creek, Swarthout canyon and Lone Pine Canyon, Hwy. 66 (county), Hwy. 138 (State)): Rock fall occurred under pre-fire conditions below steep cuts and rock outcrop areas before the fire. County maintained Hwy. 66 is a 4 lane highway with the two lanes closest to the burned slopes closed. Rock fall is likely to occur in this area along the road. Rock fall will continue. The risk of rockfall and slope wash (dry ravel) along sections of these roads that burned is considered **High to Very High**.

Rock Fall – Swarthout Canyon road (county road portion)

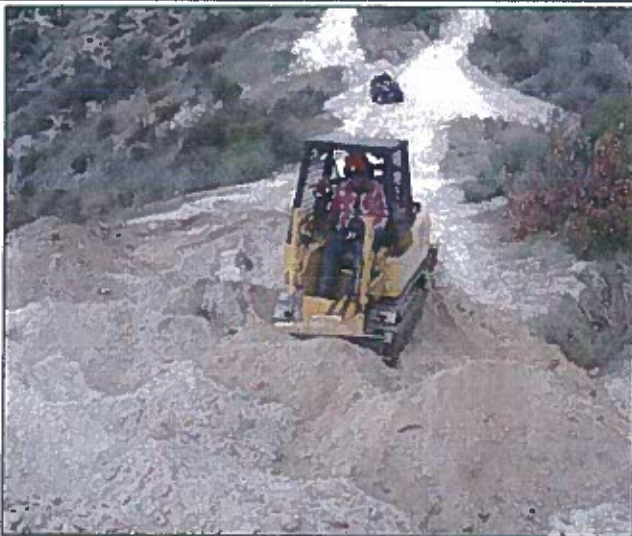
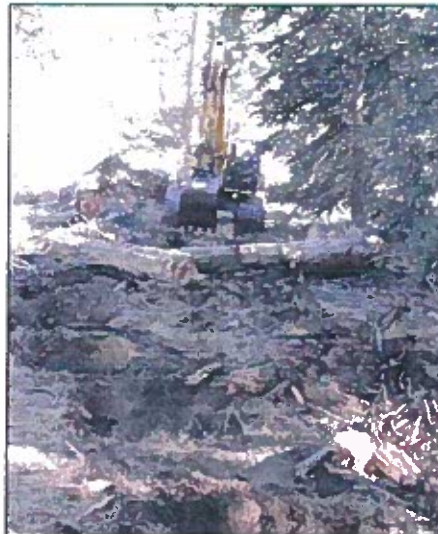
Above: Chunking with an excavator along a dozer line. After chunking, then the equipment spread topsoil and slash from the dozer piles over the treated area.
