Date of Report: 09/22/14

BURNED-AREA REPORT

PART II - BURNED-AREA DESCRIPTION**A. Fire Name:** Slide Fire**B. Fire Number:** ID-NCF-000838**C. State:** ID**D. County:** Idaho**E. Region:** 01**F. Forest:** Nez Perce-Clearwater**G. District:** Moose Creek Ranger District**H. Fire Incident Job Code:** P1J1XW**I. Date Fire Started:** 08/13/2014**J. Date Fire Contained:** estimated 30% as of 9/28**K. Suppression Cost:** \$8,000,000 (costs combined with Wash)**L. Fire Suppression Damages Repaired with Suppression Funds**

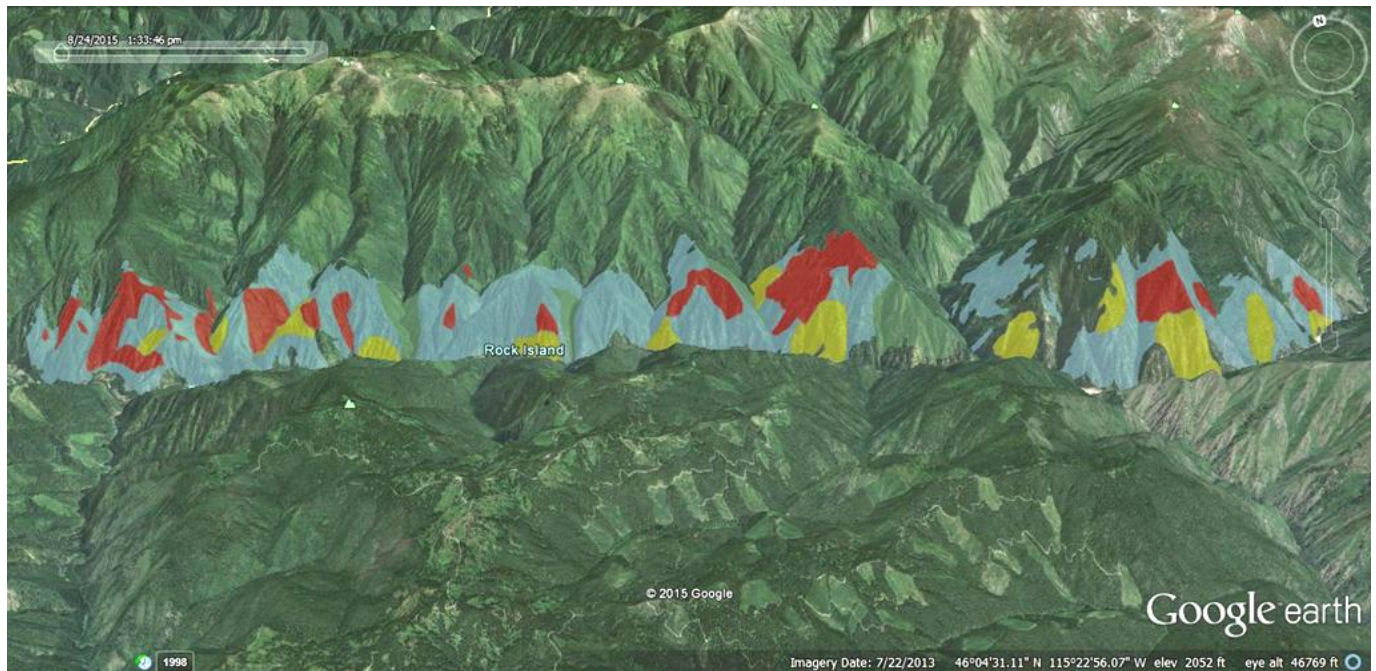
Figure 1: Google Earth Image of the fire area with the burn severity ratings shown
