Date of Report: 06/29/2022**BURNED AREA REPORT**

PART II - BURNED-AREA DESCRIPTION**A. Fire Name:** Sheep**B. Fire Number:** CA-ANF-0174**C. State:** CA**D. County:** Los Angeles**E. Region:** 05**F. Forest:** Angeles**G. District:** San Gabriel Mountains National Monument**H. Fire Incident Job Code:** P5PP6U22**I. Date Fire Started:** 06/11/2022 @ 1836 hrs**J. Date Fire Contained:** 100% as of 06.19.2022**K. Suppression Cost:** \$8 M

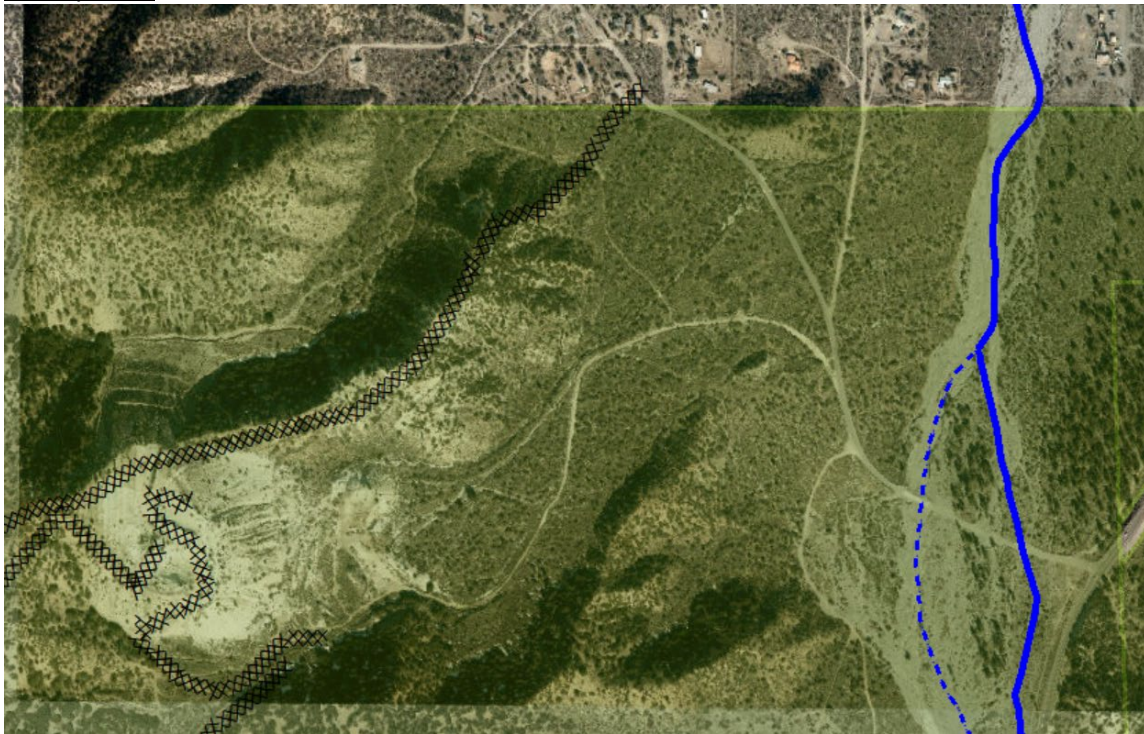
Figure 4 Roads, streams, and dozer lines. Dozer lines are marked as X and surround the quarry. Right bottom corner shows Hwy 2. Road off of Hwy 2 is Desert Front Road.

Quarry Road, Desert Front Road (non-FS road), and Hwy 2 could be damaged in a flood following a 5-yr recurrence storm (or 15-min intensity of 0.43"). For Quarry Road, there are no proposed treatments. The BAER team did note that on Desert Front Road, a concrete low-water road crossings are being undercut. For suppression repair, a firebreak was installed which paralleled 0.14 mi along the Desert Front Road. This firebreak interrupted the many small channels which the road intercepted. For suppression repair, they removed the berms created by the fuelbreak so that water would not flow

down the road, allowing it to flow across the road and continue into the channel on the other side. (Pictures of fuelbreak available upon request). The County road department should be informed of the condition of the road.

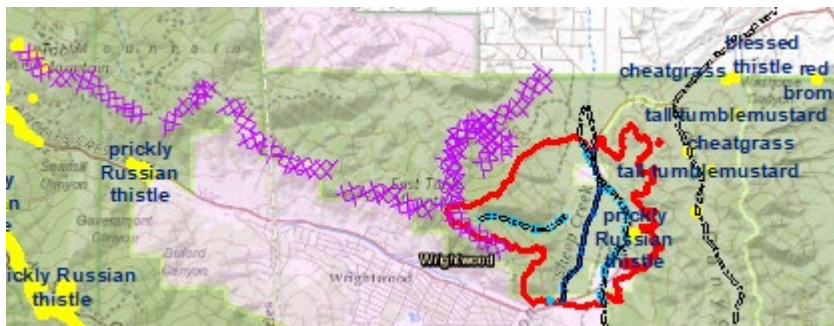
An emergency exists to address the threat of post-fire weed incursion within the fire perimeter and in areas where fire suppression activities occurred. The incursion and dispersal of invasive weeds into areas disturbed by fire suppression and rehabilitation has the potential to establish large and persistent weed populations. In addition, it is highly likely that existent weed infestations along

dozerlines and fuelbreaks will increase in the burn area due to their accelerated growth and reproduction and lack of competition with natives. These weed populations could affect the structure and habitat function of native plant communities within the burn area. The ground disturbances caused by dozer lines are also expected to create accelerated erosion and soil compaction and may contribute to inhibiting recovery of native plant communities. Approximately 16 miles of dozerline were constructed or fuelbreaks were used within and outside of the burn perimeter without a weed washing station. Therefore, it is critical that early and rapid detection surveys and treatment for invasive weeds is implemented within and around the burn perimeter, to improve native vegetation recovery. It is expected that most native vegetation would recover if weed invasions are minimized.

Figure 5. The invasive weeds can be dispersed by equipment as well as wind and water action in streams onto burned areas. (XX are dozer lines, red is fire perimeter, yellow are invasive weed locations with species' names, blue/dark blue are streams.)

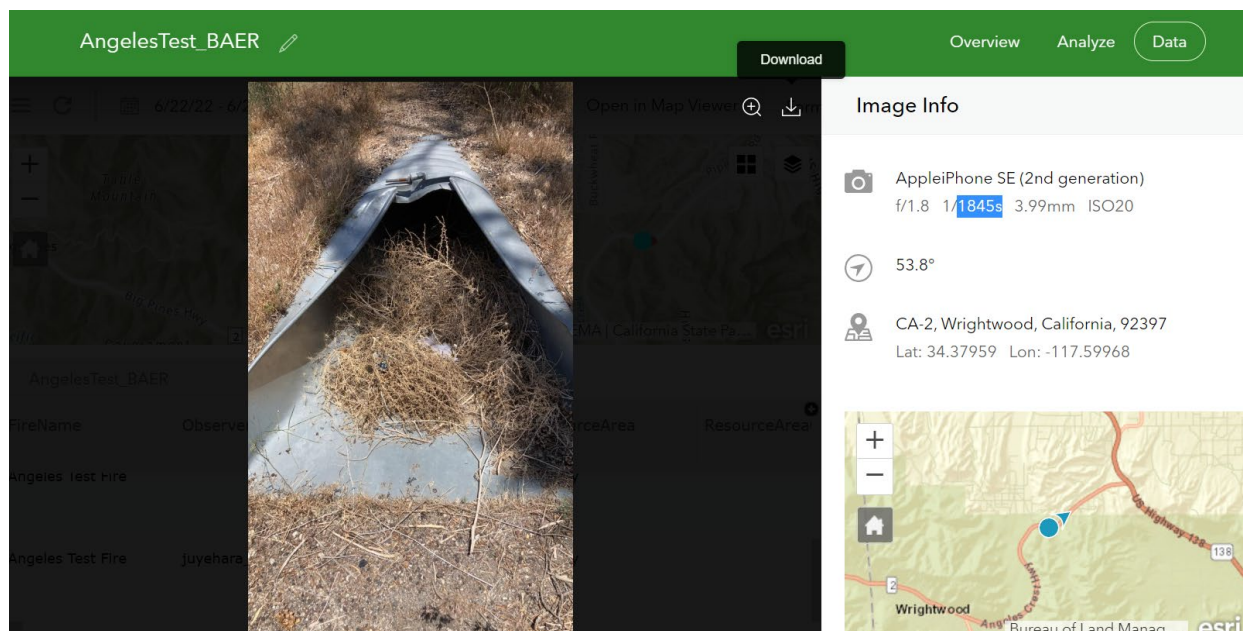
Along Hwy 2, there was a flume with dead prickly Russian thistle. This is within the CalTrans ROW but may want to let them know to remove the Russian thistle along their ROW.

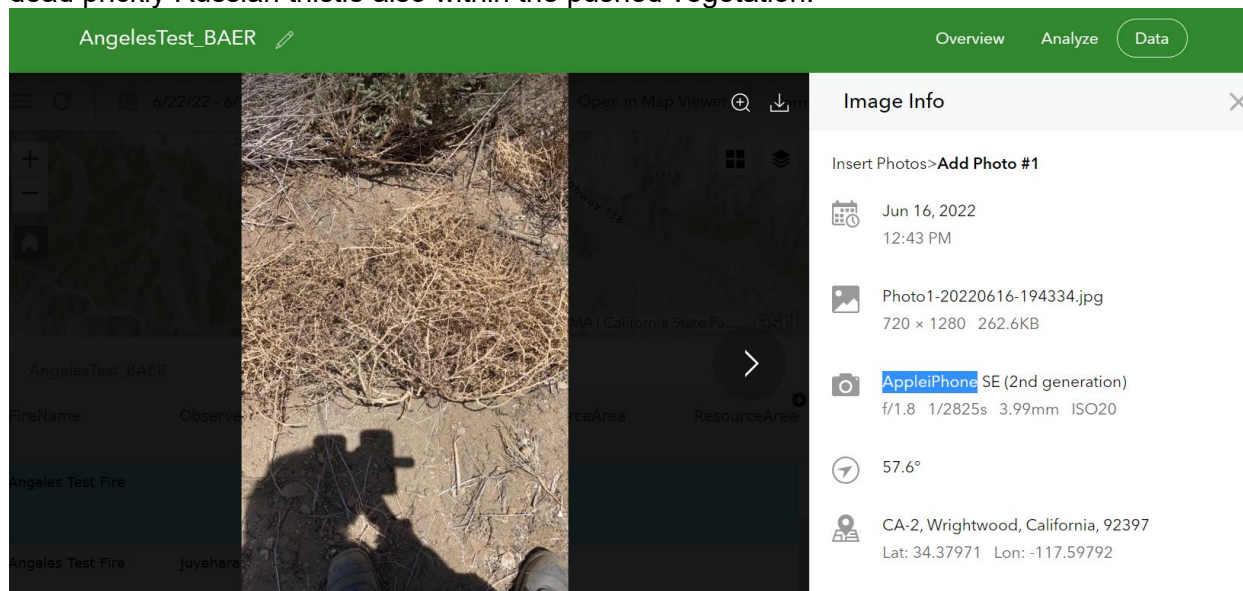
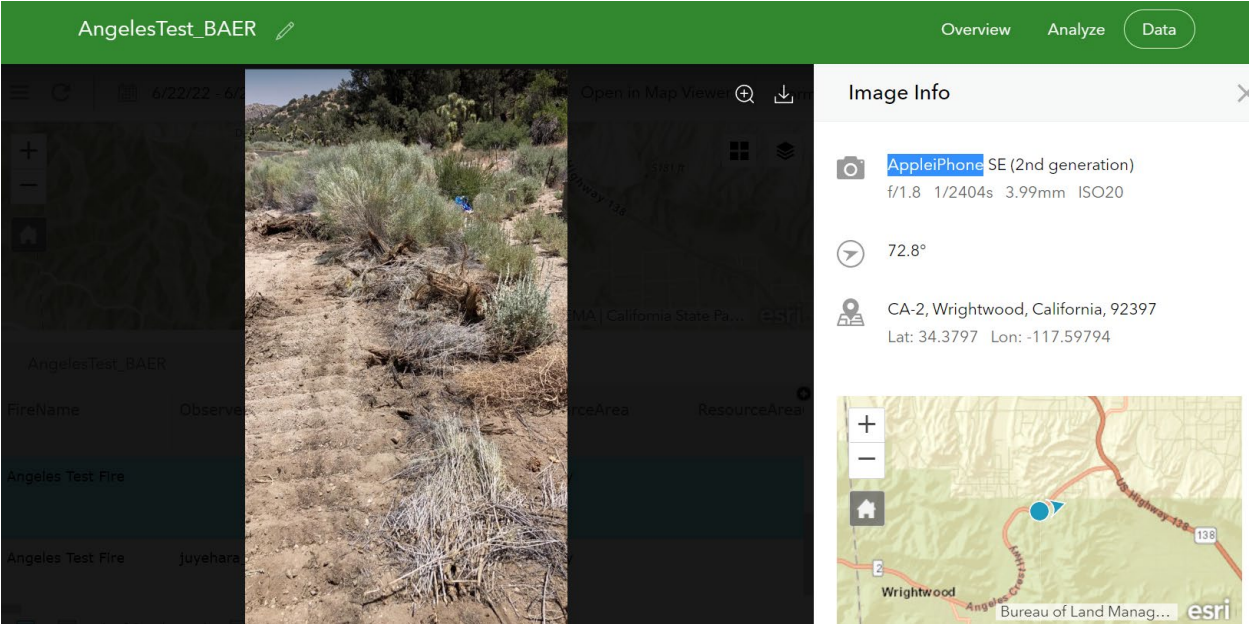
Below, are photos of the shoulder where the vegetation was pushed aside, widening the shoulder. Here was dead prickly Russian thistle also within the pushed vegetation.
