**IRON - ALPS COMPLEX BURNED AREA REPORT**  
(Reference FSH 2509.13)

Granite Fire in Trinity Alps part of the Iron-Alps Complex

- A. Fire Name: Iron-Alps Complex
- B. Fire Number: CA-SHF-001057
- C. State: CA
- D. County: Trinity
- E. Region: 5
- F. Forest: Shasta-Trinity
- G. District: Trinity River Management Unit
- H. Fire Incident Job Code: P5D8HV
- I. Date Fire Started: 6/20/2008
- J. Date Fire Contained: 9/05/08
- K. Suppression Cost: 72 million
- L. Fire Suppression Damages Repaired with Suppression Funds
1. Fireline (miles): 352
  2. Fireline waterbarred and seeded (miles):
  3. Other (identify):
- M. Watershed Number: 26539846 - Trinity River
- N. Total Acres Burned: 105,367
- NFS Acres( 101,000)    Other Federal (1,386 )    State ( 10)    Private ( 3,180)

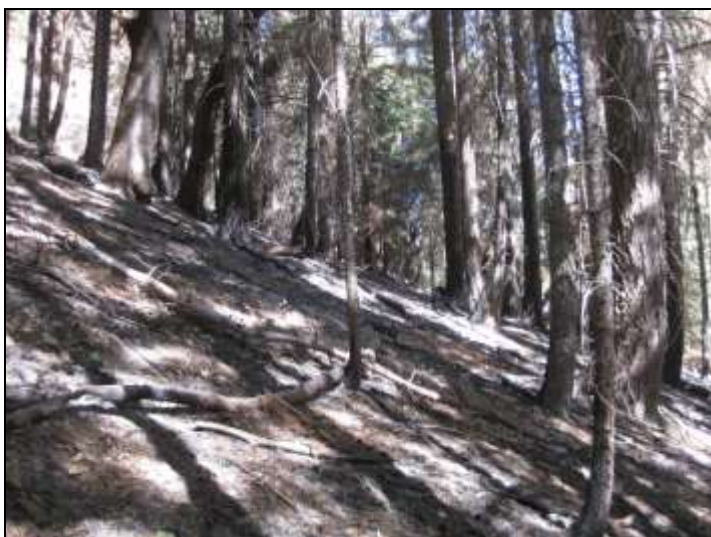
Approximately 17% burned at high and moderate soil burn severity (see soil burn severity map below). The rest of the fires were either low or very low soil burn severity. General trends are forested areas that were north or east-facing slopes were nice mosaic under-burns. Forested areas that were south or west-facing slopes burned hotter and had tree mortality of 30-60% with ridges burning hotter (see pics below).

Ironside Fire under-burn

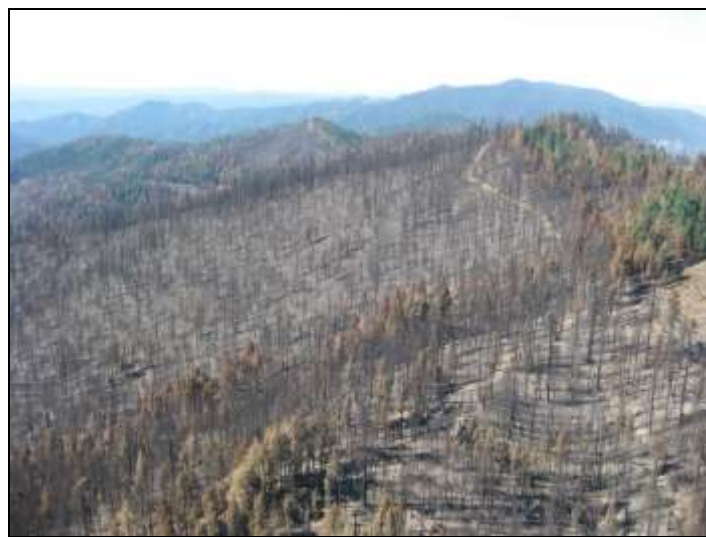
Eagle Fire ridgeline above Big Creek into Hayfork

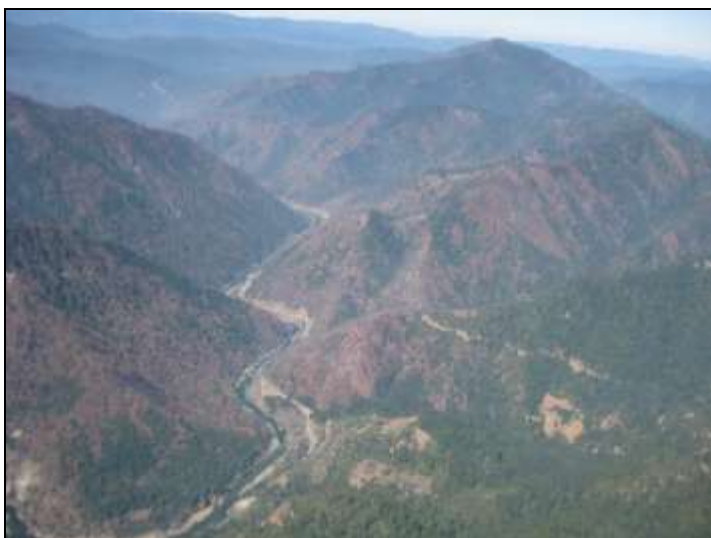
Chaparral areas that were north or east-facing slopes had moderate soil burn severity were patchy. Chaparral areas that were south and west-facing, burned moderately high to high soil burn severity removing almost all vegetation (see pics below).

Cedar and Buckhorn Fire mixed timber/brush

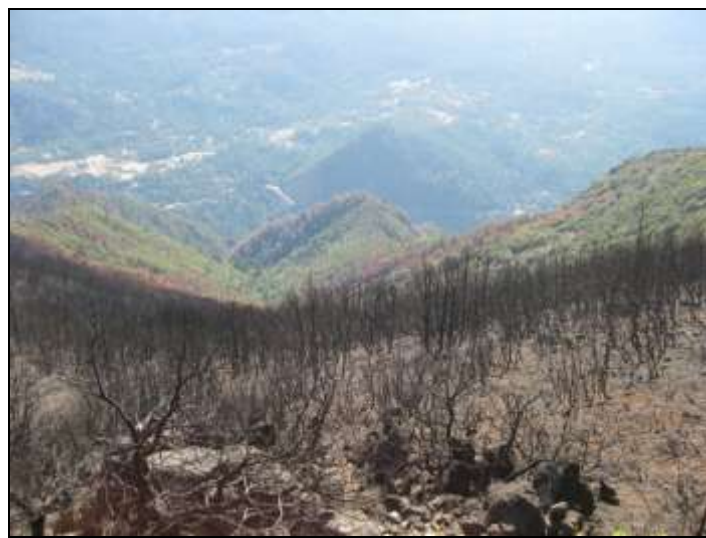
Ironside Fire brush fields

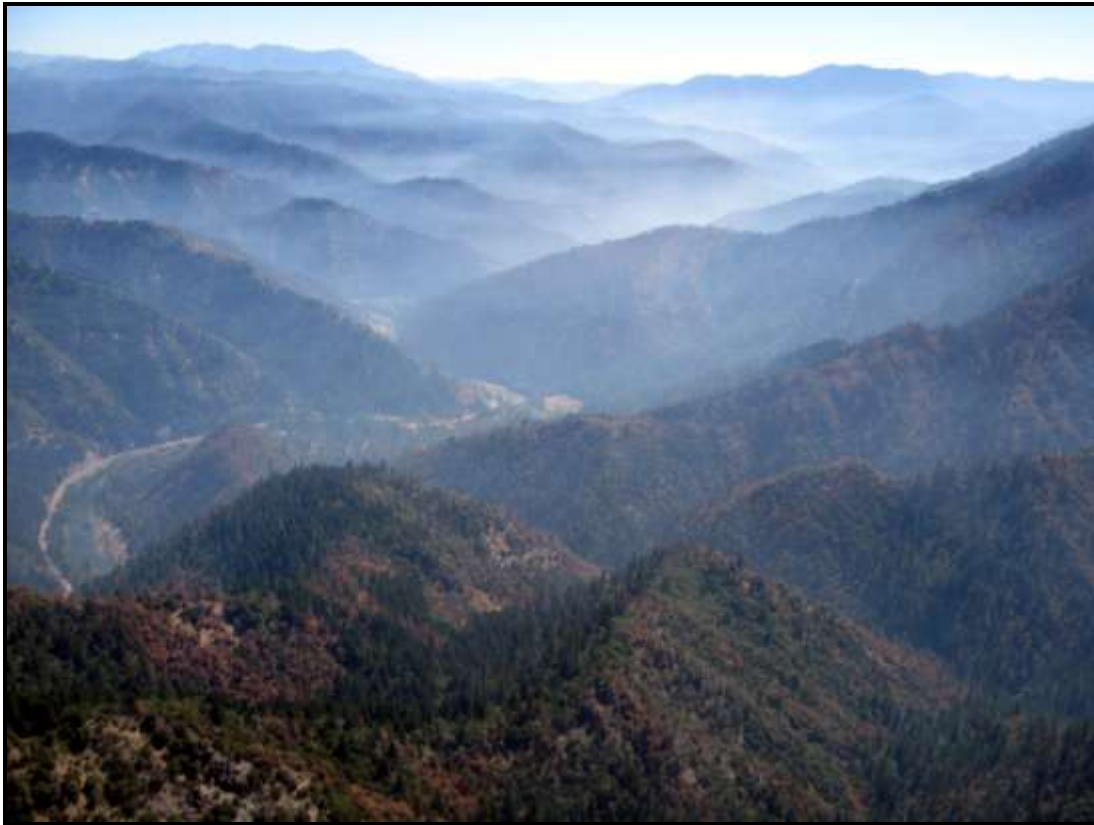
Eagle Fire, Big Bar Vicinity
