FORENSIC ANALYSIS OF FAILED SURGE ARRESTORS

Gujarat Energy Transmission Corporation Limited

28th April 2016

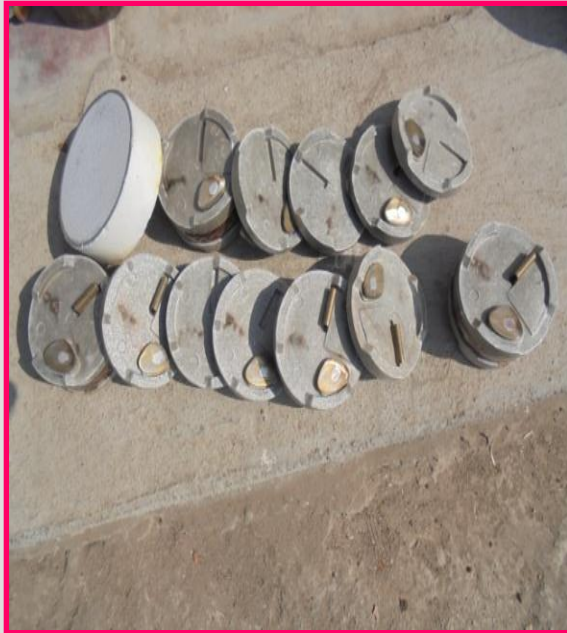
Moisture Ingress

Green Copper
Oxidation

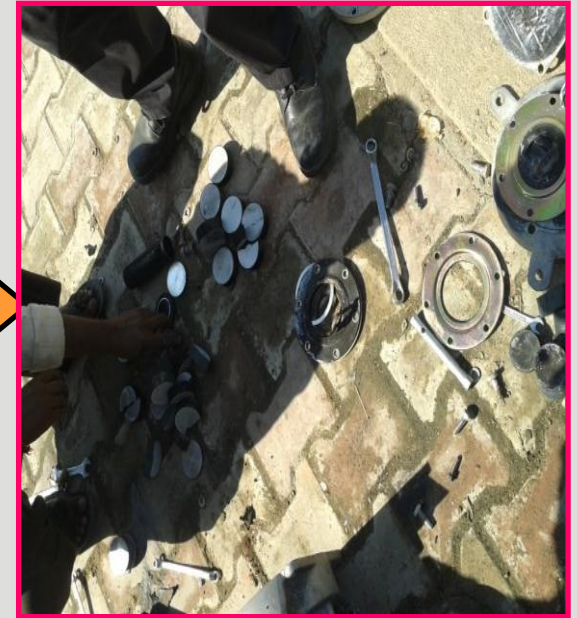
Cracked Discs

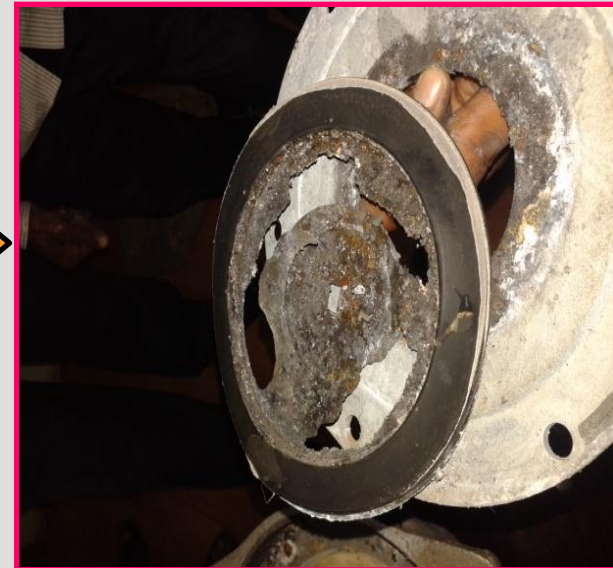
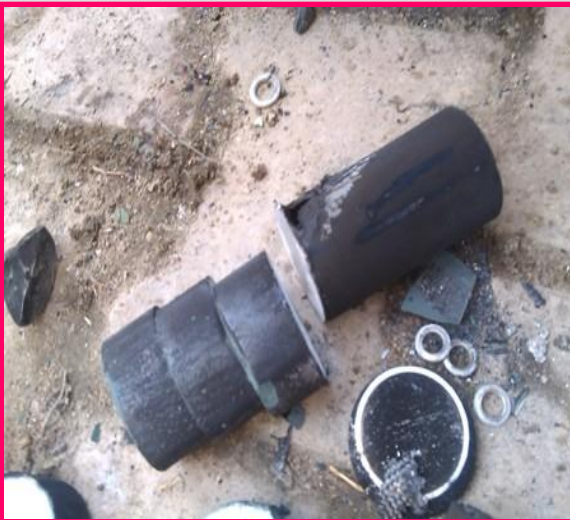
Multicolor
Growth

Corroded
Internal Parts

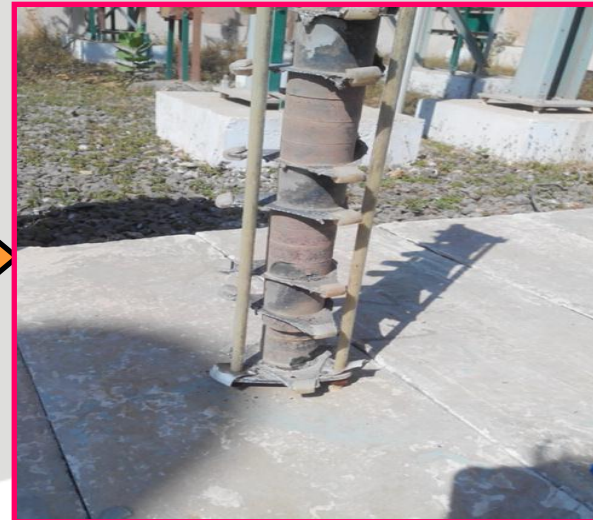
Broken edges
& corners

Discoloration
of internal
parts

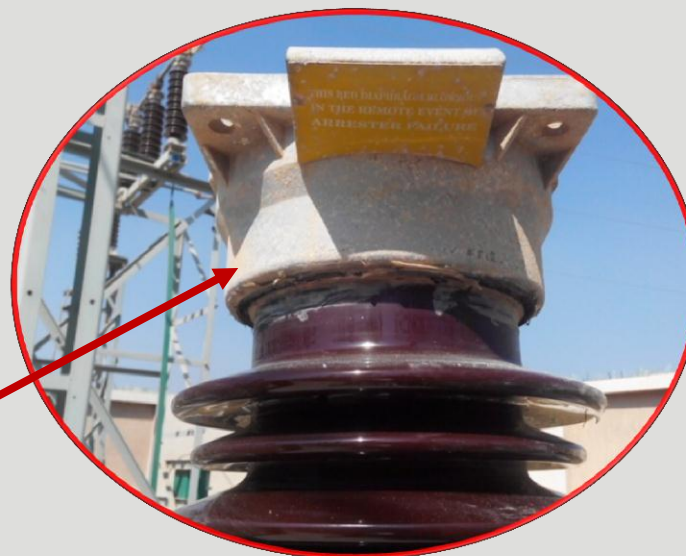
- Bushing & casting found intake.
- No any flashover marks observed .
- Top end cover plate found open.
- Seal damaged.

Sealing at top flange found damaged which indicates possibility of moisture ingress inside surge arrester.

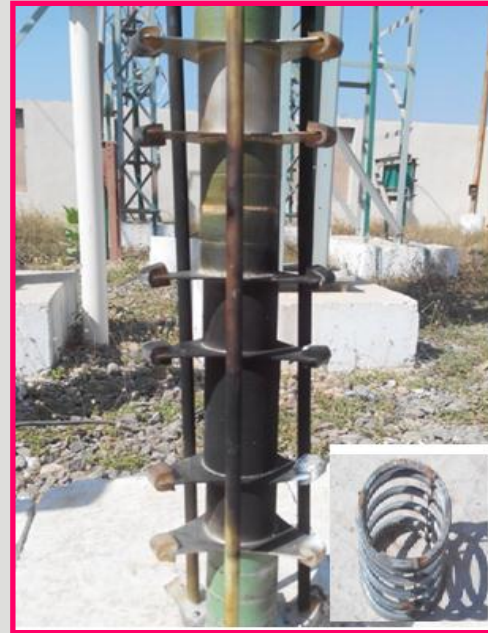
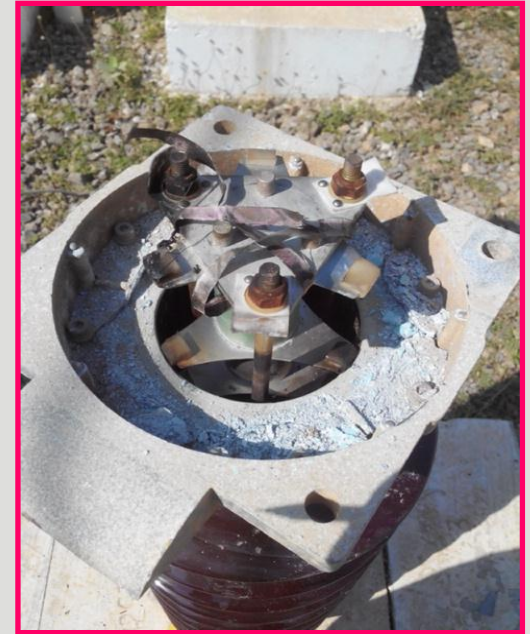
- ZnO discs found flashover.
- Carbon contamination observed at stack.
- FRP rod found damaged.
- Stack separators and supporters melt partially.
- Spring corroded slightly.
- Gasket found damaged.

- Brown rust on metal parts, white rust on aluminium parts, corroded spring and damaged gasket denote entrance of moisture inside.
- Discoloration on some of the discs, multi colored growths on rubber components and colored internal parts were observed which points out possibility of Partial Discharge.

Rusting on metal parts and carbon contamination confirm presence of moisture inside surge arrestor. Due to this moisture, partial discharge activity accelerated and finally resulted in thermal runaway of surge arrestor.

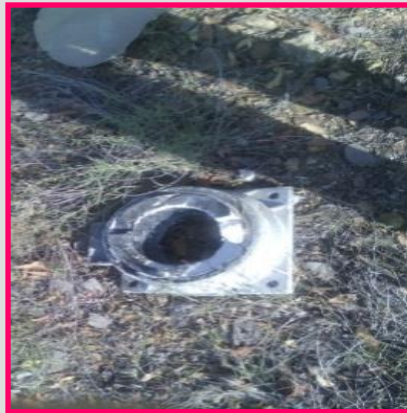
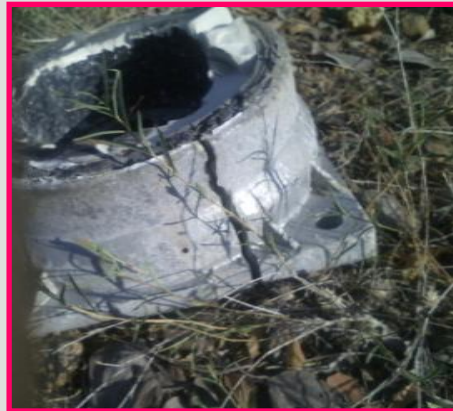
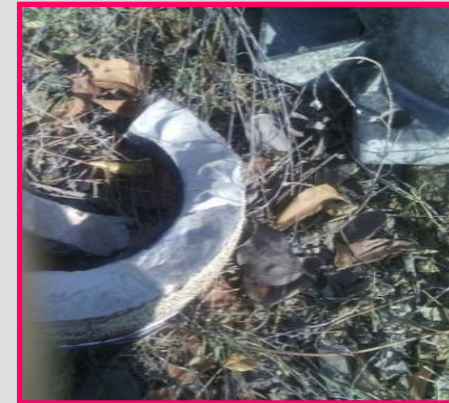
- Bushing completely broken in pieces
- Both end cover plates damaged

Totally broken bushing and end cover plates designate heavy pressure produced inside the surge arrestor.

- Gaskets totally damaged
- Stack found displaced
- All discs damaged
- Presence of flashover marks on FRP rod
- Stack supporters and few of stack separators partially melted

So it is certain that there was an exchange of moist air between atmosphere and surge arrestor which resulted in internal flashover with heavy pressure developed inside.

Due to this acute pressure, bushing was broken into pieces with blast.

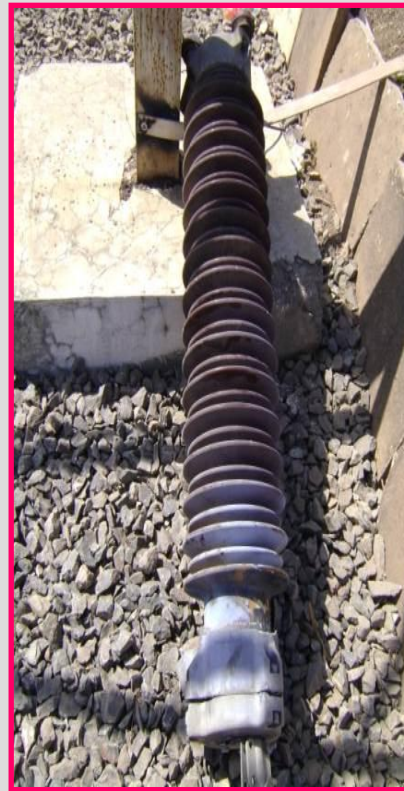
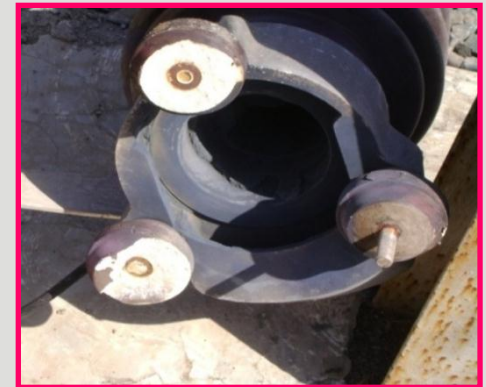
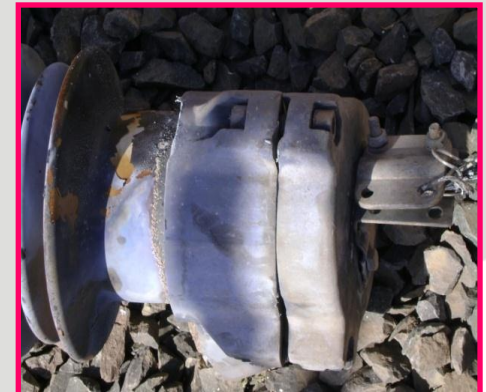
- Flashover marks on bushing
- Castings ,Terminal connectors and terminal bracket & Support insulators broken.
- Bottom portion of surge arrester damaged completely.

Marking of arcs on housing & base envisage possibility of external flashover.

As per field report, the surge arrestor was having high leakage current (LCM reading- **444 μA**) which indicates degrading of property of ZnO discs at rated voltage.

Moreover, this surge arrestor was installed at 132 kV **capacitor bank**, so it is prone to frequent switching surges.

In view of this, it can be concluded that during any switching operation the surge arrestor might get failed while withstanding voltage swing and consequently flashed.
