# 787-8

## Flight Crew Operations Manual Bulletins

### Air India Limited

Bulletin Package Revision: 8F  
Bulletin Package Date: January 23, 2013

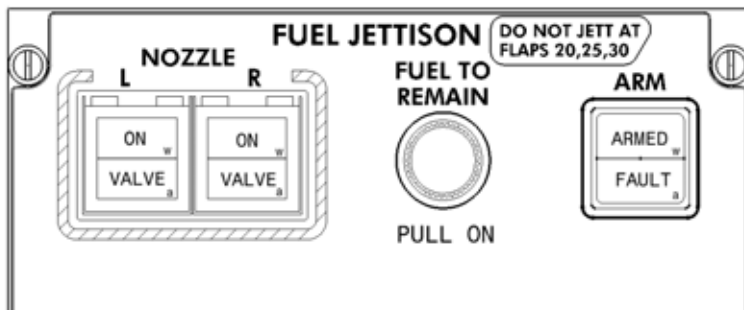
**Reason:** Flaps 20 or greater, in combination with certain side-slips, causes the fuel to re-attach/impinge on the aft portion of the wing while jettisoning fuel.

Do not jettison fuel at Flaps 20, 25, or 30. This restriction is included in the “Fuel Jettison” Checklist as well as the placard installed on the Fuel Jettison Control Panel as shown below:

Development and testing of a replacement jettison nozzle is underway. The re-designed nozzle is expected to allow jettison at all flap settings and jettison attitudes.

Note: Do not jettison fuel at flaps 20, 25, or 30

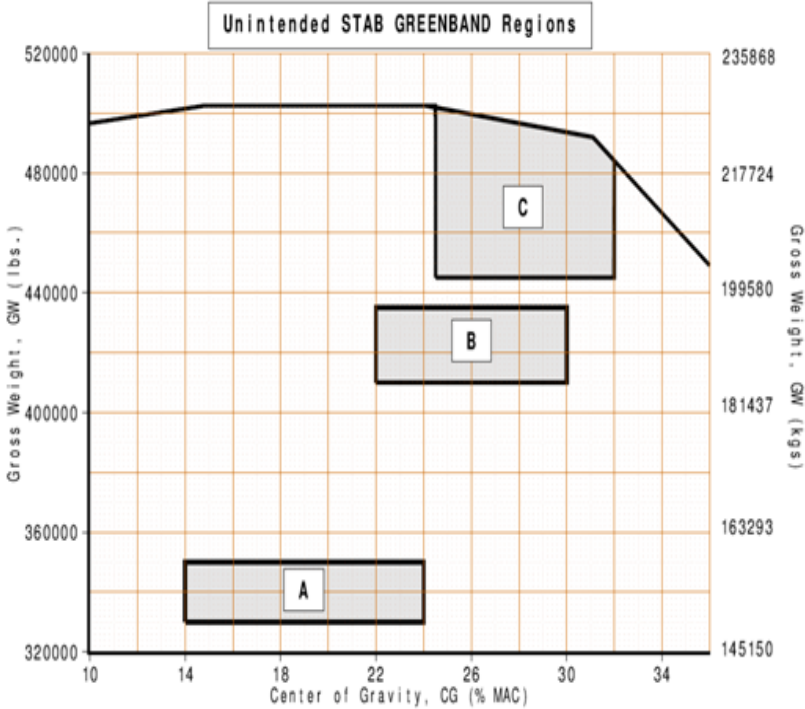
When verifying airplane loading an additional check may be accomplished to verify that the STAB GREENBAND message is a nuisance. Use the chart below to identify regions of the GW and CG envelope most susceptible to this nuisance message. If the airplane GW and CG are in region A, B, or C, the flight crew may confirm the nuisance by temporarily entering a CG value 3% MAC forward (lower value) than the value on the load manifest. This temporary entry causes the greenband trim range to be recalculated. If the message blanks after approximately 5 seconds, the nuisance condition is verified. (If the message stays shown after 5 seconds, the nuisance condition is NOT verified.) The flight crew must then re-enter the correct CG value from the load manifest and check that the stabilizer is set to the correct position. The message is likely to show again approximately 30 seconds after the correct CG is re-entered. If the STABILIZER GREENBAND checklist is displayed again, it should be overridden.

In the remote case that the STAB GREENBAND message is accurate and a real mistrim exists in one of these regions, takeoff can still be safely accomplished. This amount of mistrim has been demonstrated during flight test and can be flown safely using normal pilot technique.

Area	CG Range (% MAC)	GW Range (lbs)	GW Range (kgs)
A	14 - 24	330000 - 350000	149685 - 158757
B	22 - 30	410000 - 435000	185973 - 197313
C	24.5 - 32	445000 - MTW	201849 - MTW

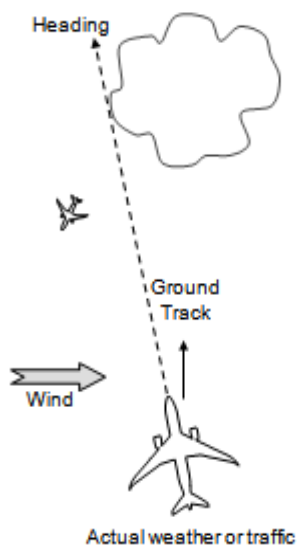
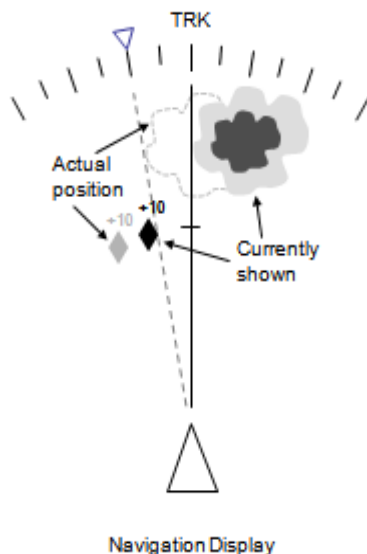
All other information including terrain, navigation data, and VOR pointers are shown with the correct track-up orientation.

This error only affects the relative bearing of the information shown and does not affect TCAS or PWS alerting functions.

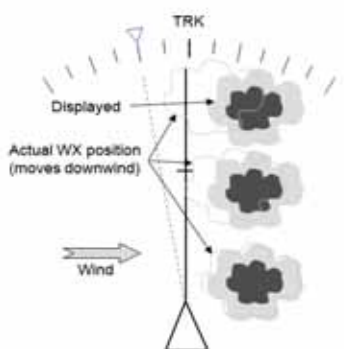
ND Radar Target Displayed  
Downwind of Track

Weather shown downwind of the track line will continue to move away from the track line. For weather shown upwind of the track line, the aircraft track will be further from the weather than shown. While the angular error stays constant (equal to the drift angle), the magnitude of the cross track error will decrease as the range to the weather decreases and will be zero when the aircraft is abeam the weather target.

- Crews should plan the aircraft track to clear weather with the appropriate margins.
- In Visual Meteorological Conditions (VMC), the crew should avoid hazardous weather visually.
- In Instrument Meteorological Conditions (IMC), the crew should assess the weather radar display as the airplane approaches potentially hazardous weather and adjust the aircraft track to clear the weather as shown with the appropriate margins.
